A Reliable Method For Moisture Content Measurement At Inspections And The Results From Nine Swedish Timber Bridges

Niclas Björngrim¹, Per-Anders Fjellström, Göran Berggren

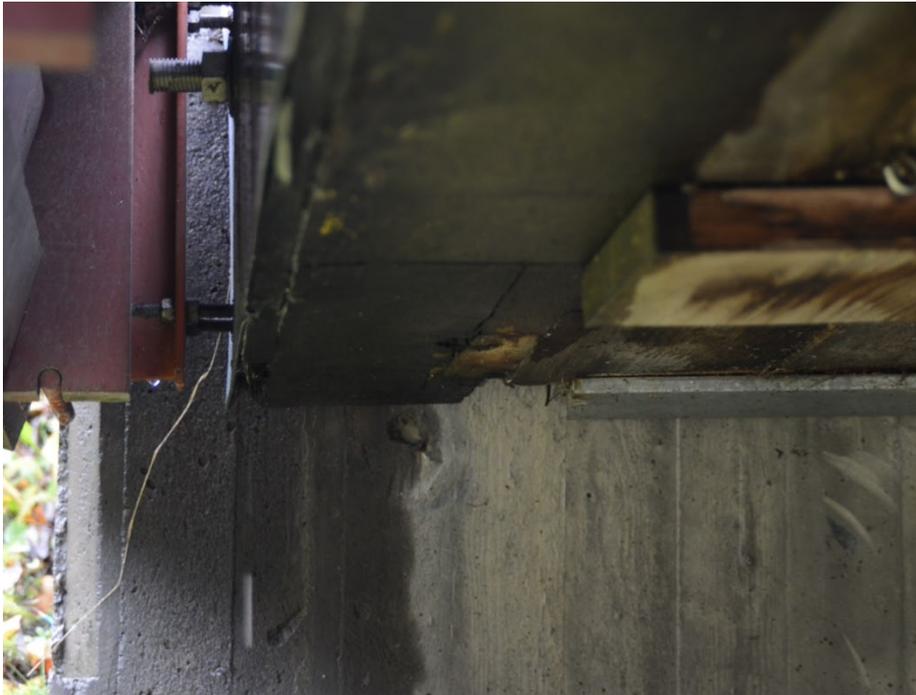
The two consecutive bridges that are similar in construction and appearance. An unusual detail is the outer beams made of oak. The sensors show high surface MC, this originates from a problem with detailing of the edges. On the long bridge this has been exchanged to a better solution and the surface moisture is now normal. The bridge deck underneath the waterproofing membrane show good MC values.

Figure 1. Wet outer beam from Klockarleden short.

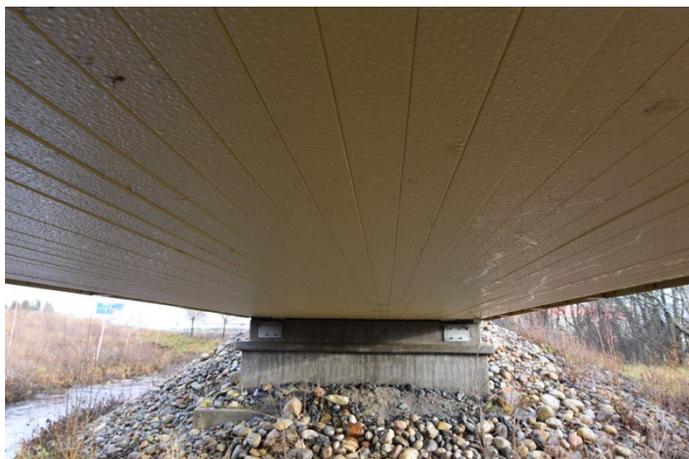
A pedestrian bridge equipped with four sensors. The bridge has increased level of surface moisture due to water condensing (Figure 2), which has led to cupping of the bridge deck.

Figure 2. Condensation on bottom of the bridge deck.

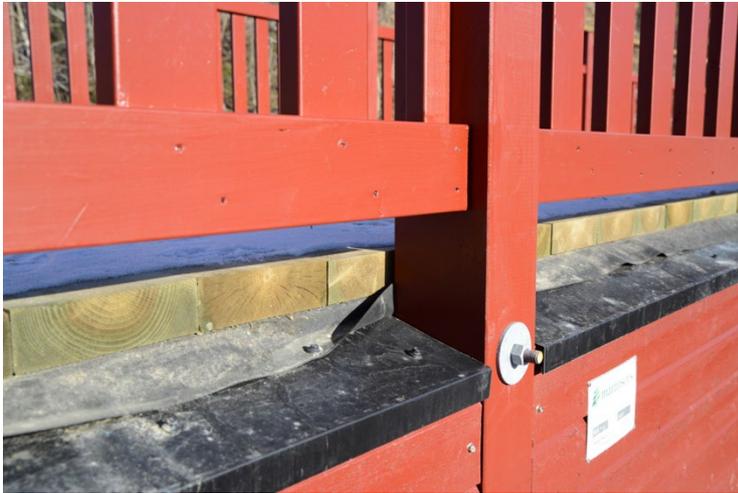
The bridge is a pedestrian bridge with timber decking of treated pine (Figure 3). The bridge has ten sensors factory installed. The manual measurements is showing a MC between 12-16% under the membrane.

Figure 3. Stress laminated deck with a thin rubber membrane and plank decking.

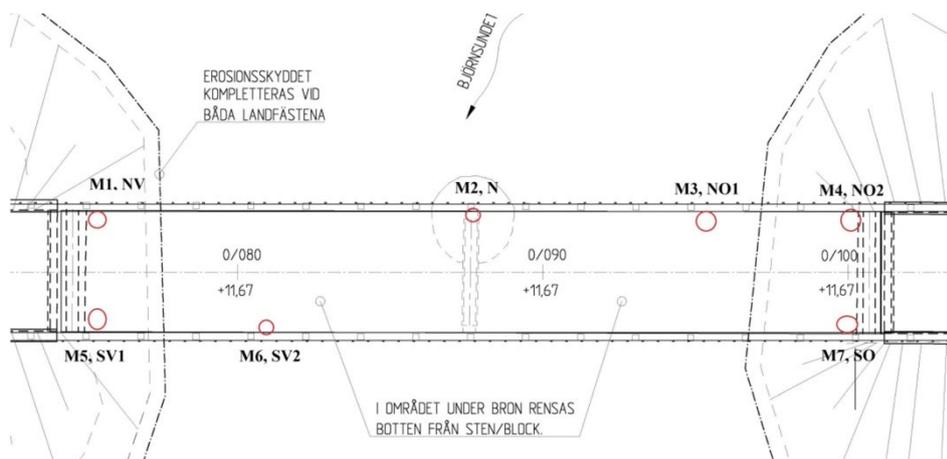
The bridge is a single lane traffic bridge. During the assembly of the bridge one glulam beam, the outermost with sensors M1-M4 in Figure 4, partly fell in to the water. The wet beam was attached and stressed together with the deck in its wet state. The interface between the wet beam and its neighboring dry beam was monitored and it could be concluded that the high local MC dried down to normal levels after a few months. The placing of the sensors can be seen in Figure 4. The MC for 0-45mm in to the deck is shown in Table 2 and the MC 50-520 mm in to the deck is shown in Table 3. Logging of sensor M1, NV 0-45mm is shown in Figure 5. It can be seen that the MC dries down to around 15% from the initial high MC.

Figure 4. Sensor placing Sundbron.

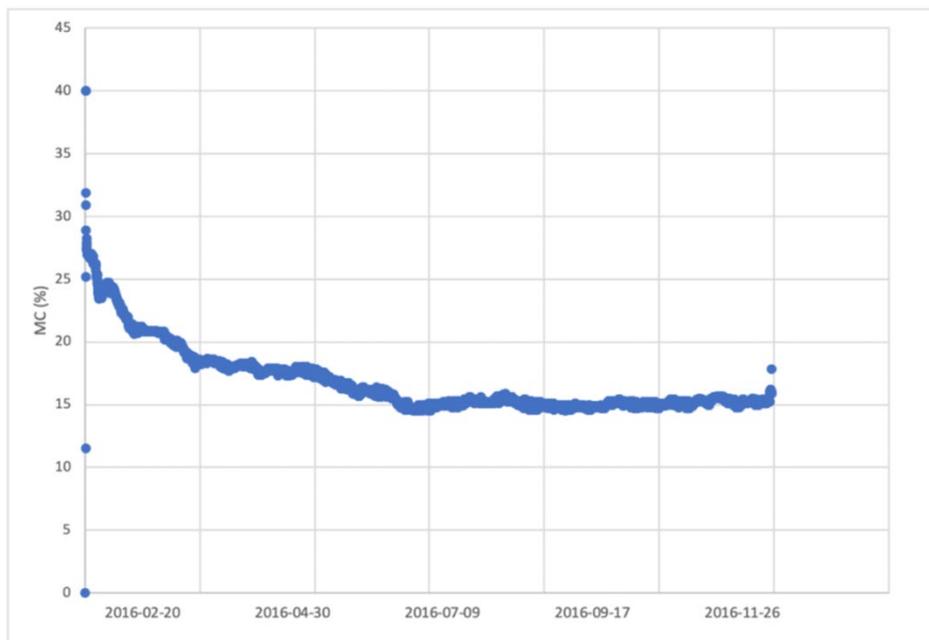
Figure 5. Logging of sensor M1, NV 0-45mm from 11-2-2016 to 15-10-2016.

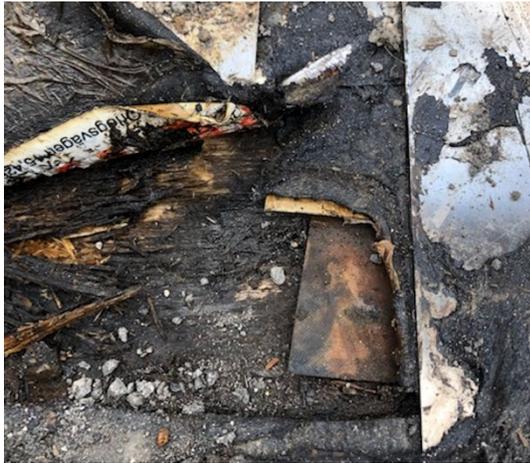
The Gislaved bridge is Sweden's largest road bridge in timber [4]. The bridge is equipped with 16 retrofitted sensors. This bridge shows the importance of acting fast when monitoring data show high moisture content. Elevated moisture content was determined in 2015 and with no actions taken by the owner, areas with severe decay were found during inspections in 2020. After removing the asphalt several problems were found. The membrane strip on the edge of the deck still had the protective backing on (Figure 6) resulting in no adhesion to the deck. The membrane strip joints were not welded which leads to water penetrating in under the drip edge and into the wood deck.

Figure 6. Detail of Gislaved bridge. Membrane strip not properly attached. Decayed wood is also visible.

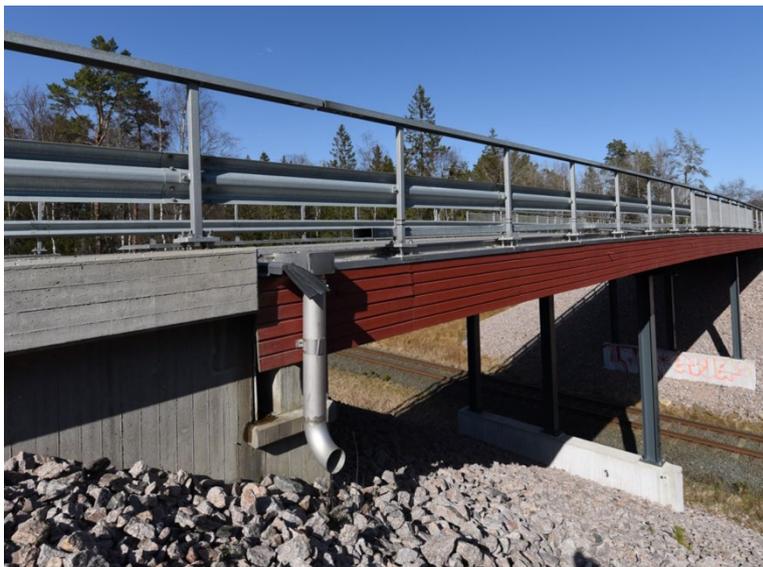
A road bridge spanning a railroad with ten retrofitted sensors. The timber deck from three inspections show expected MC where good detailing such as examples in Figure 7 is a contributing reason.

Figure 7. Good detailing of expansion joint drainage and down pipe.
