# Structural Rehabilitation of a Historic Covered Bridge: Bridgeport Covered Bridge

*Lawrence E. Jones<sup>1</sup>, S.E., Brian S. Wiens, S.E.*

The Bridgeport Covered Bridge was constructed in 1862 by David Inglefield Wood of the Virginia Turnpike Company as a major toll road to support the development of the Comstock Silver Lode across the Sierra Nevada Mountains in western California. The bridge has a substantial span of 63.4 meters (208 feet) over the South Fork of the Yuba River in Nevada County, California. It utilizes a Howe Truss fitted with a supplementary timber arch chord on either side of each main truss. The span has the distinction of being the longest remaining single-span covered bridge in the United States.

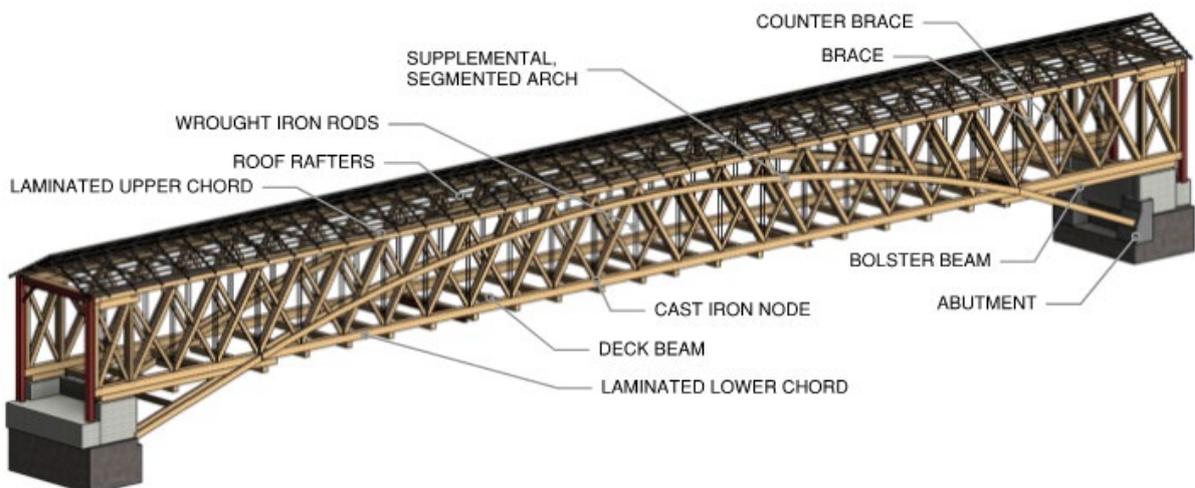
Figure 2 – Graphic of Bridge Components

The Bridgeport Bridge is comprised of timber and iron with stone masonry abutments. The primary bridge structure utilizes a truss on either side of the floor deck which are flanked with a supplemental, segmented arch on the inside and outside face of each truss. The truss has an upper and lower chord with double braces and single counter-braces within the web. The vertical web members consist of two iron tension rods. The chords, braces, counter-braces and tension rods are coincident at cast iron nodes.

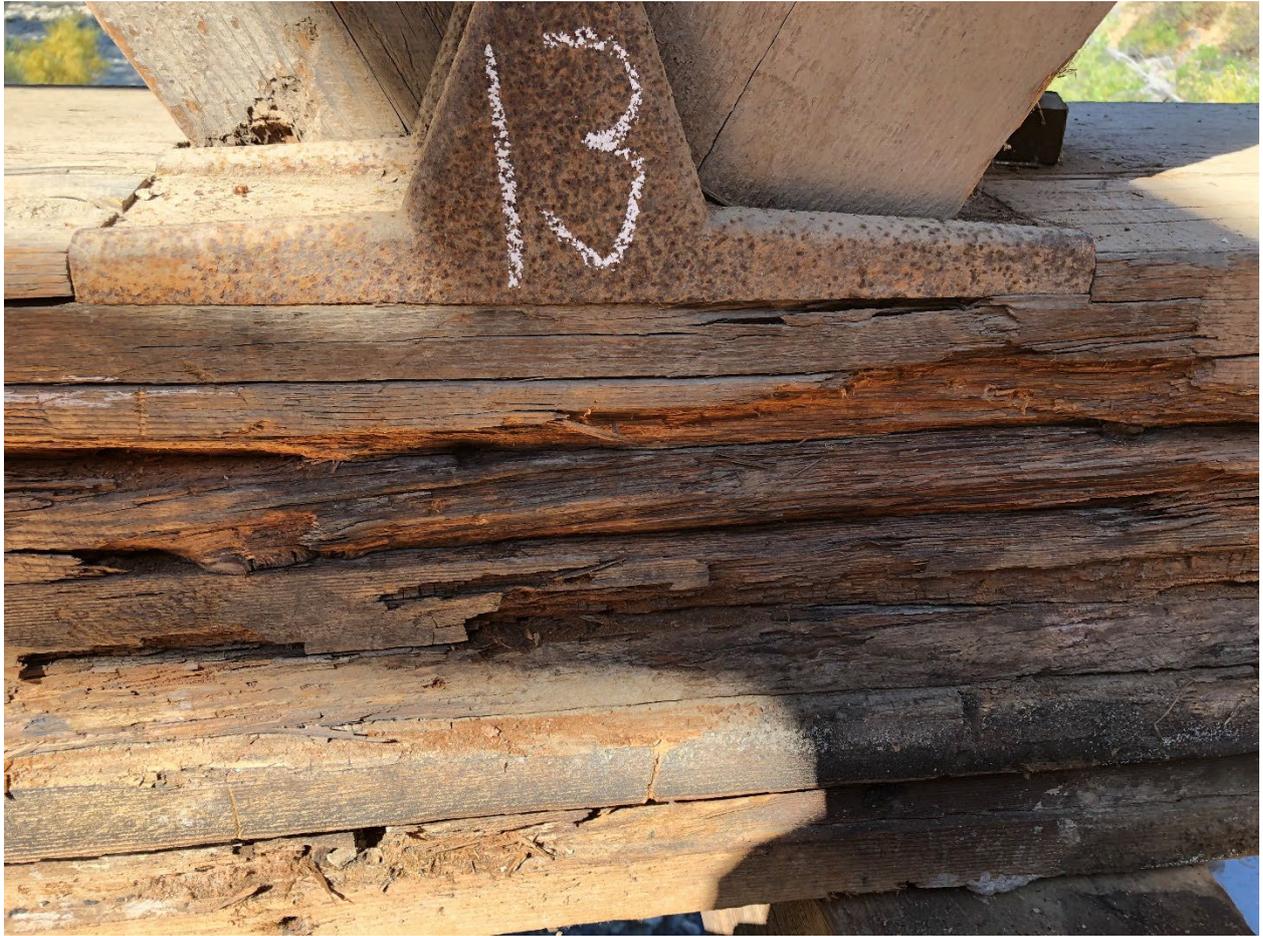
Figure 3 – Photograph of Bottom Chord Decay prior to repair (Lawrence Jones)

The original timbers used to construct the bridge were old-growth timber likely sourced very near to the bridge site (Miller & Knapp, 2013). Wood members were visually graded to obtain member allowable stresses. Specific areas of core decay were identified in the top chord along with local crushing at tension rod connections. One tension rod had failed near the top threaded portion of the rod just below the nut. The existing tension rods were tested for strength and microstructure and the wrought iron rod strength was found to be consistent with historic material strengths.

After disassembly, re-assembly began with repair work on the bottom chord damage. Lamina were replaced and stitched together with GRK timber fasteners. The entire bottom chord assembly was then retro-stitch bolted to strengthen for shear transfer in the staggered laminations. Original cast iron stitch bolts were retained for the historic fabric and augmented with supplemental staggered stitch bolts. For minor wood imperfections, the contractor utilized repair epoxy to fill holes and checks and provide uniform support for the cast iron seats on the truss chords.

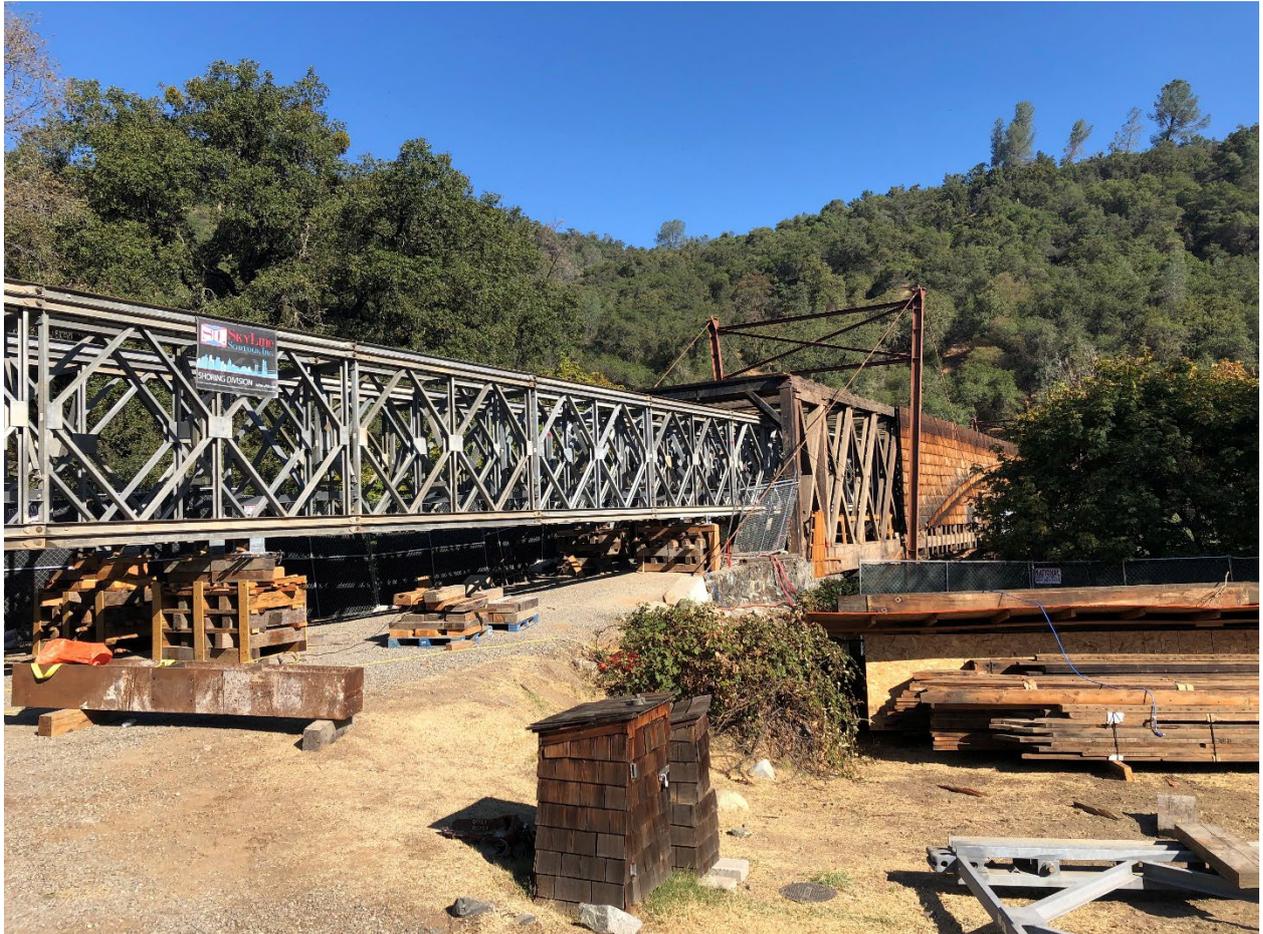
Figure 4 – Launch of shoring (Lawrence Jones)

This box steel truss, named the Mabey Truss, was assembled at one end and launched (pushed) through the bridge and across shoring towers located on the amended footings of the temporary stabilization system coincident with the arch to bottom chord intersection point of the bridge.

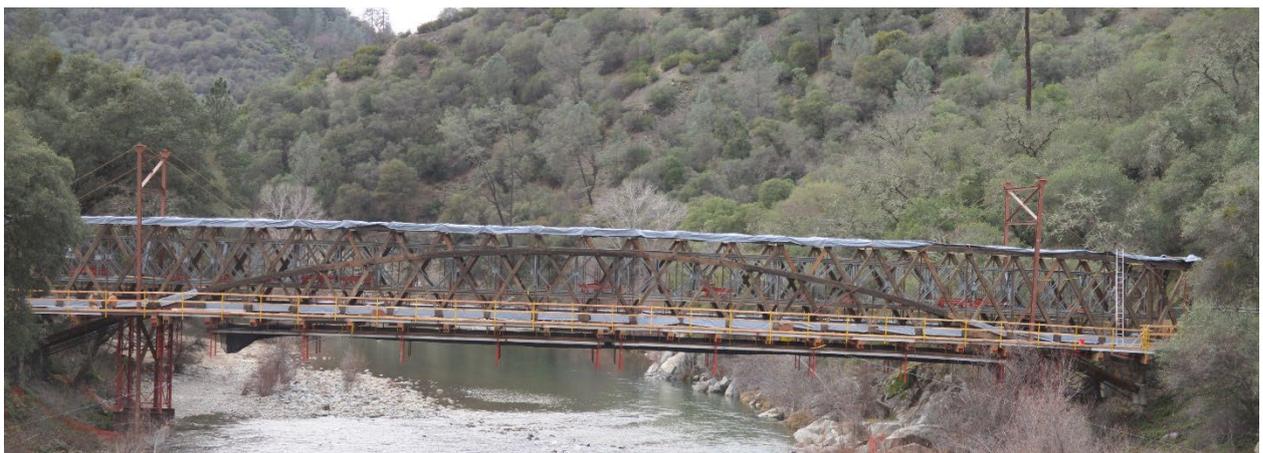
Figure 5 – Bare bridge with shoring installed (John Rebenstorff)

The shoring truss was intended to carry gravity and lateral wind loads during construction. One complication of this shoring system was the inability to support a fully loaded dead weight of the bridge while allowing for completion the bridge floor decking until the shoring rods that supported the work platform which was suspended below the bottom chord were removed. This limitation in the shoring design

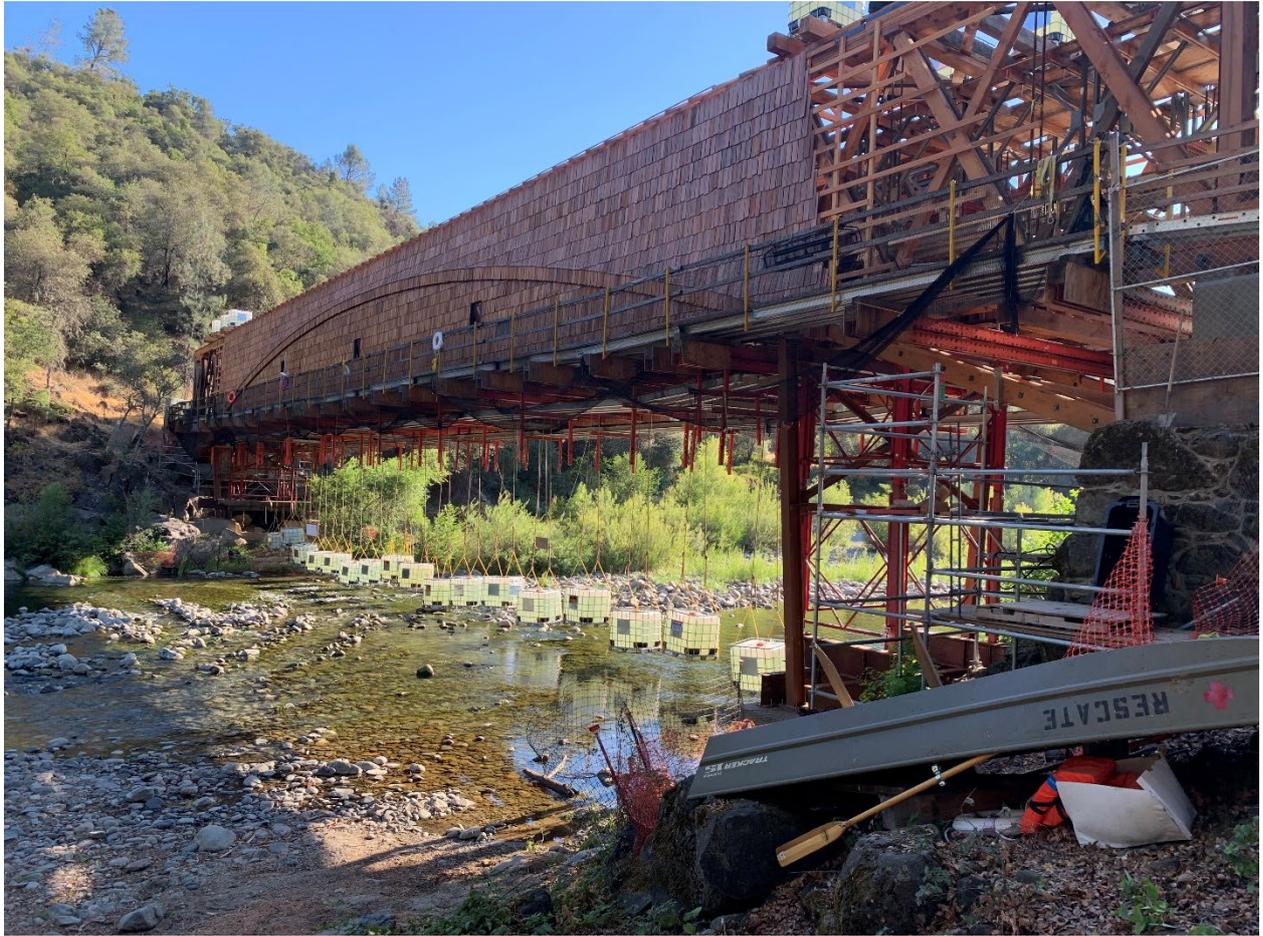
Figure 6 – Load testing bridge prior to shoring removal (Lawrence Jones)

A full-scale dead and moving live load testing program was incorporated into the final approval of the bridge. The dead loads from the skin and decking that were in conflict with the shoring system had to be artificially applied using suspended water totes. The live load testing was accomplished by using calibrated jacks at discrete points against the shoring truss system that was now no longer needed as a gravity support.

Load testing was monitored by a survey of points on the structure to note deflections, strain gages to monitor tension in the bottom chord, and load cells at arch chord seats to monitor compression reactions at abutments. Sounding frequencies of tension rods and arch chord were documented in the testing process.
