Vibration serviceability of timber pedestrian bridge based on field test and analysis

Shingo Kato¹, Hideyuki Honda², Atsushi Toyoda³

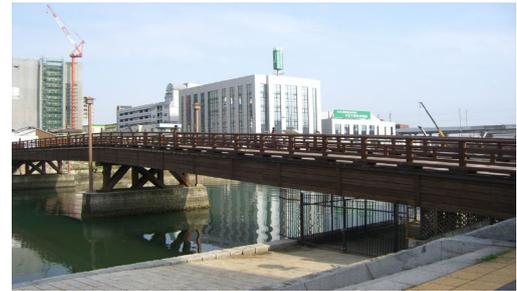
Figure 1. Tokiwa Bridge; subject of this study

The purpose of this study is to evaluate vibration serviceability of timber pedestrian bridges based on experiment and analysis. The subject bridge is Tokiwa Bridge, a large scale three spans continuous girder made by bongossi wood material and constructed at 1995 in Kitakyushu City in Japan as shown in Fig.1. The design geometry is: bridge length: 84.4 m, maximum span length: 31.0 m and clear width: 6.0 m.

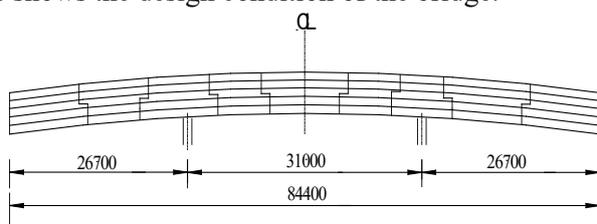
Figure 2. General drawing of Tokiwa Bridge

The general drawing of Tokiwa Bridge; the subject of this study is shown in Fig. 2 to Fig.4. The bridge length is 84.4 m, and the maximum span length is 31.0 m. Each main girder with the cross section of 1200 x 265 mm is 3 spans continuous girder laminated by bongossi material of 5 layers. For this lamination method, drift pins driven in 25 cm interval are used. Fig. 5 and Fig. 6 show the outside and inside of joint part. The reinforce steel element shown in Figure 6 was newly installed in reinforcing work at 2005. Table 1 shows the design condition of the bridge.

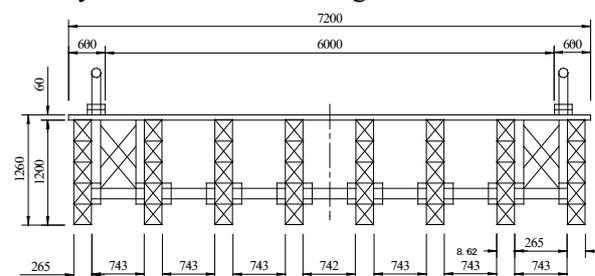
Figure 3. General drawing of Tokiwa Bridge

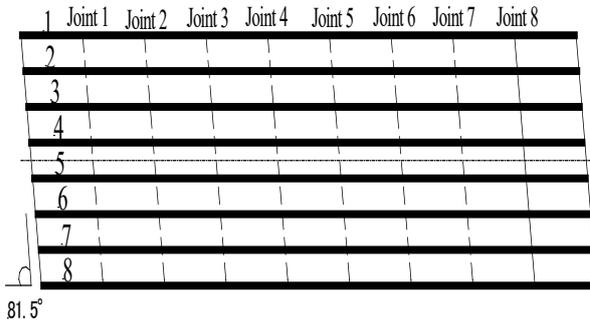
Figure 4. General drawing of Tokiwa Bridge

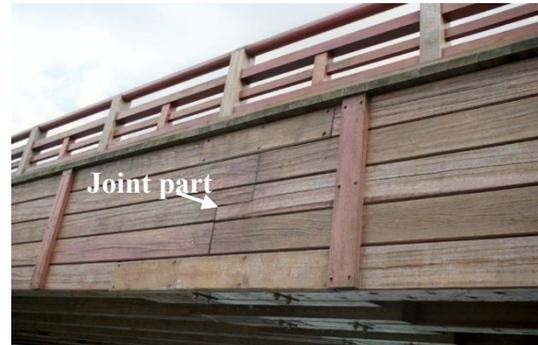
Figure 5. Outside of joint part

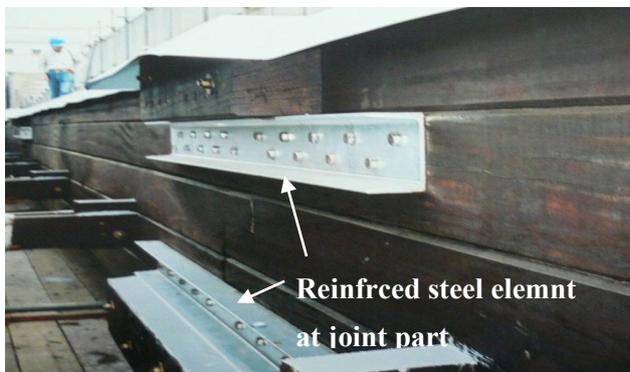
Figure 6. Inside of joint part

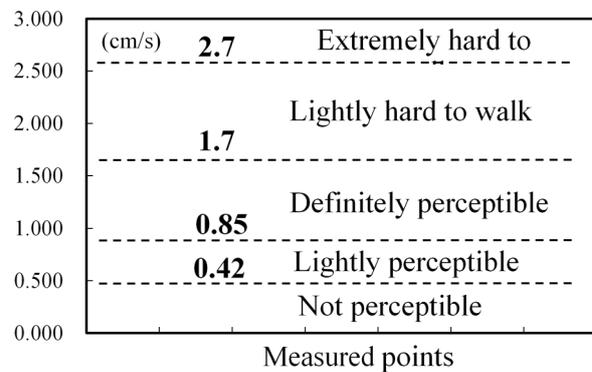
Figure 7. Vibration limit by maximum value of response velocity

In Japan, the vibration limit on discomfort of pedestrian is based on the evaluation of response velocity. The studies by Kobori and Kajikawa (1974), and Kajikawa (1982) greatly contribute for the vibration limit. There are 2 methods to evaluate vibration serviceability by response velocity. Fig. 7 shows the vibration limit by maximum value of response velocity for vibration serviceability. The response velocity of 2.4 cm/s with the sense that pedestrian reacts with a lightly hard to walk feeling is evaluated as a vibration limit value for vibration serviceability of pedestrian bridges. Fig. 8 shows the vibration limit by root mean square (rms) value of response velocity for vibration serviceability. The response velocity of 1.7 cm/s with the sense that pedestrian reacts with a lightly hard to walk feeling evaluated as a vibration limit value for vibration serviceability of pedestrian bridges.

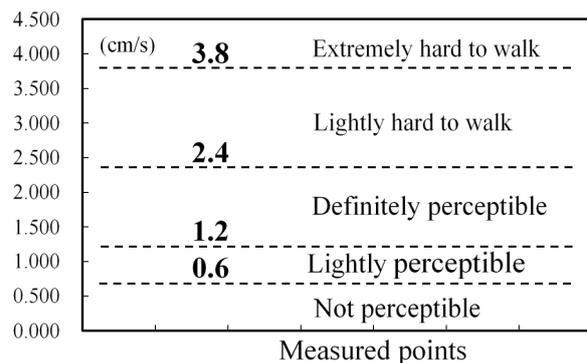
Figure 8. Vibration limit by root mean square (rms) value of response velocity

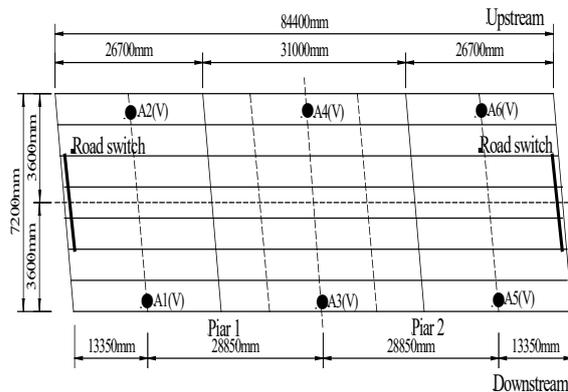
Figure 9. Measurement points of resonant waking and running tests

The field dynamic test was conducted in order to investigate dynamic characteristics of Tokiwa Bridge in 2007. The dynamic test was done by tests such as (1) ambient vibration test, (2) impact loading test by dropping of sand bag with weight 0.3 kN and (3) resonant waking and running tests of pedestrians. The measured data is checked and stored in digital recorder and personal computer, and then the dynamic behaviour and characteristics of the bridge are analyzed in monitoring system of field test. In resonant waking and running tests, the 1-2 pedestrians walked and ran in a pace equal to vertical flexural first natural frequency of 2.25 Hz of the bridge obtained by the ambient vibration and impact loading tests, and then the response velocity and acceleration were measured. This is a critical experimental method in which the bridge becomes in resonant state by the external force of pedestrian with 2.25 Hz. Fig. 9 shows the measurement points of resonant waking and running tests. The symbol of V in this figure indicates the vertical direction of the bridge. The signal of In and Out on transfer of pedestrian is measured by the load switch shown in this figure. The transfer cases of pedestrian are walking and running at edge part of upstream.

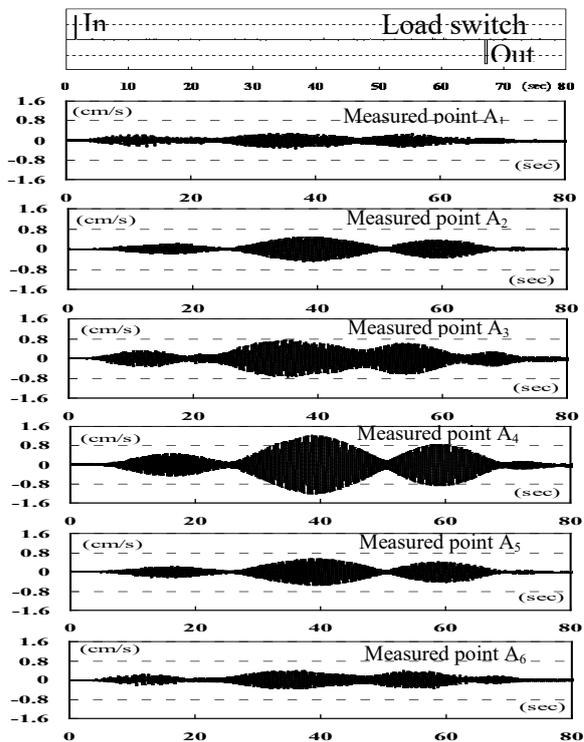
Figure 10. An example of response velocity in one person walking test with resonant pace of 2.25Hz at edge part of upstream

Fig. 10 shows an example of response velocity in one person walking test with resonant pace of 2.25Hz at edge part of upstream. The structural characteristics of three spans continuous girder has appeared clearly from this vibration response wave. In the walking test of one pedestrian, the maximum value of response velocity was 1.23 cm/s at measured point of A4. That value was 1.63 cm/s at A4 in the walking test of two pedestrians. In the running test of one pedestrian, that value was 4.25 cm/s at A4. In the walking test of one pedestrian, the rms value of response velocity was 0.44 cm/s at A4. That value was 0.51 cm/s at A4 in the walking test of two pedestrians. In the running test of one pedestrian, that value was 1.69 cm/s at A4.

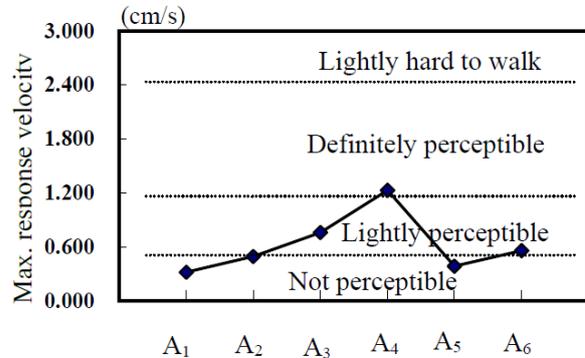
Figure 11. Evaluation of vibration serviceability

Fig. 11 shows an example for evaluation of vibration serviceability by maximum response velocity in the walking test of one pedestrian. Pedestrian may have vibration sense of lightly perceptible, when one person walks in the resonant state. Fig. 12 shows an example for evaluation of vibration serviceability by maximum response velocity in the running test of one pedestrian. Pedestrian may have vibration sense of extremely hard to walk, when one person is running in the resonant state.

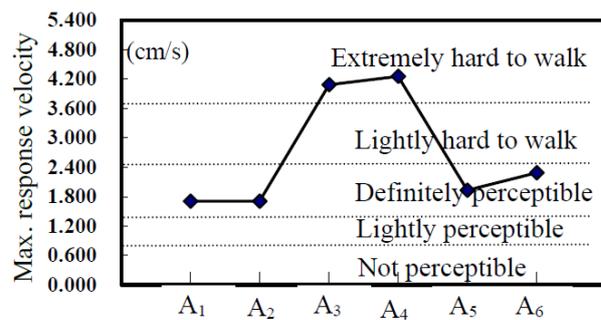
Figure 12. Evaluation of vibration serviceability

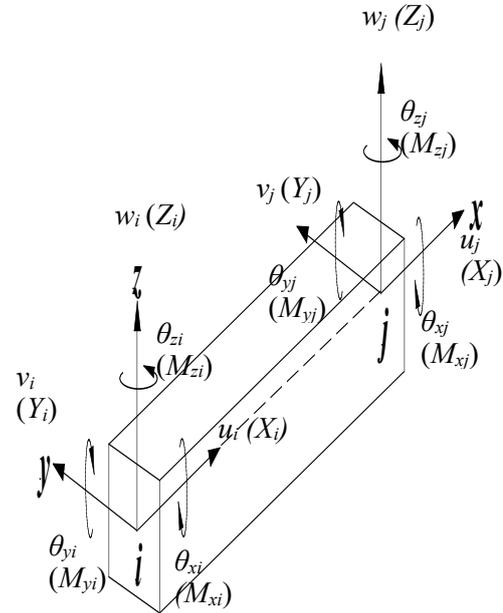
Figure 13. Coordinate system of element member

In the three dimensional dynamic response analysis of the bridge due to walking and running of pedestrian, Fig. 13 shows the coordinate system of x, y and z axis on node displacement and node force of element member. The u_i and u_j in this figure are axis displacement in x direction at node i and j. The v_i and v_j are axis displacement in y direction. The w_i and w_j are axis displacement in z direction. The θ_{xi} and θ_{xj} are rotational angle in x axis. The θ_{yi} and θ_{yj} are rotational angle in y axis. The θ_{zi} and θ_{zj} are rotational angle in z axis. The x_i and x_j are axis force in x direction at node i and j. The y_i and y_j are axis force in y direction. The z_i and z_j are axis force in z direction. The M_{xi} and M_{xj} are bending moment with respect to x axis at node i and j. The M_{yi} and M_{yj} are bending moment with respect to y axis. The M_{zi} and M_{zj} are bending moment with respect to z axis.

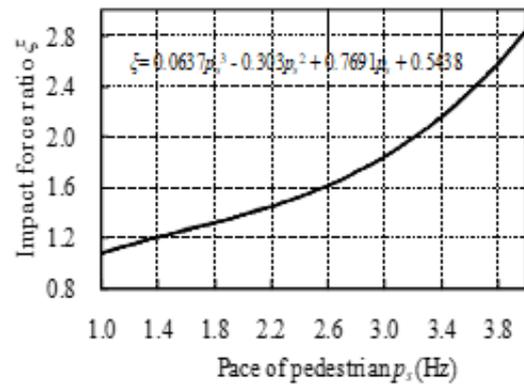
Figure 14. impact force ratio of pedestrian

The field experiment at the subject bridge and laboratory experiment which changed body weight, pace and step size of pedestrian were conducted in order to calculate the impact force ratio ξ with four load cells of plate type. Fig. 14 shows the result obtained by those experiments. There are many cases in which pedestrian generally does walking and running in 2.0 - 2.5 Hz pace. The external force of pedestrian in this study improved the method by using sine wave which Kajikawa (2000) proposed. As it is shown in Fig. 15, the method where half sine wave removed negative load part (load to top from under floor system) of input sine wave was used.

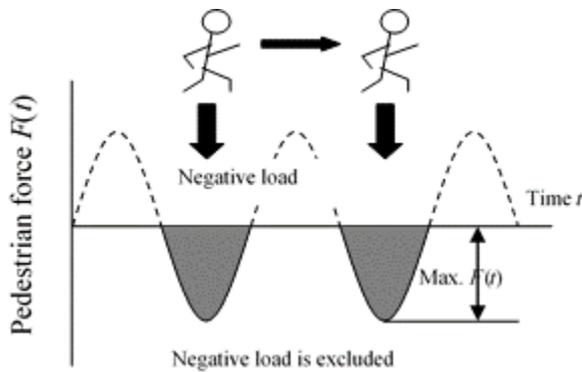
Figure 15. Half sine wave of external force

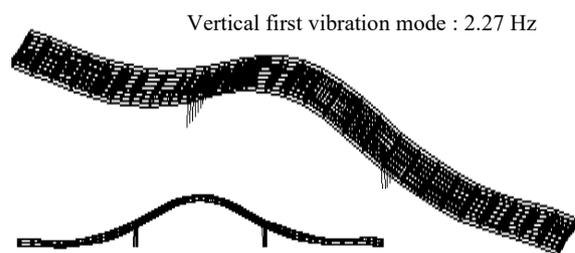
Figure 18. Analyzed vibration mode

However, it was proven that three dimensional dynamic response analysis was difficult on this structural model, because the node number is enormous. From this fact, the structural analysis model was improved again, and a structural model of 3 spans continuous girder laminated in 2 layers which considered the effect of bracing member was made. This structural model is shown in Fig. 17. The eigenvalue analysis was carried out for this structural model. The results are shown in the analyzed natural frequencies of Tables 2. The vertical first vibration mode analyzed is shown in Fig. 18.

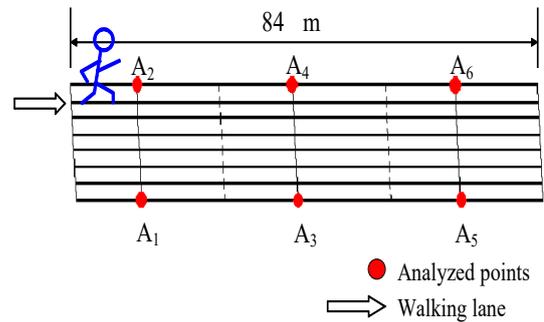
Figure 19. Analyzed point and walkin lane

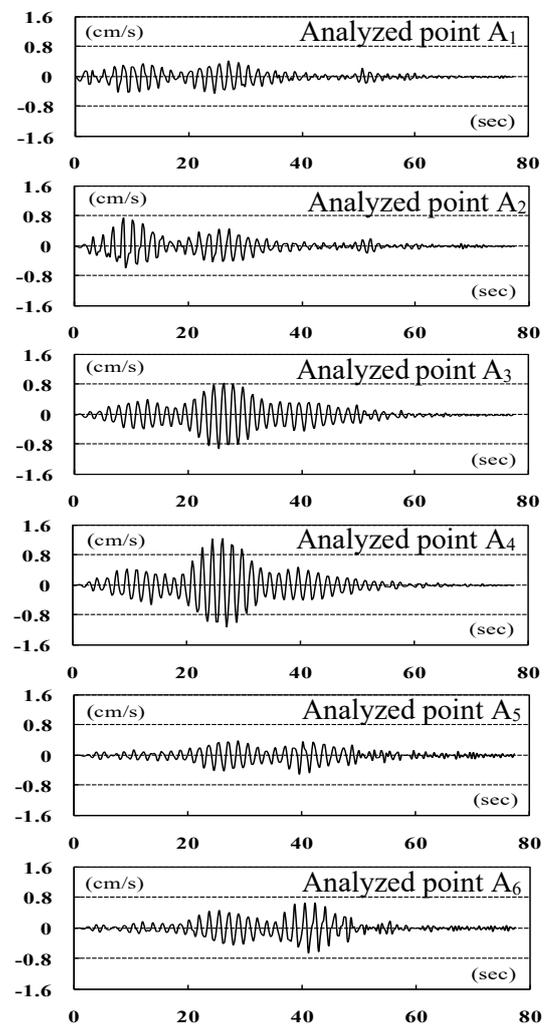
Figure 20. An example of response velocity analyzed by waking of one person with resonant pace of 2.25Hz at edge part of upstream

Three dimensional dynamic response analysis of this bridge due to walking of one pedestrian was carried out using the girder model laminated by 2 layers shown in Fig. 17. The response velocity waves at each analyzed point in resonant walking are shown in Fig. 20. As well as measured wave in Fig. 12, the vibration behaviour of three spans continuous girder has appeared clearly from this analyzed wave. The maximum value of measured point and analyzed point which is close to walking lane increases from other values, when analyzed wave in Fig. 20 and measured wave in Fig. 12 are compared. It is shown that lateral load sharing is clearly small, though the simple bracing member between each main girder has been installed. The maximum values and wave shapes based on experiment and analysis almost agree.

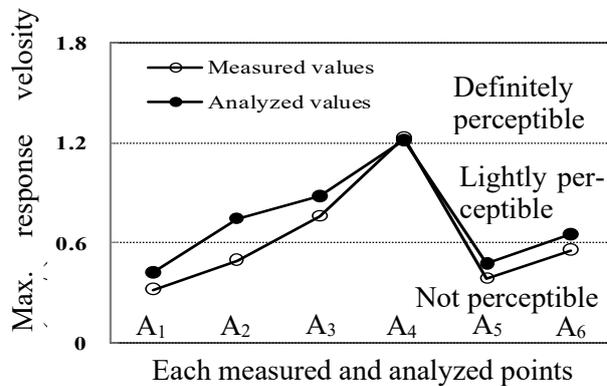
Figure 21. vibration serviceability of this bridge

The evaluation of vibration serviceability may become less for rms value which has meaning of mean value for variational data. From this fact, vibration serviceability in this study was evaluated by maximum value of response velocity. Fig. 21 shows evaluation of vibration serviceability for the subject bridge by maximum response velocity obtained by the experiment and the analysis due to resonate waking of one pedestrian at edge part of up-stream. From this figure, it is proven that the measured and analyzed values cause both reactions of "not perceptible for vibration" or "lightly perceptible" on vibration serviceability of this bridge. It is also proven that that analyzed and measured values agree well and that the shape of response velocities resemble. From this fact, they seem to be able to evaluate vibration serviceability of the subject bridge analytically, even if dynamic testing of the actual bridge is not done, when the vibration characteristic of the subject bridge has been proven.

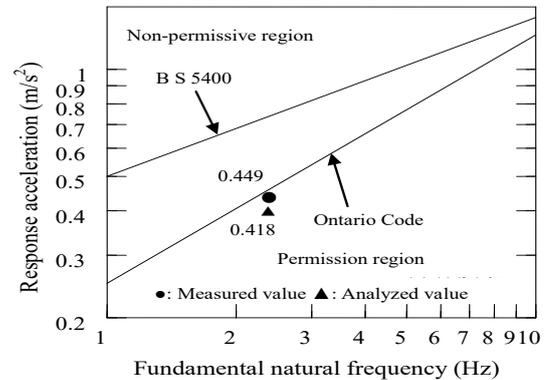
Figure 22. An example on vibration serviceability of the objected bridge by maximum acceleration values using Ontario code and BS5400.

As an example, vibration serviceability of the subject bridge was investigated by maximum value analyzed and measured response acceleration using the vibration limit of Canadian Ontario Code and BS5400. The result is shown in Fig. 22. The measured and analyzed values are proven of becoming very close values, and both values are also within the permission region of the Ontario Code.
