International Conference on Timber Bridges ICTB2021^{PLUS}

Conference Proceedings

International Conference on Timber Bridges ICTB 2021^{PLUS}
Conference Proceedings
9 - 12 May 2022

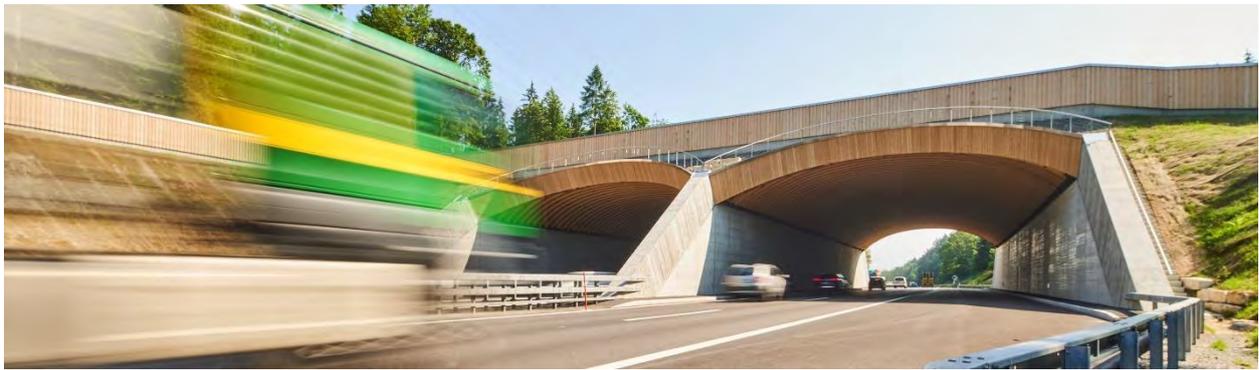
Figure 15: Built wildlife overpass Rynetel AG, Switzerland. Picture: Nils Sandmeier, Timbatec

Stefan Zöllig wrote the first study on wildlife bridges made of wood in 1998. Afterwards, it took 22 years until the first wooden wildlife overpasses could be built. So, the first wooden wildlife overpasses of Switzerland were built in 2020 in Rynetel AG (Figure 15) and 2021 in Neuenkirch LU (Figure 16). The wildlife overpass in Rynetel AG is a double arch with 17.5 m span each. The wildlife overpass in Neuenkirch LU is designed as a double single span girder with 17.5 m span each and a center support.

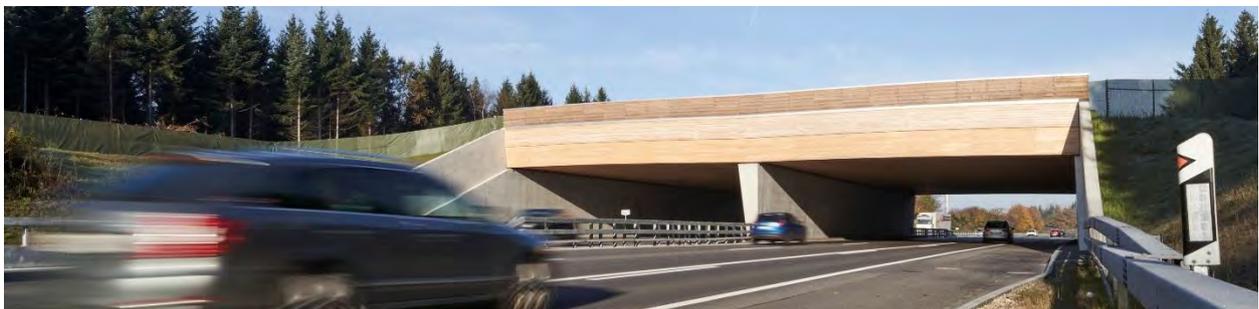
Figure 16: Built wildlife overpass Neuenkirch LU, Switzerland. Picture: Nils Sandmeier, Timbatec

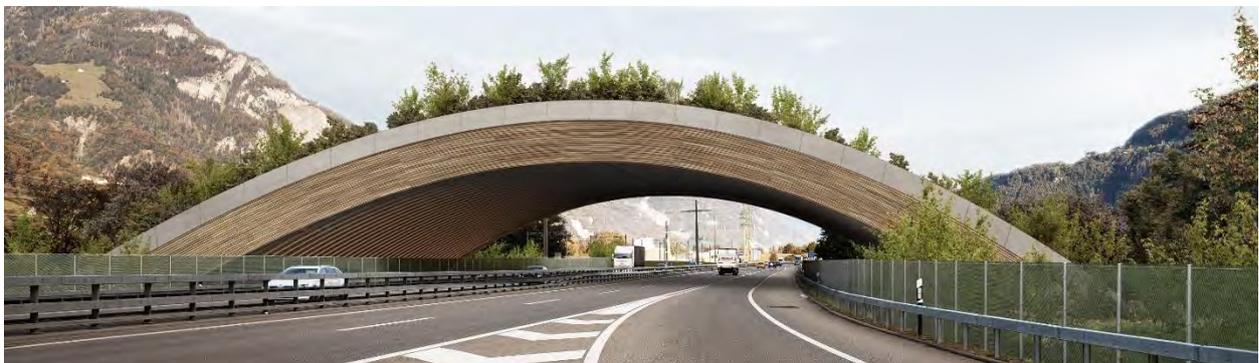
Figure 17: Planned wildlife overpass Biberlikopf Ziegelbrücke GL, Switzerland. Picture: Nightnurse Images, Zürich

Further wildlife bridges are planned in Ziegelbrücke GL (Figure 17) and in Tenniken BL. The wildlife bridge in Ziegelbrücke GL will be designed as an arch with a span of 57 m.

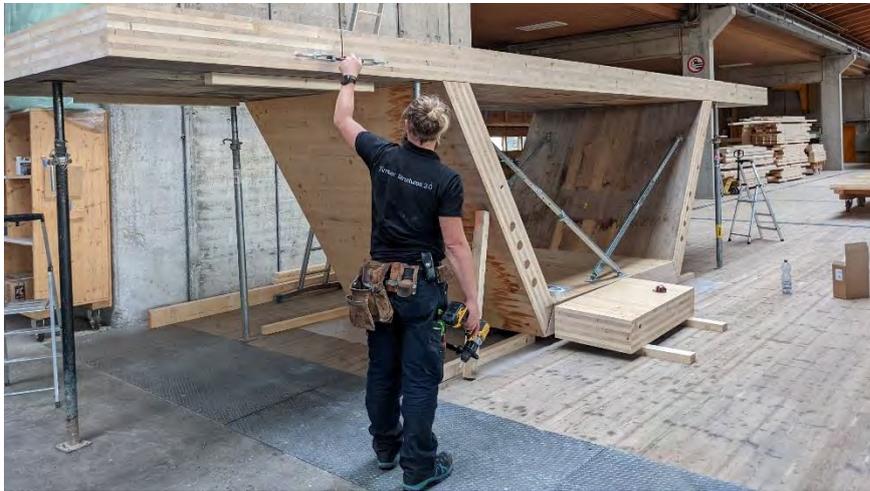
Figure 18: Manufacturing box-girder modules at the factory. Picture: Flück AG, Wangen b. Dübendorf

Two box-girder modules in the courtyard of the Bern University of Applied Sciences in Biel, as shown in Figures 18 to 20, will be used as working models where the envisaged static models, but also practical exercises can be carried out. It is to be expected that, in the course of the research project, new findings will

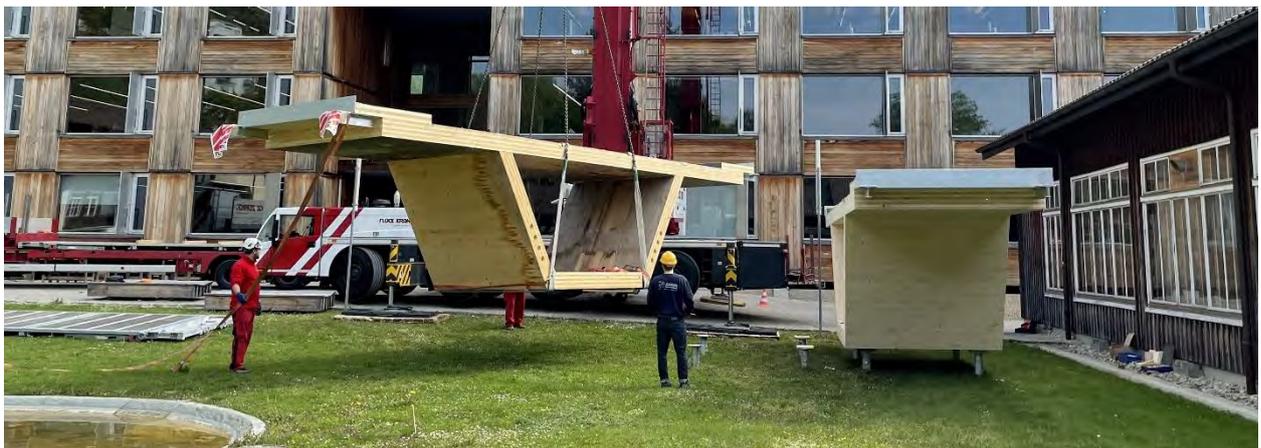
Figure 19: Installation of the box-girder modules. Picture: Steffen Franke

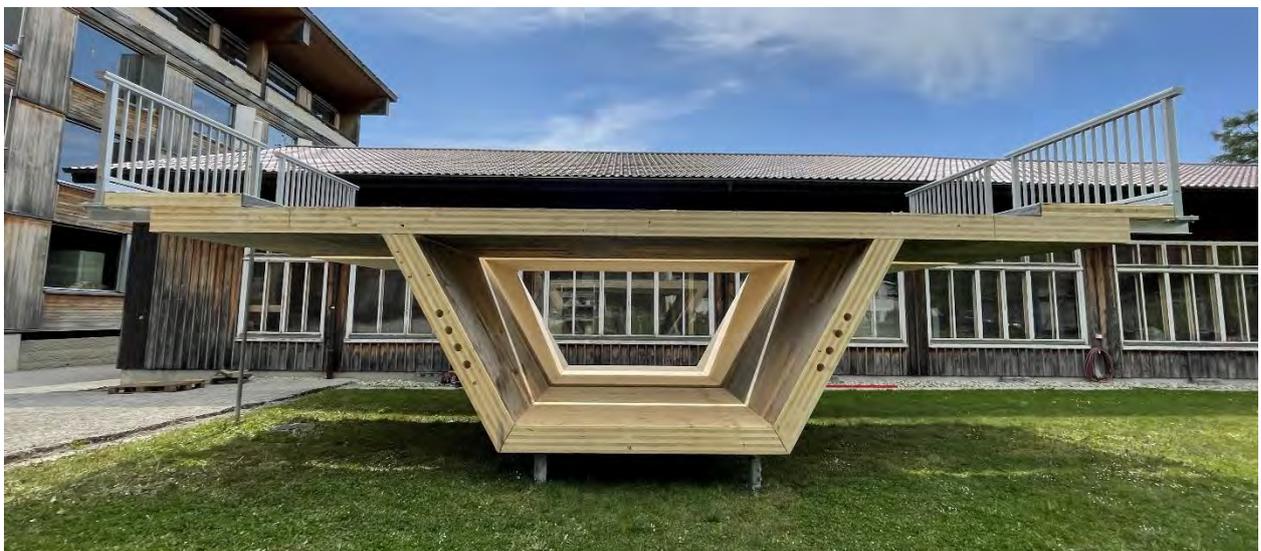
Figure 20: Box-girder modules in the courtyard of the Bern University of Applied Sciences Biel. Picture: Steffen Franke

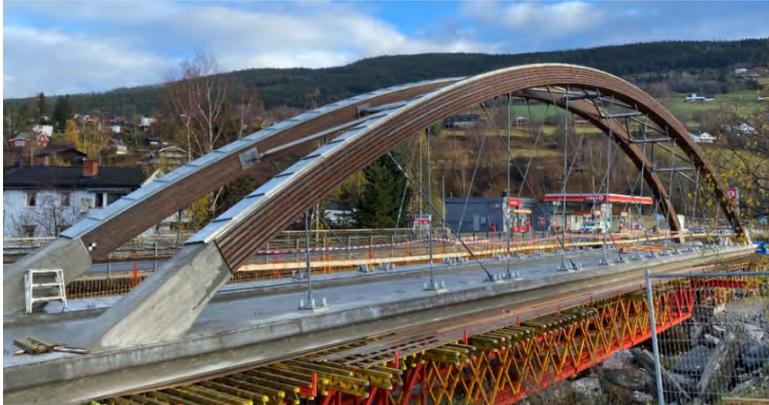
Figure 10 Våla bru under construction (photo: H. E. Wedum)

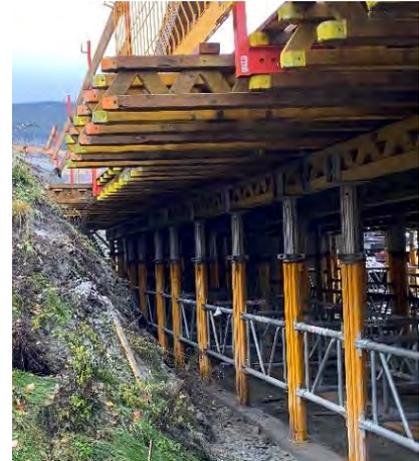
Figure 11 Våla bru – scaffolding on flood-plain (photo: H. E. Wedum)

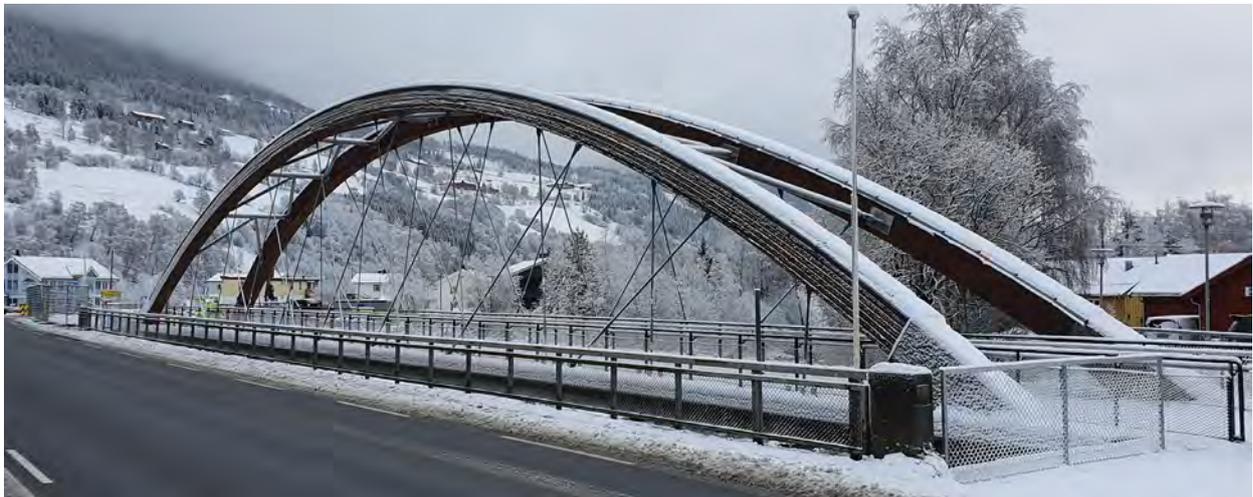
Figure 12 Våla bridge (photo: H. E. Wedum)

The paper shows the importance of right choice of the network patten, and that the network arch timber bridges have a potential for medium span footbridges. Figure 12 and Figure 13 present the completed bridge.

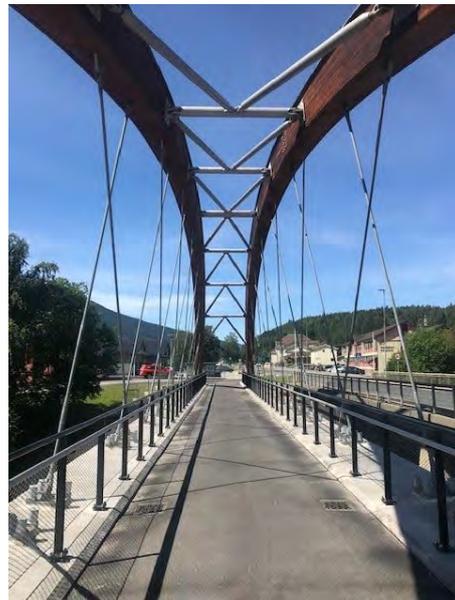
Figure 13 Våla bridge (photo: P. K. Ekeberg)

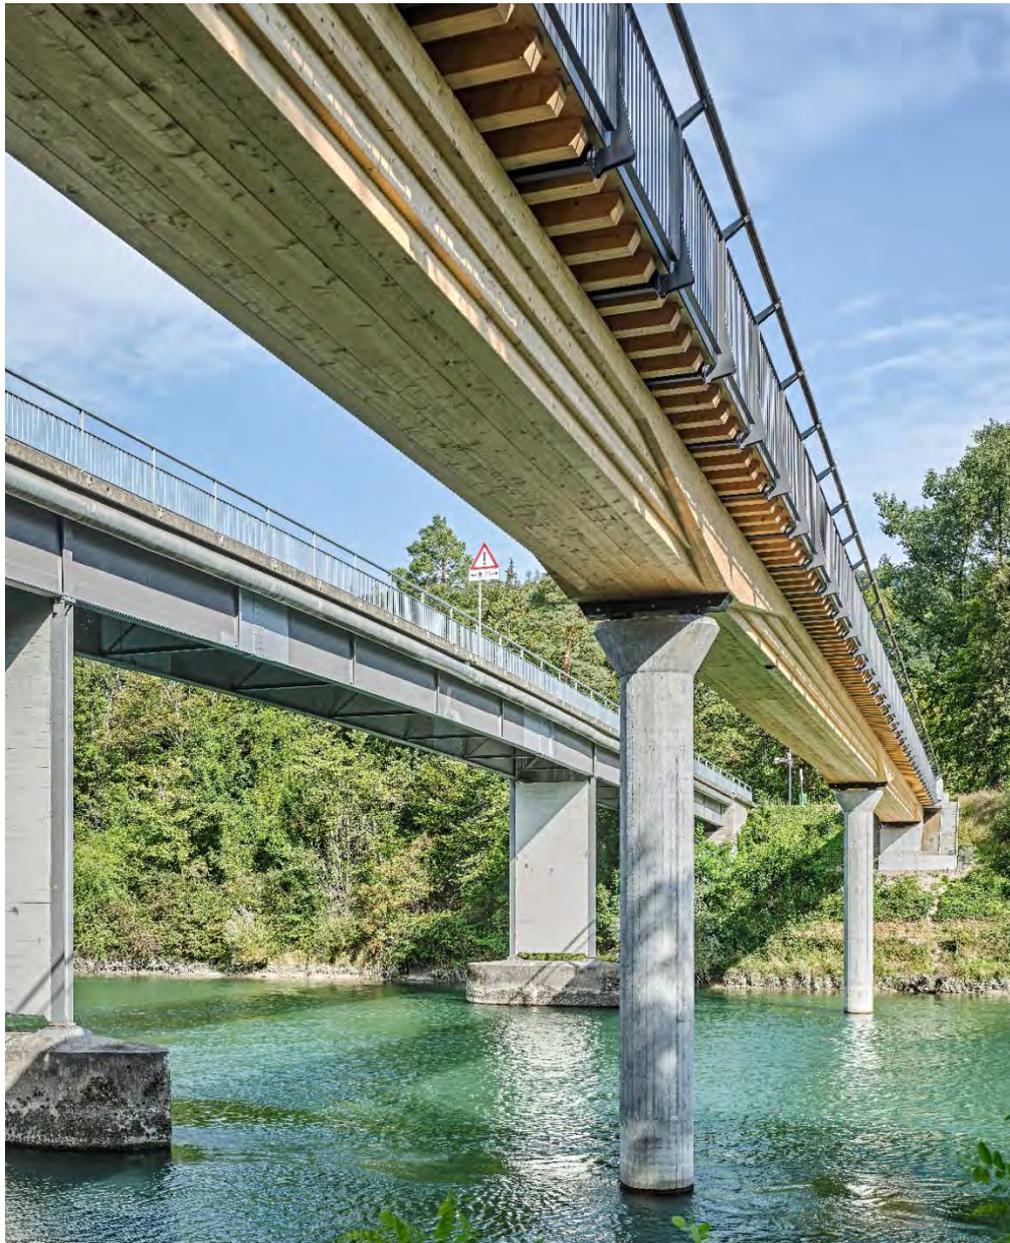
Figure 1: Bridge B, three-span girder next to the existing road bridge [Roger Frei, Zurich]

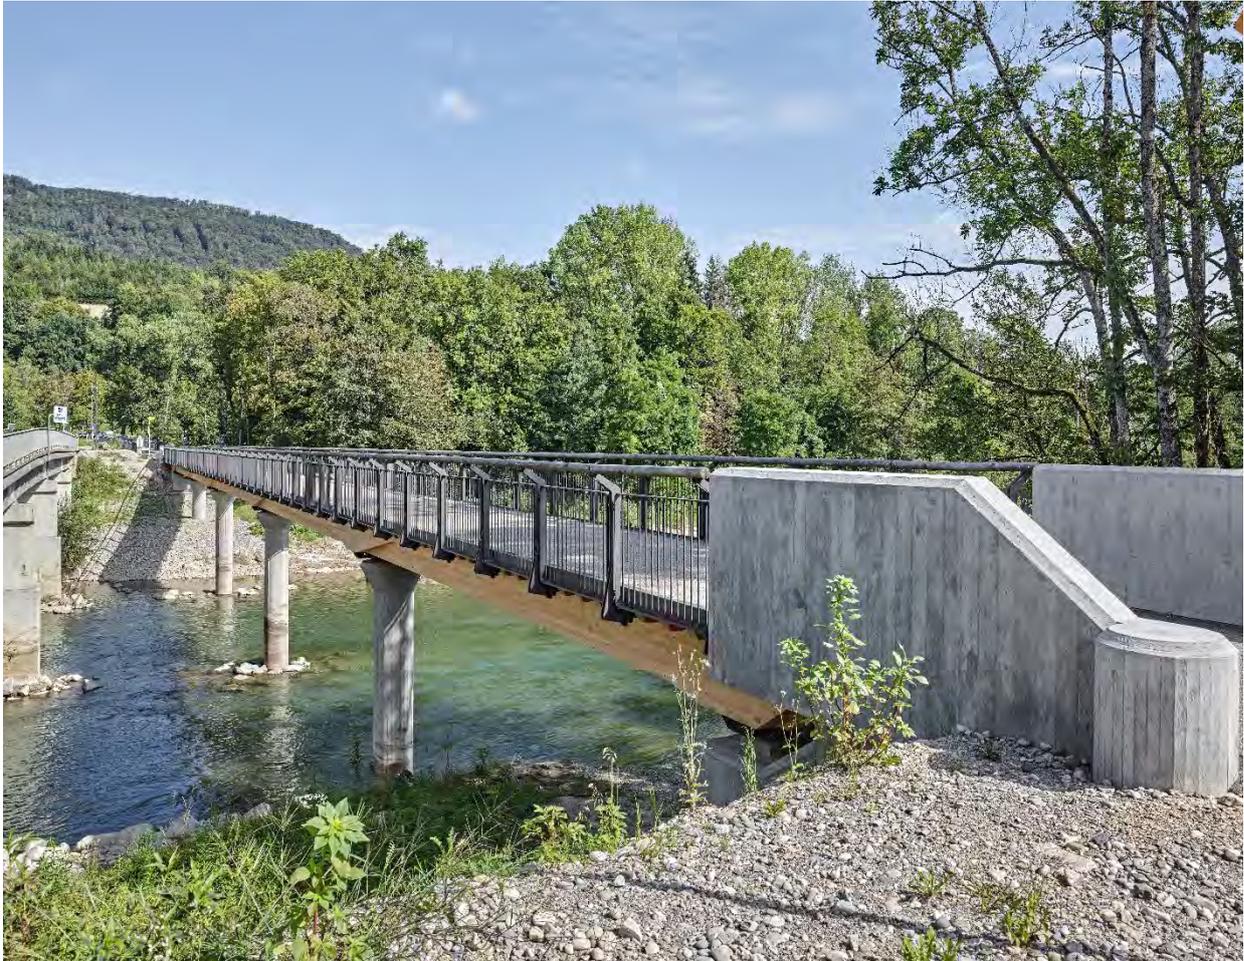
Figure 2: Bridge A, five-span girder [Roger Frei, Zurich]

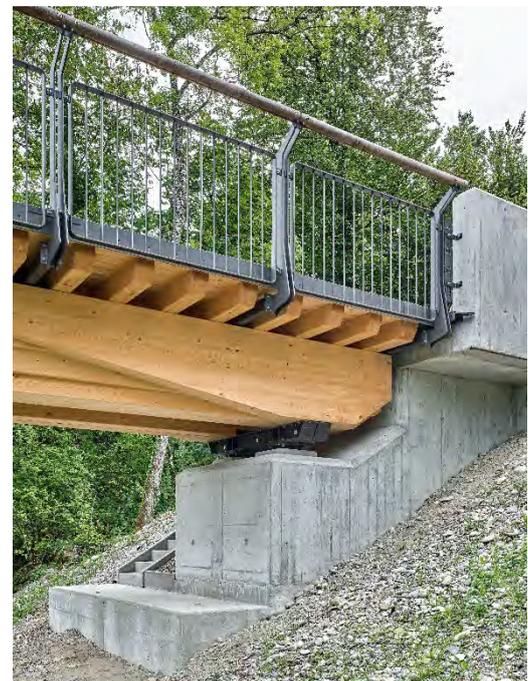
Figure 4: Abutment [Roger Frei, Zürich]

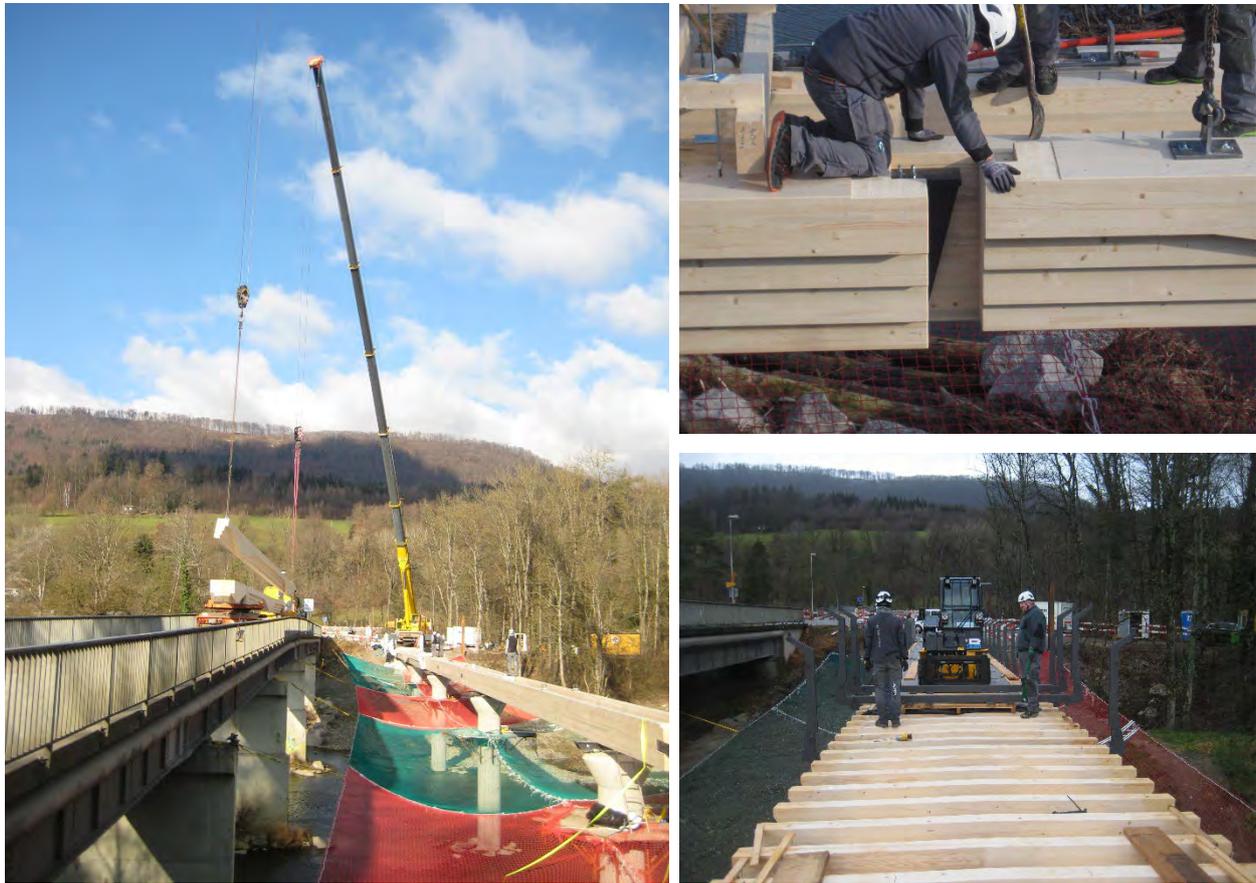
Figure 6: left: pendulum lift; above: connection of the main girders; below: installation of crossbeams and railing frames

From the existing bridge, they were lifted onto the piers just in time via pendulum lift using two large truck-mounted cranes (figure 6). Thanks to an ingenious arrangement of the joints of the individual girders and multifunctional connecting components in the superstructure, the system is configured to function statically as a continuous girder.

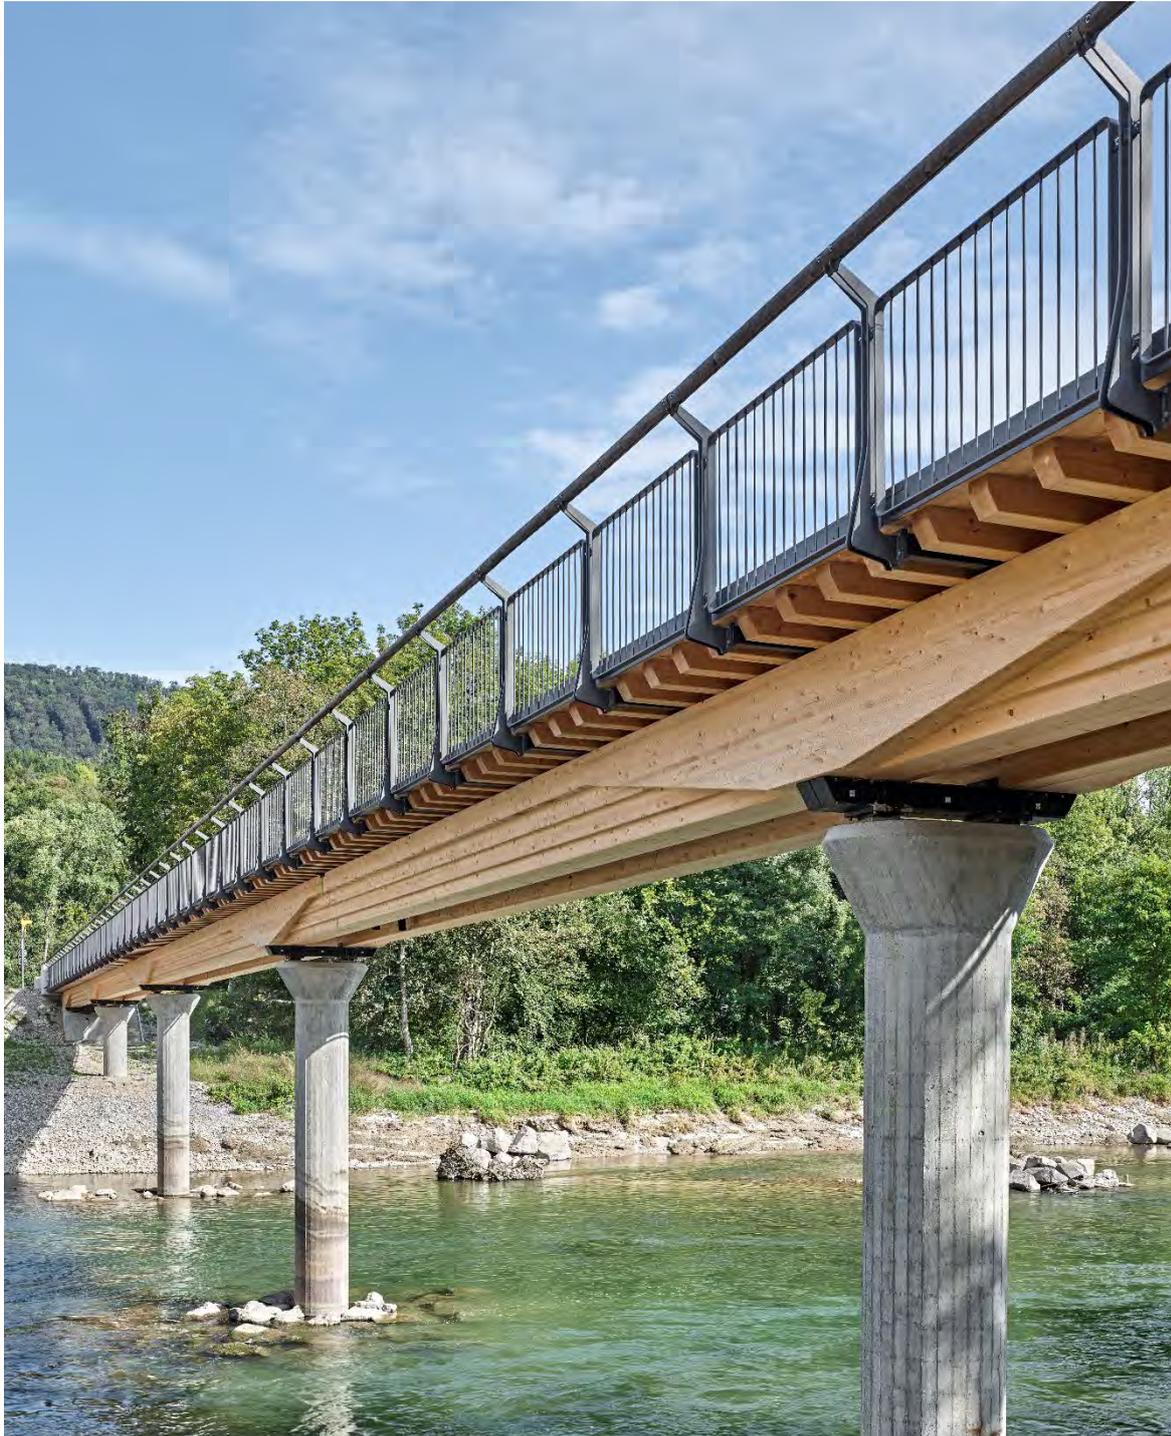
Figure 8: Bridge A, five-span girder [Roger Frei, Zurich]

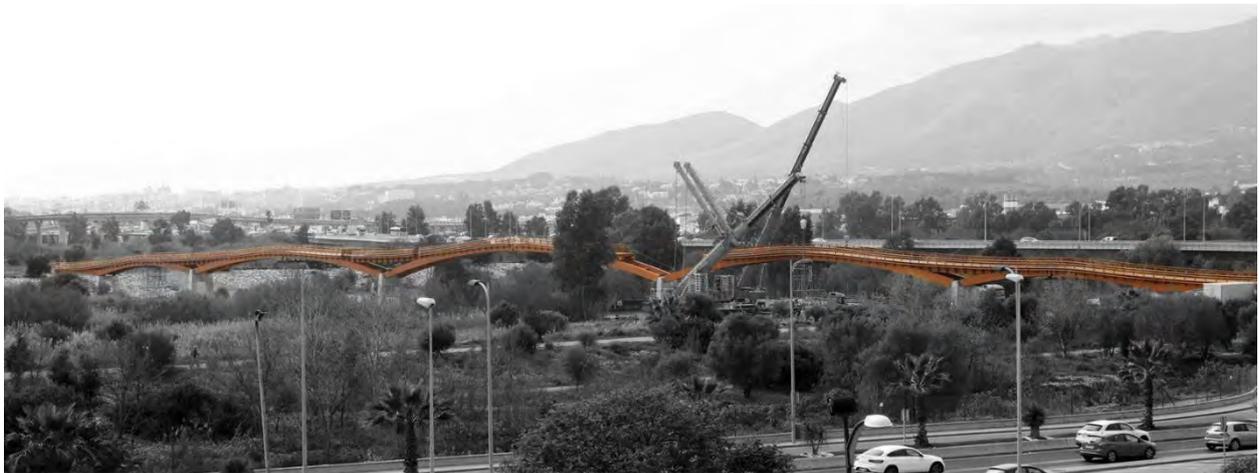
Fig. 2. The Guadalhorce footbridge during its construction

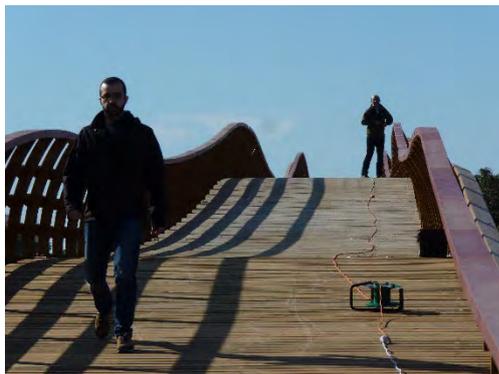
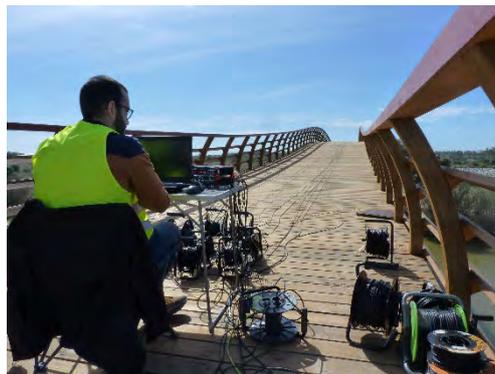
Fig. 3. Dynamic testing of Guadalhorce footbridge

Pedestrian footbridges, like many other building and civil engineering structures, must meet a number of criteria prescribed in standards. Most of the criteria refer to safety conditions. It is also desirable to comply with serviceability conditions, sometimes included as recommendations in the standards and design guidelines [1, 2, 3]. When both the actions and the behaviour of the material are well known, the criteria fulfilment can be checked by simulation. This is usually the case with the ultimate strength criteria undergoing overloads, often considered to be quasi-static loading. However, if the behaviour is not so well defined (as in the case of structural timber [4]) or the actions are dynamic ones (as in the case of pedestrian transits) the evaluation by simulation may present serious deficiencies, mainly due to the lack of knowledge of the damping coefficient. Furthermore, with this type of material, the parameters that define the behaviour (both static and dynamic) significantly depend on environmental factors such as humidity and temperature. It is therefore necessary to evaluate on the basis of estimates and to check, once the footbridge has been built, that the estimates are correct or at least conservative. Otherwise, corrective action may be required. Dynamic tests such as those described in this paper are necessary for these checks. Another application of these tests, which is not covered in this work, would be the calibration of the computational model in order to simulate the behaviour in situations that are difficult to experiment with, such as the case of a crowded footbridge.

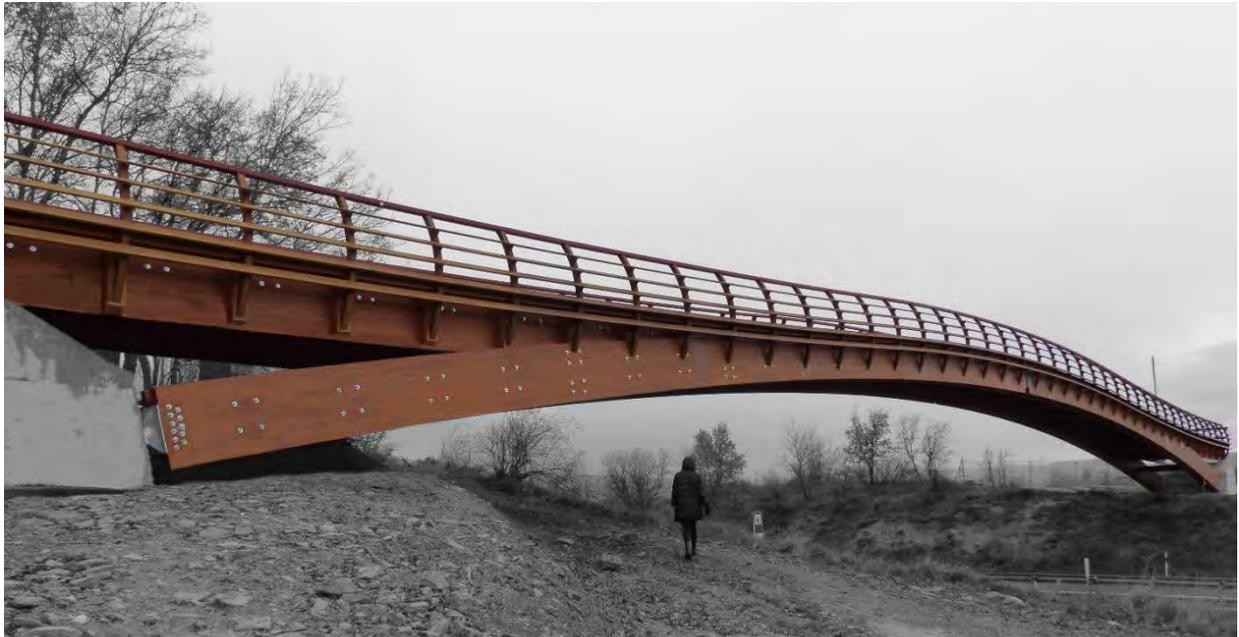
Fig. 4. Green Ring footbridge in Vitoria

In December 2019, the Green Ring (*Anillo Verde*) of Vitoria was completed by placing a footbridge over the N-102 at km 347. The footbridge is designed as a three-hinged arch of 61 m. The width is 3 m and a maximum height above the road is 6 m. Figure 1(a) shows an overview of the whole structure. At the time of its construction, it was the longest single-span footbridge on the Iberian peninsula, although in February 2020 it was surpassed by the central span of the footbridge over the Guadalhorce River in Málaga, which is 70 m long. The assembly (Figure 1(b)) was carried out in only 6 hours, the abutments had already been built previously.

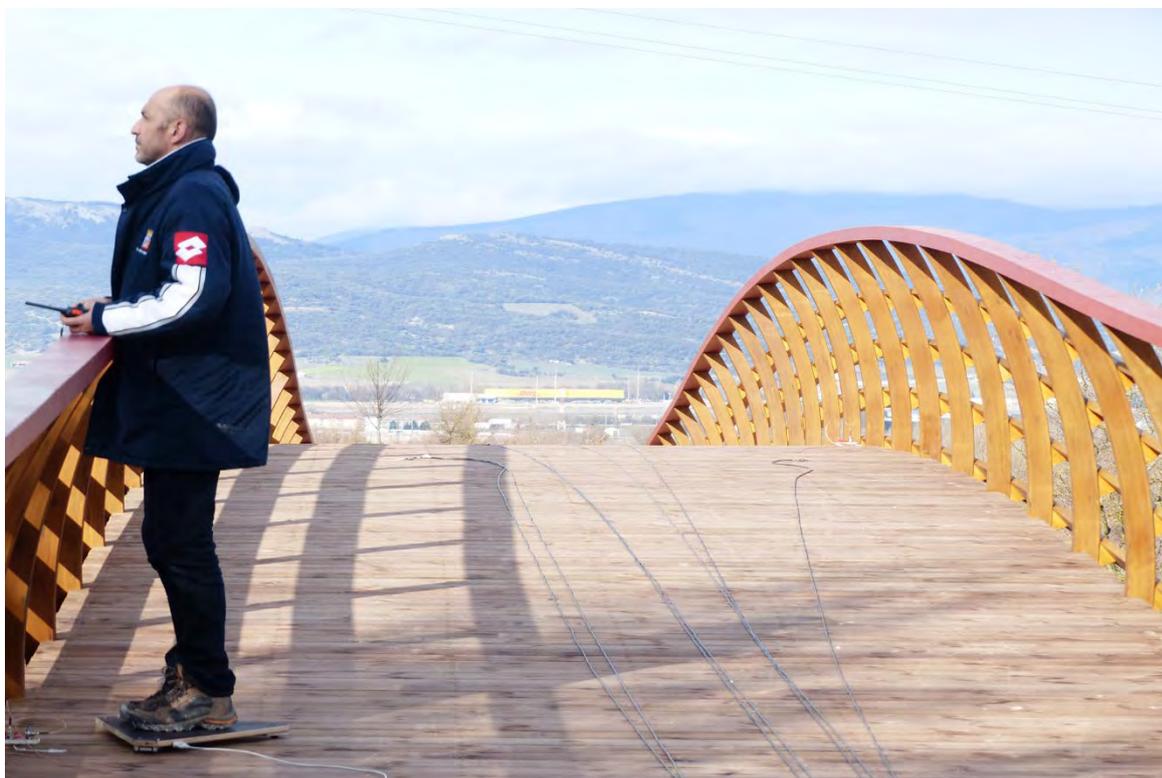
Fig. 6. Bouncing on a forceplate.

Once the input (bouncing, Figure 6) and the outputs (accelerations) are synchronously registered by means of a proficient and battery-powered datalogger, the frequency response functions (FRFs) relating them, also known as accelerances, can be calculated by means of an estimator such as H_v [5, 6].

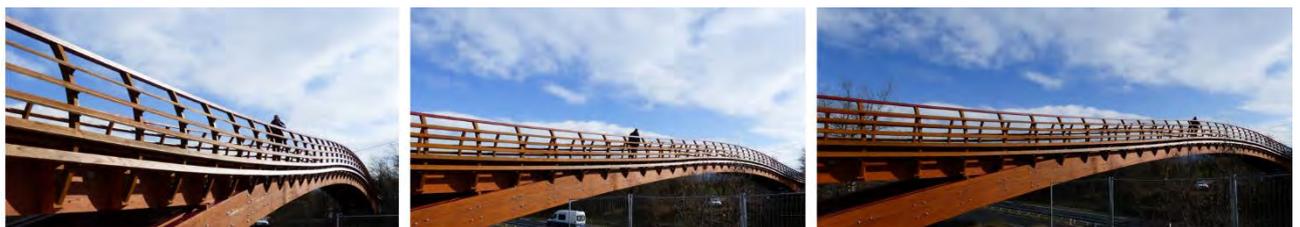
Fig. 9. Transits on the footbridge. A single pedestrian walking test.

Once the modes have been identified (mode shapes, natural frequencies and damping ratio), determining if any of them is prone to be excited by human locomotion is relatively easy. Usual walking and running are in the range from 95 bpm to 256 bpm (1.58 to 4.26 Hz), which covers the 1st to 4th identified modes. Experimental results are presented by crossing (figure 9) the footbridge at paces matching modes 2 and 3, that are the ones likely to resonate with normal walking and running activities. After the corresponding round-trip transits (90 kg pedestrian with the help of a metronome) the vertical accelerations shown in figures 10 are obtained.

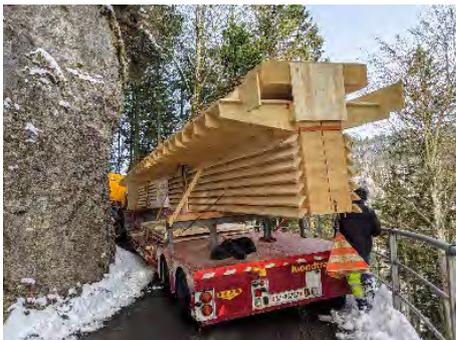
Figure 7: Rigiaa bridge, Transport of the girders with pre-assembled formwork

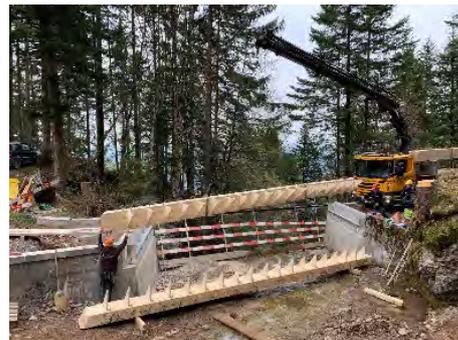
Figure 8: Fruttli bridge, Assembly of the girders with the pre-assembled formwork

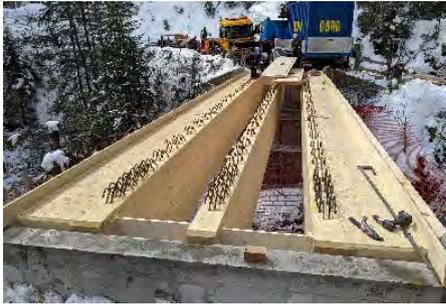
Figure 9: Rigiaa bridge, the glulam girders placed on the abutments

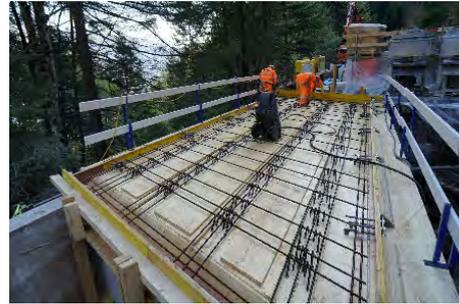
Figure 10: Fruttli bridge, the reinforced bridge slab

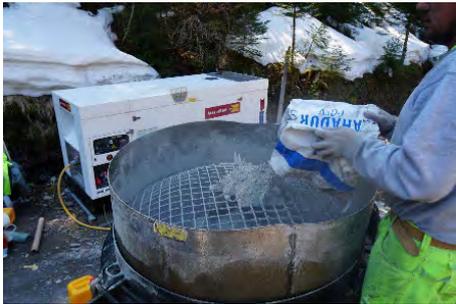
Figure 11: Rigiaa bridge, Mixing UHPC

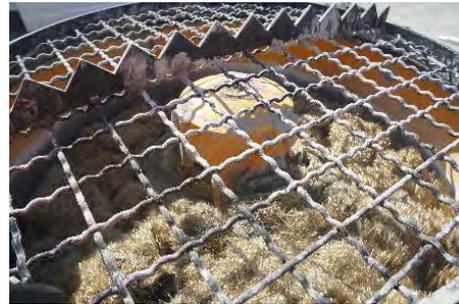
Figure 12: Fruttli bridge, Mixing UHPC

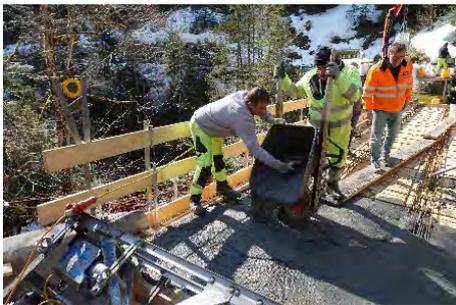
Figure 13: Rigiaa bridge, casting of the UHPC

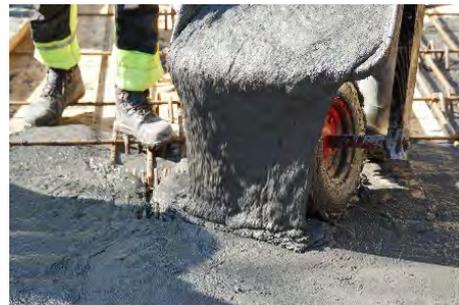
Figure 14: Rigiaa bridge, casting of the UHPC

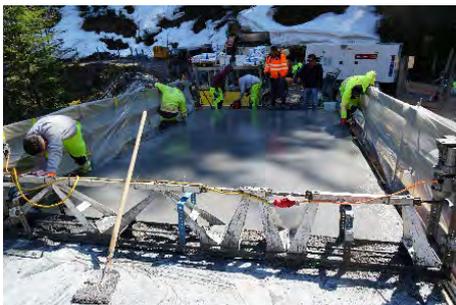
Figure 15: Rigiaa bridge, smoothing of the first layer of the UHPC deck

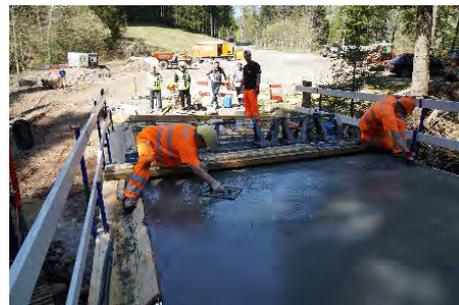
Figure 16: Fruttli bridge, smoothing of the UHPC deck

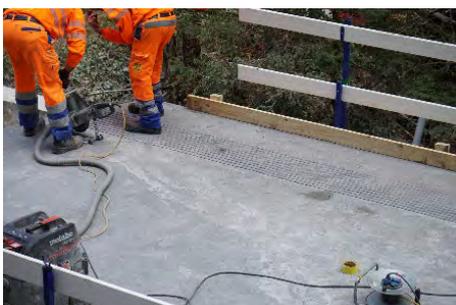
Figure 17: Fruttli bridge, Milling the grooves to increase skid resistance

To increase sliding resistance of the deck, grooves were finally milled into the surface of the Fruttli bridge. The steel fibres contained in the UHPC that stood up more due to the milling were then flamed with a gas flame. This was a premiere that led to the desired, flawless result.

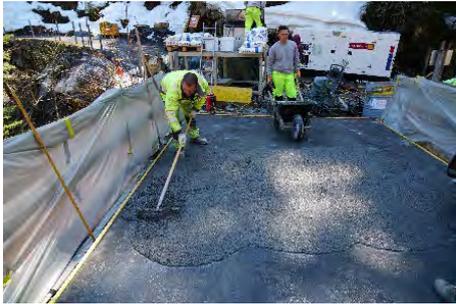
Figure 19: Rigiaa bridge, casting the second layer

In contrast, for the Rigiaa bridge, a two-layer UHPC slab with the same overall thickness as for the Fruttli bridge was chosen. On top of the first layer of conventional UHPC with steel fibres, a second layer of UHPC was poured. This second layer contains chippings instead of steel fibers

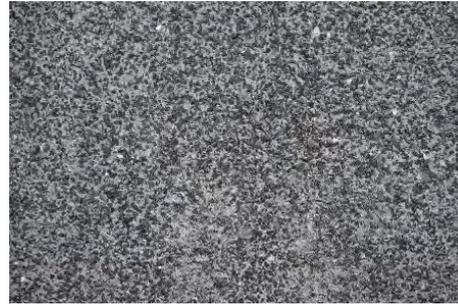
Figure 20: Rigiaa bridge, surface

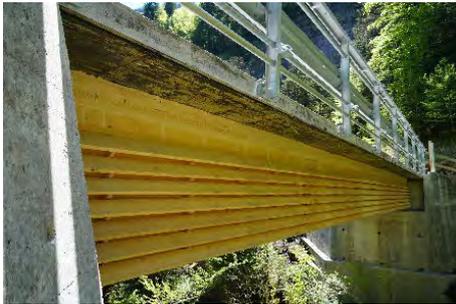
Figure 21: Rigiaa bridge, lateral view of the girders and the bridge slab

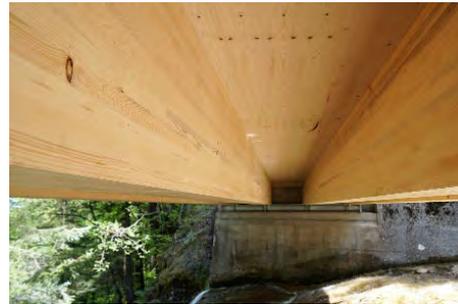
Figure 22: Fruttli bridge, soffit with beams and 3-layer panels

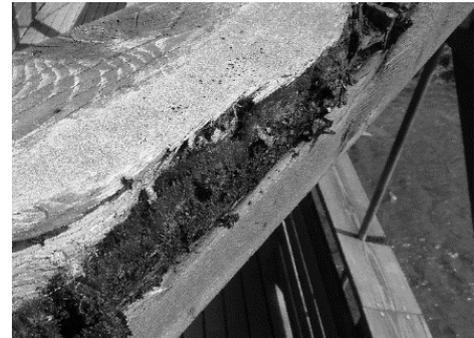
Positions- und Schadensplan

A condition analysis from 2017 shows that the bridge is in such a bad state again that it is in need of major rehabilitation. The components rehabilitated with epoxy would all have had to be replaced. However, due to the construction, the primary components could hardly be replaced without dismantling the entire bridge.

As a basis for the new bridge design, a thorough damage analysis was first carried out.

- Large cross-sections lead to severe cracking
- Large, cracked cross-sections absorb more moisture and dry out more slowly.
- With large cross-sections, the cross-section core can hardly be impregnated, which remains susceptible to rot in the event of moisture penetration.

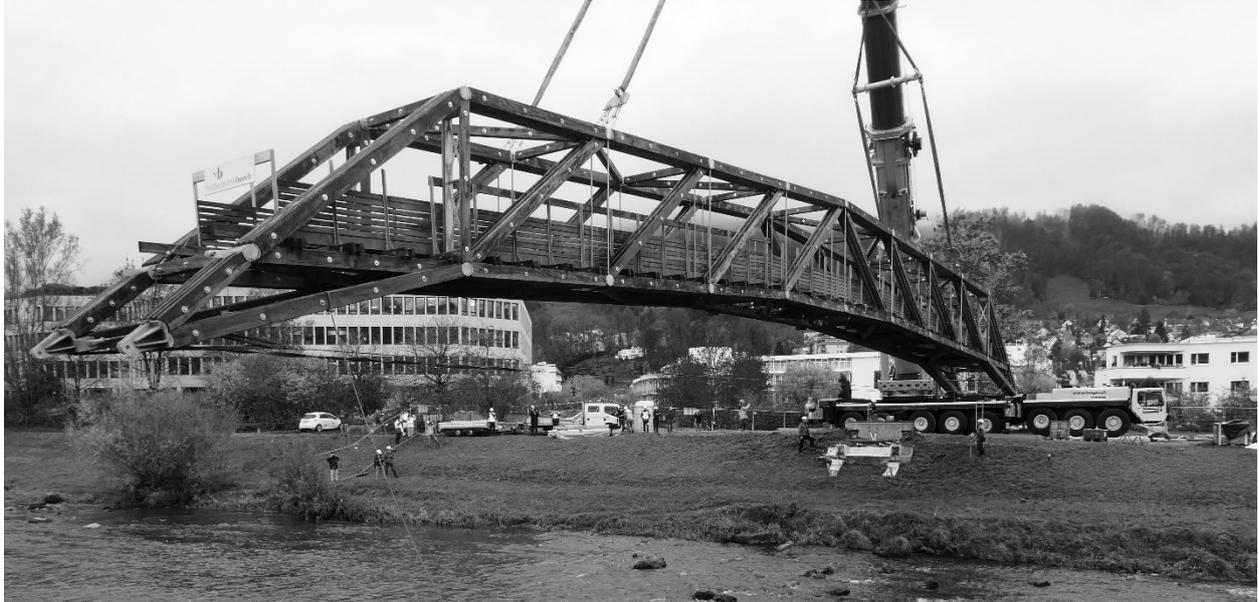
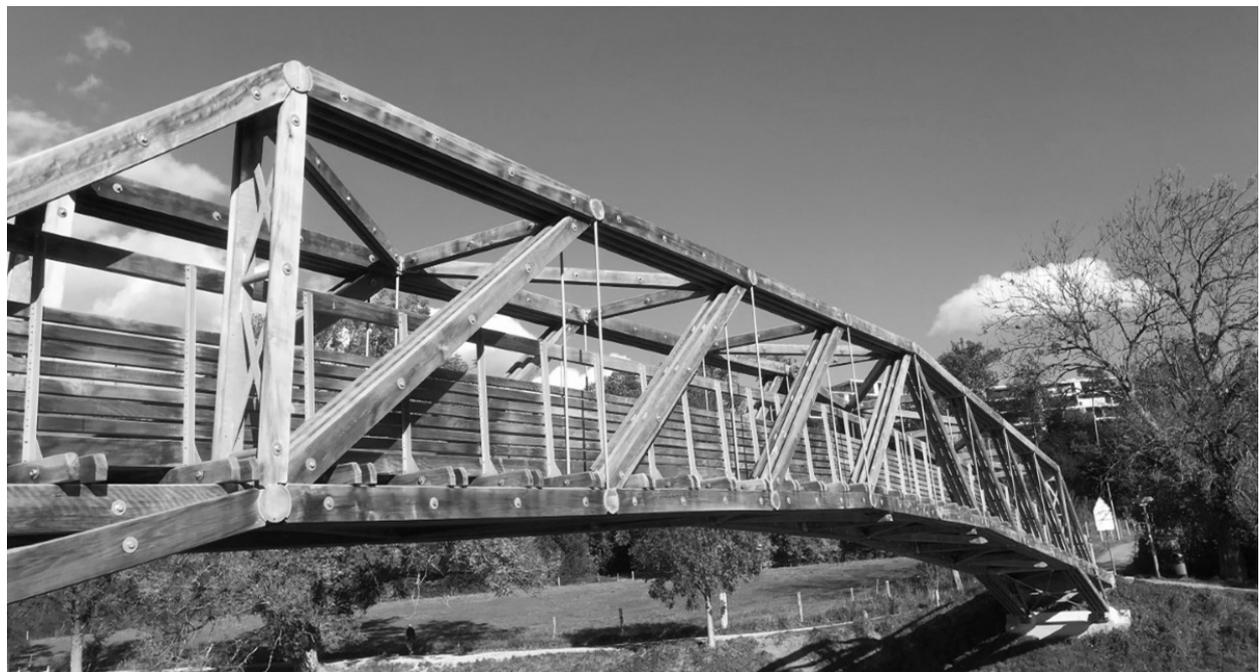
The bridge was mostly pre-assembled in two parts at the factory (Burch Sarnen) and pre-assembled on site. The bridge, which weighed around 30 tonnes, was then lifted into place on the supports using a large pneumatic crane.

During the one-year inspection, it was noted that the beechwood bridge has been behaving very well so far, as expected.

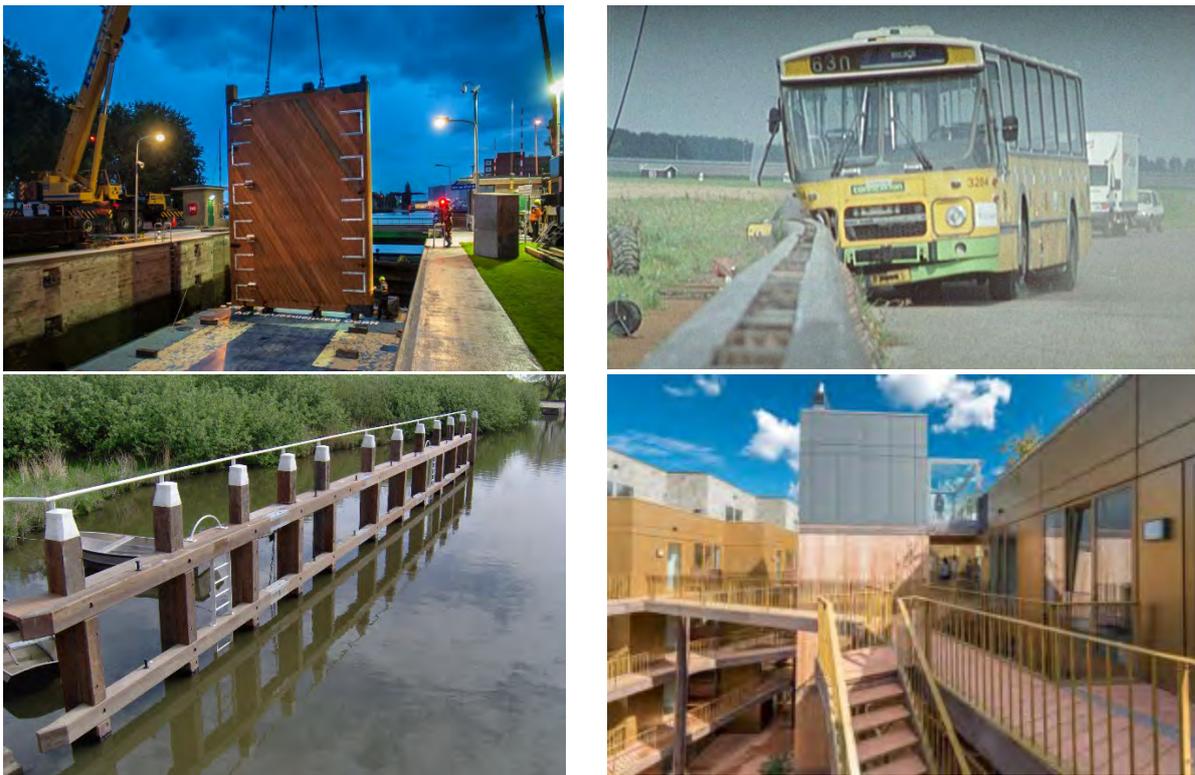
Figure 1: several examples of the use of ekki in timber structures other than bridges (from left to right, high to low): Lock gates (Bernhardsluis, Deventer), guide rail (during tests, Lelystad), fenders (location unknown), and stairways and balconies (Kop van Lombok, Utrecht)

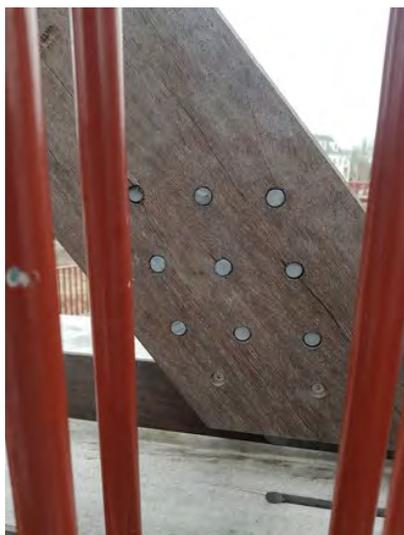
Figure 2 dowelled connection

Ekki has proven nearly impossible to glue into engineered wood products for structural applications like Glued Laminated Timber (GLT) or Cross Laminated Timber (CLT). However, connections can easily be made using either (1) carpentry joints, (2) connections with mechanical fasteners such as screws, bolts, dowels, in combination with slotted in plates, too (Figure 2). In the design of connections, general rules set by the EN 1995 [11] are used, along with requirements set by national annexes. (3) Separate beams can be dowelled together to form a dowel laminated timber beam [11], like done in the largest span of 15 meters of the 'Fietsen door de Heide' bridge in Belgium (Figure 3). In practice, beams with a height of a little over 1 meter and lengths up to 25 meters are built using this technique, making it a easy way to build cyclist in and pedestrian bridges with medium spans, even for light traffic loads such as service vehicles even up to 16 tons.

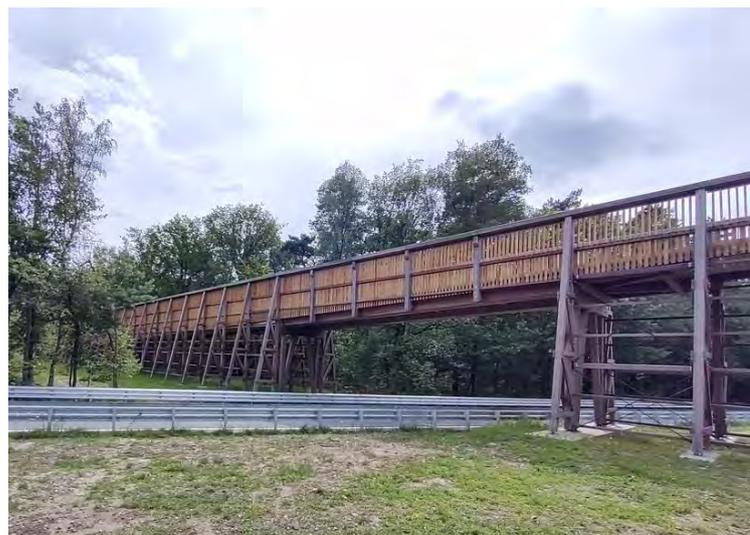
Figure 3: 15 meter span of the 'Fietsen door de Heide' with dowel laminated beams

The parapets were made with softwood that was partially obtained from the local forest. The softwood was treated to increase its natural durability. The deck was made of prefabricated concrete elements, which span the distance between the timber supports of 3 meters. In the main span of 15 meters length crossing a road, dowel laminated beams were used to carry not only vertical loads, but collision loads from traffic too. Figure 7 shows a picture of the final bridge and an illustration of the bridges main load bearing system.

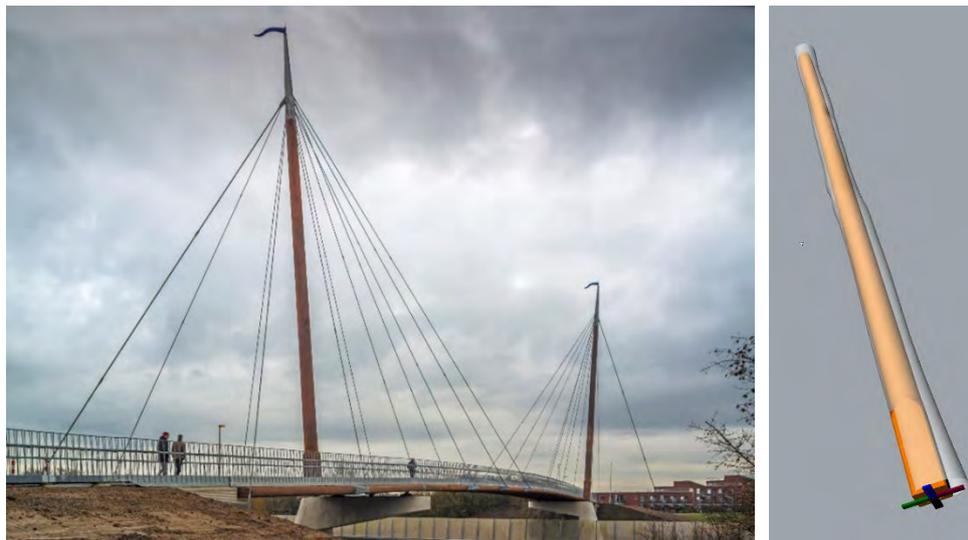
Figure 4: Illustration of the sizes of pillars used in the 'Botterbrug' in Harderwijk

Ekki can also be obtained from the trees in large dimensions. The timber is known to grow straight, containing only little number of irregularities like knots. A special case are the pillars of the ‘Botterbrug’ in Harderwijk which are 22 meters long and have a tapered diameter of 60 cm/80 cm (top/bottom) and are made out of one single trunk (Figure 4). These trunks were specially selected in the forest and transported in on single piece by road and sea, to the woodturner and then to the building site.
