International Conference on Timber Bridges ICTB2021^{PLUS}

Conference Proceedings

International Conference on Timber Bridges ICTB 2021^{PLUS}
Conference Proceedings
9 - 12 May 2022

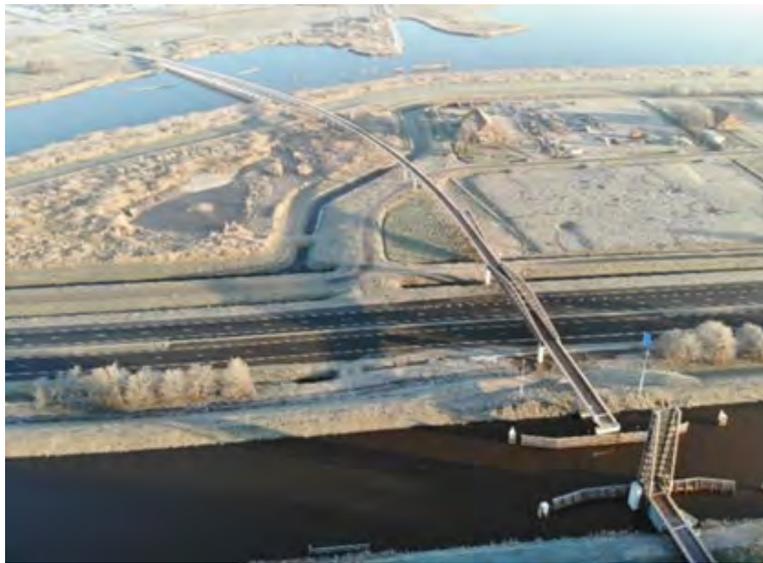
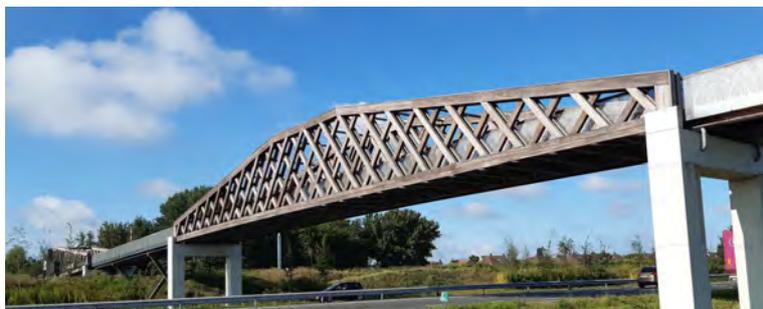
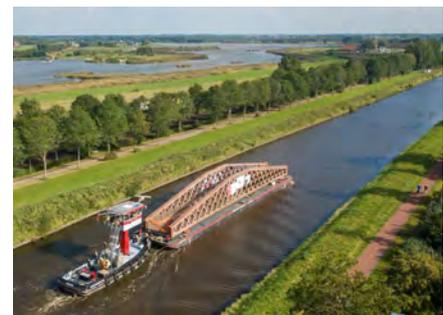
Figure 5: Aerial photo of the 'Pieter Smitbrug' along with a detail of the main span (above) and the main span and transport for the production site in Kampen to the building location by boat.

The ‘Pieter Smitbrug’ with a length of 800 meters was the largest cyclist bridge in Europe at the time of its construction. It crosses a canal (Winschoterdiep), a highway (A7), a nature reserve, and a part of a lake ‘Oldamstermeer’ (Figure 5). It being a bridge of these dimensions makes it an exceptional example of how timber can be used to create infrastructure for pedestrians and cyclists using a renewable material, modular design, with outstanding end of life capabilities. Apart from connecting two smaller towns and thus creating an easy access of each other’s education, commercial, and recreational facilities too, the construction of the bridge was also used to strengthen the local ecology. Trees were planted along the new bridge to encourage bats to cross the highway. Nesting boxes for birds were placed below the deck and lighting was especially selected that would not disturb wildlife at night. The bridge was designed for a service life of 80 years. This was achieved by protecting the main structural elements with ekki boards.

As the main span of the bridge crosses a highway, it was necessary to account for possible collision forces from traffic underneath the bridge [13]. According to the Eurocodes, this needs to be done once the bridge is less than 6 meters above the underlying road. In the Netherlands, this height is increased to 7 meters. These loads are in the order of 200 tons too. This led to the reinforcement of the lower chord of the truss structure with steel. The upper chord and the bracing were made of timber. The bridge was officially opened for use in winter of 2021.

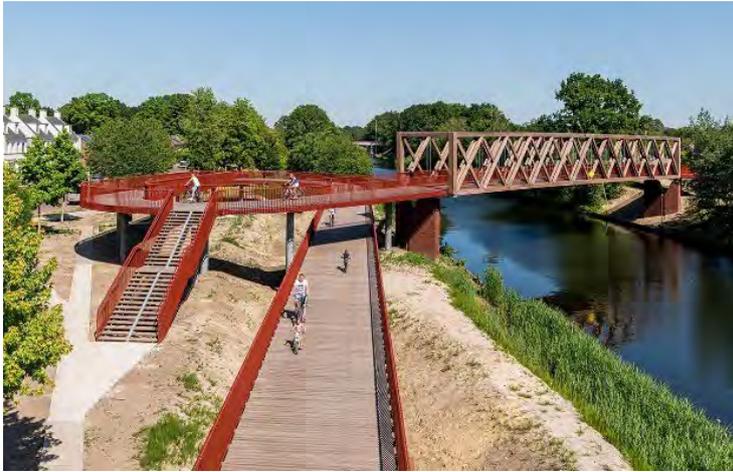
Figure 6: the 'Stonner Meijwaardbridge' (@JDFV, 2020) along with a cross section of the main span (above) and the top and side view of the main span (below)

The 'Stöner Meijwaardbridge' in Oirschot and has a total length of 240 meters. The truss bridge crossing the 'Wilhelminacanal' under an angle has a span of 41 meters and a width between parapets of 4 meters. It connects the town's neighbourhoods located south of the canal with the city center.

Although this bridge was not located over a highway or other road, collision loads had to be accounted for that originated from inland shipping traffic. This also meant that the lower chord of the truss structure had to be reinforced with steel. The upper chord and bracing could be carried out in timber. It still resulted in a slender and elegant bridge, which was officially opened for use in summer of 2020.

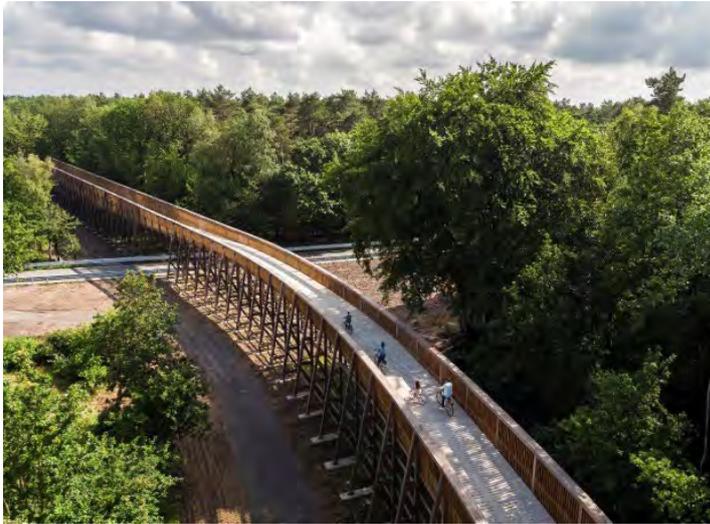
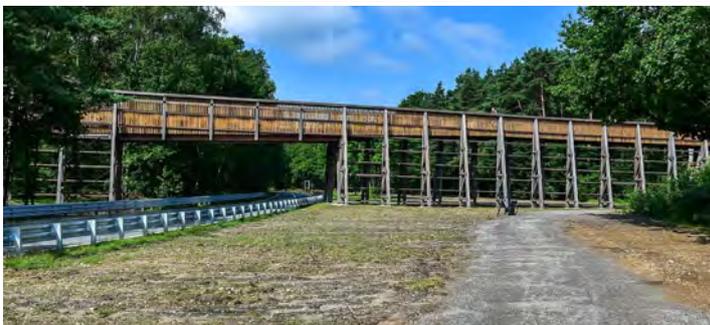
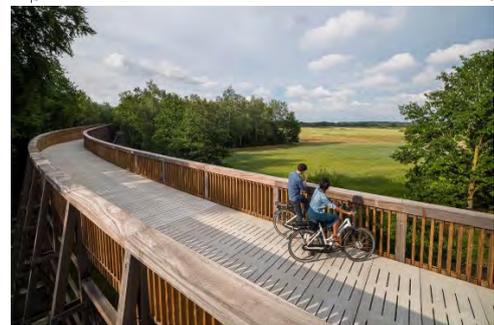
Figure 7: Aerial picture of the highest section of the 'Fietsen door de Heide' (@VisitLimburg) along with a detail of the supporting frames of the main span (above) and a side view of the main span and the view from the highest point of the bridge (@VisitLimburg)

The parapets were made with softwood that was partially obtained from the local forest. The softwood was treated to increase its natural durability. The deck was made of prefabricated concrete elements, which span the distance between the timber supports of 3 meters. In the main span of 15 meters length crossing a road, dowel laminated beams were used to carry not only vertical loads, but collision loads from traffic too. Figure 7 shows a picture of the final bridge and an illustration of the bridges main load bearing system.

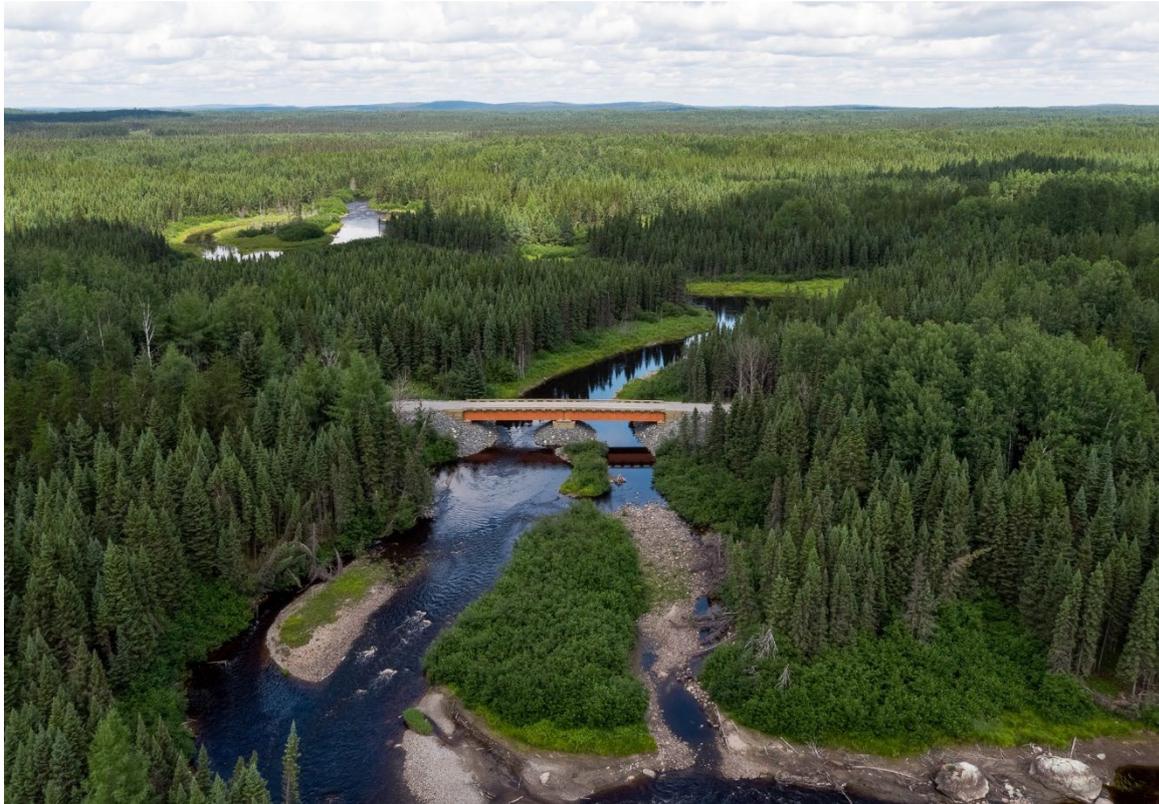
Figure 1: Dalime Bridge - Manufacturing: Nordic Structures – Photo credit: Adrien Williams

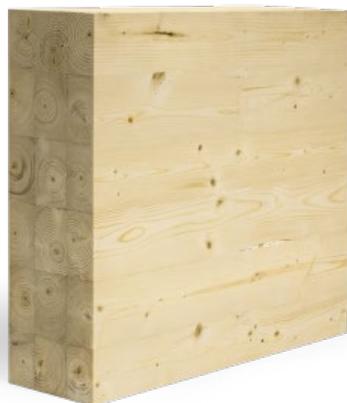
Figure 2: Glulam made of local black spruce (picea mariana) (credit: Nordic Structures)

The majority of glulam produced in northern Quebec is made from Black Spruce. This specie is known for its high density and fibre strength, as well as its limited diameter, thin annual rings and small knots. In order to optimize this raw material, a proprietary product, NordicLam, is manufactured by laminating small sections in both directions (Figure 2).

Despite its high strength, black spruce is difficult to treat with chemicals due to the closing of the pit chambers during drying. Therefore, the durability of the infrastructures made with black spruce glulam relies mainly on good design and manufacturing details to avoid the presence of moisture, as well as on effective finishing products to protect the wood against rain and UV rays.

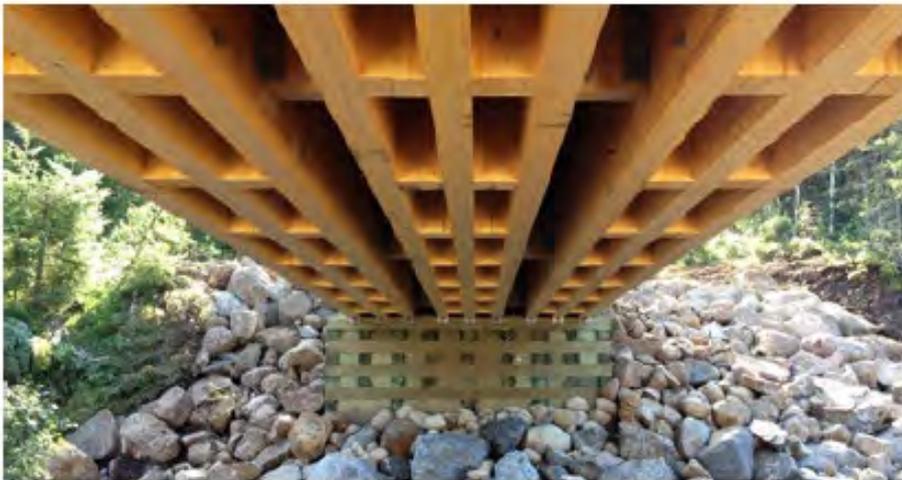
Figure 3: Concept with pre-assembled glulam girders (credit: Nordic Structures)

The fabrication and assembly of glulam forest bridges were optimized in order to be economically competitive. Concepts favouring the pre-assembly of girders in groups of 2 or 3 allow efficient connections between the girders and the diaphragms, a fast and easy construction process, as well as an easier installation of a waterproofing protection on top of the girders (Figure 3).

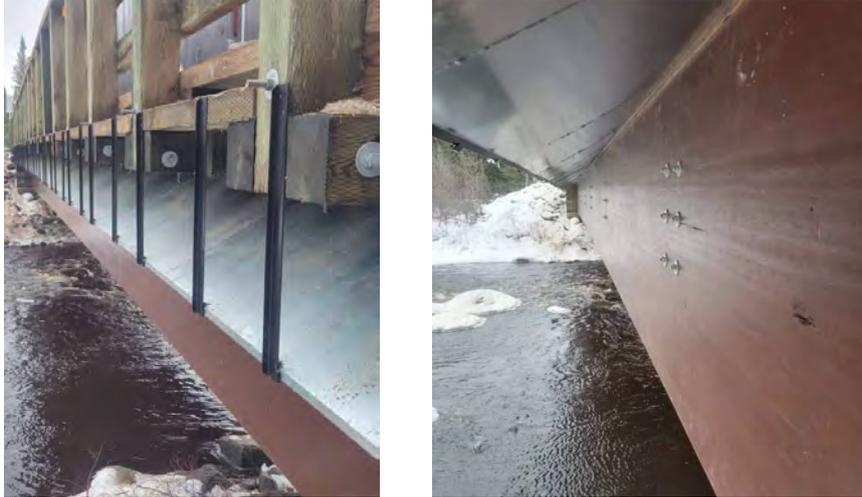
Figure 6: Rivière Tachereau Bridge - Manufacturing: Nordic Structures – Photo credit: Stéphane Routhier

A new bridge was built recently respecting the recommendations of the Cecobois guide, including the use of a dark opaque finishing product to protect the wood against rain and UV and flashing to provide a 30° angle protection to the main glulam side girders (Figure 6).

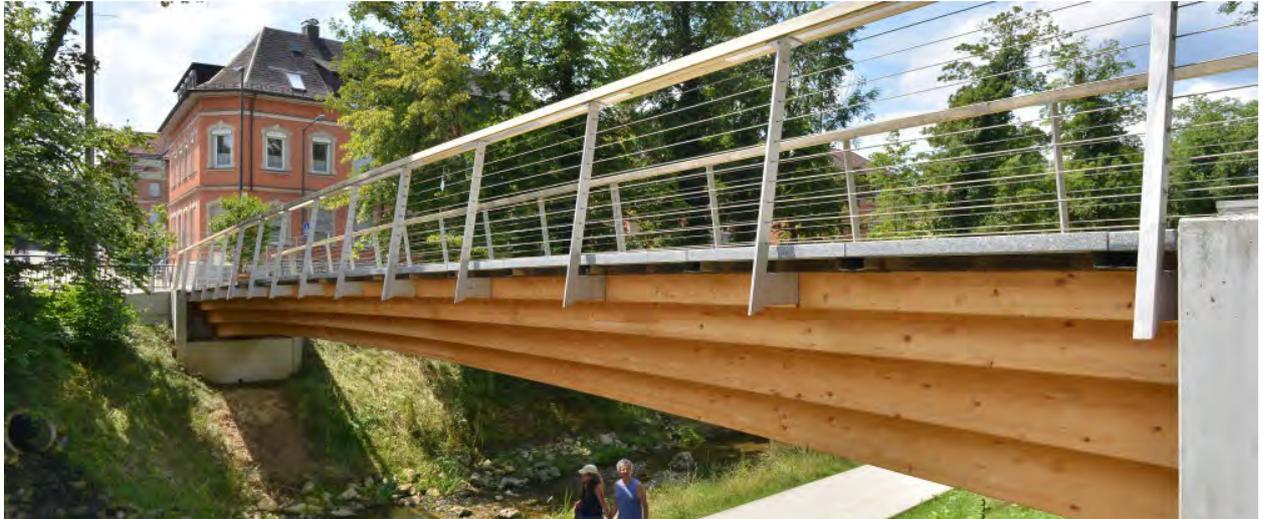
Figure 1: Bridge – Schwäbisch Gmünd (GER) - 2012

2012: First time while stepped geometry follows a 30° angle for protection. Also innovative: waterproof pavement with huge granite plates and transversal gutters

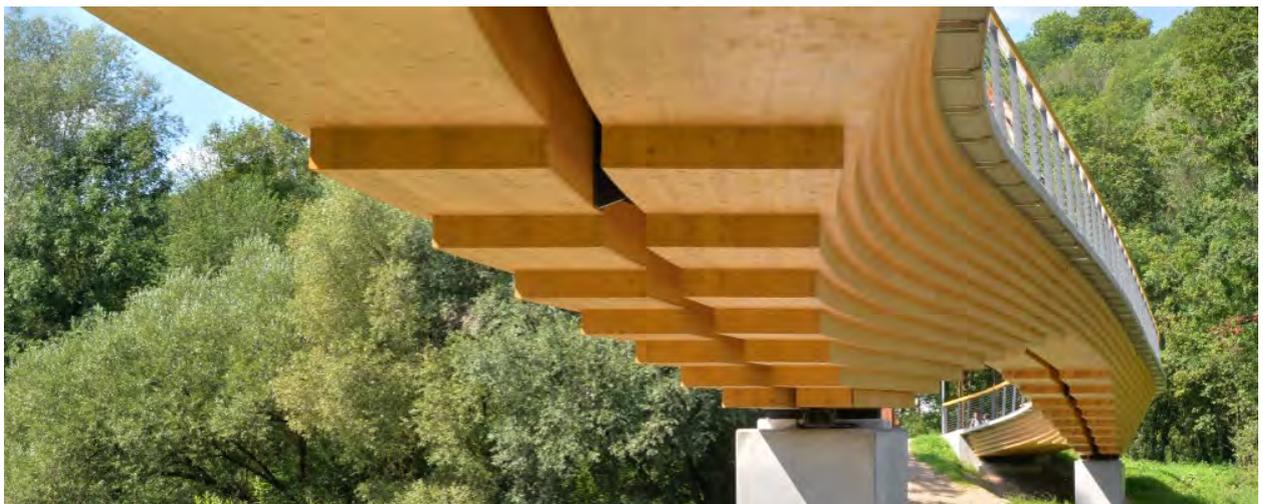
Figure 2: Bridge – Neckartenzlingen (GER)

2017: Dominance of 30° rule follows function: first time with 2m high horizontal beams for bloc glued timber. Covering by overhanging prefab concrete slabs on top.

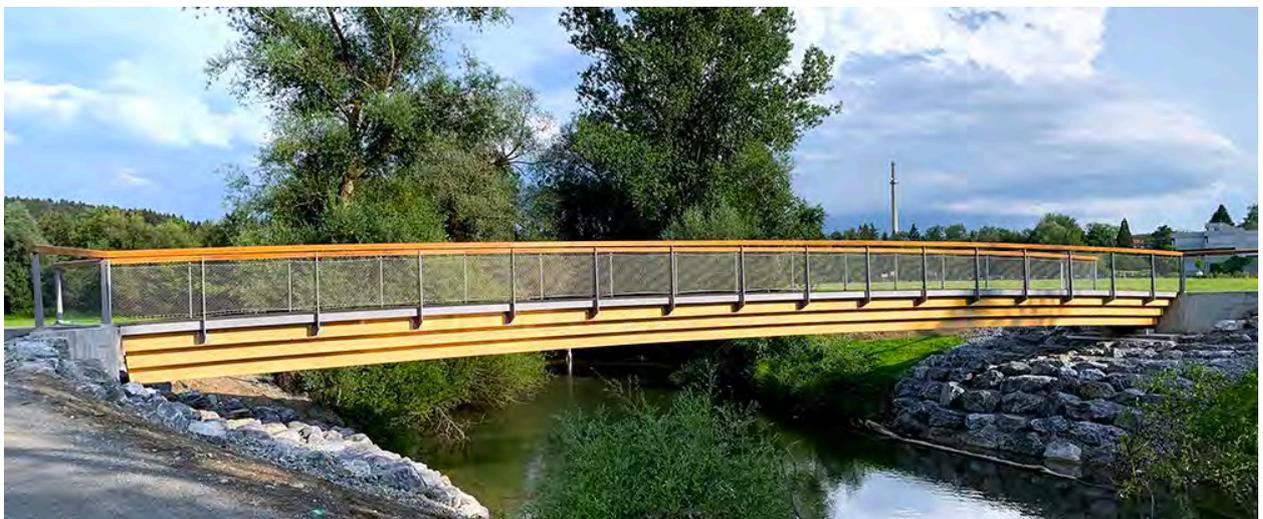
Figure 3: Bridge – Wangen/Allgäu (GER)

2020: efficient bridge Solution with parallel beams spans over 30m – covered with asphalt on top.

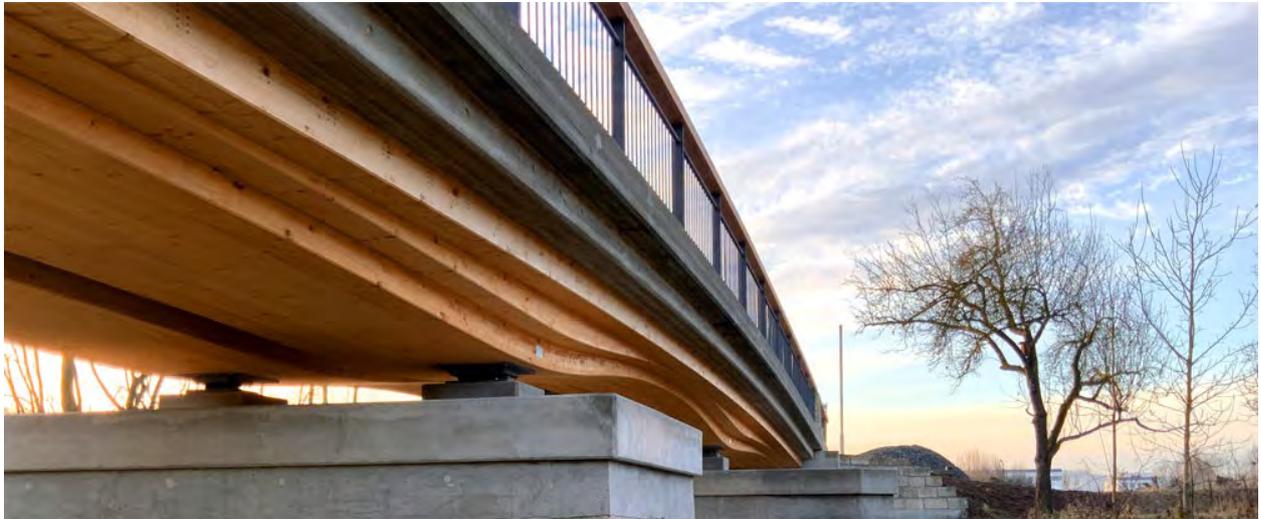
Figure 4: Bridge – Schäfersheim (GER)

2022: Solution for a timber concrete composite (TCC) bridge – also with stepped concrete plate

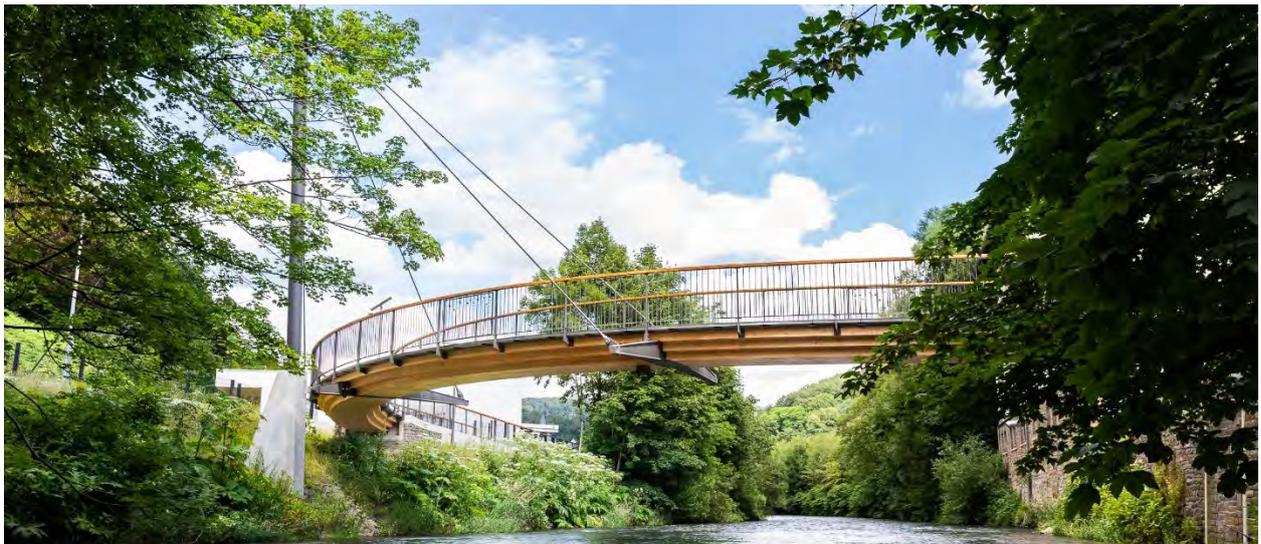
Figure 5: Bridge – Engelskirchen (GER)

2020: continuous stepped bloc glued beam with horizontal curvature

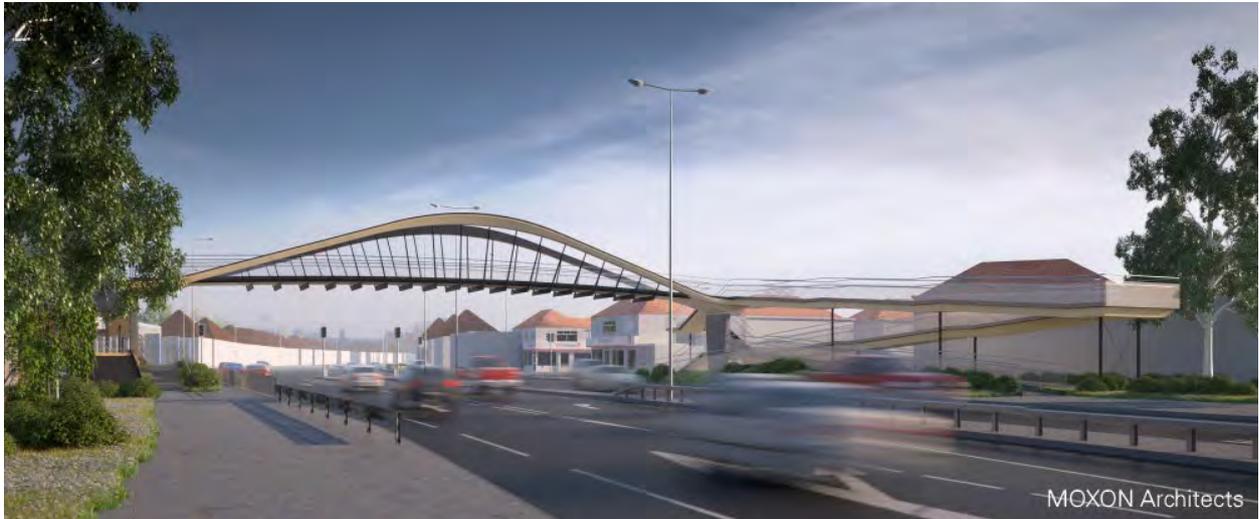
Figure 7: Bridge – London (UK)

Competition design: arch bridge with cladding on top and interior – without cladding from the outside view

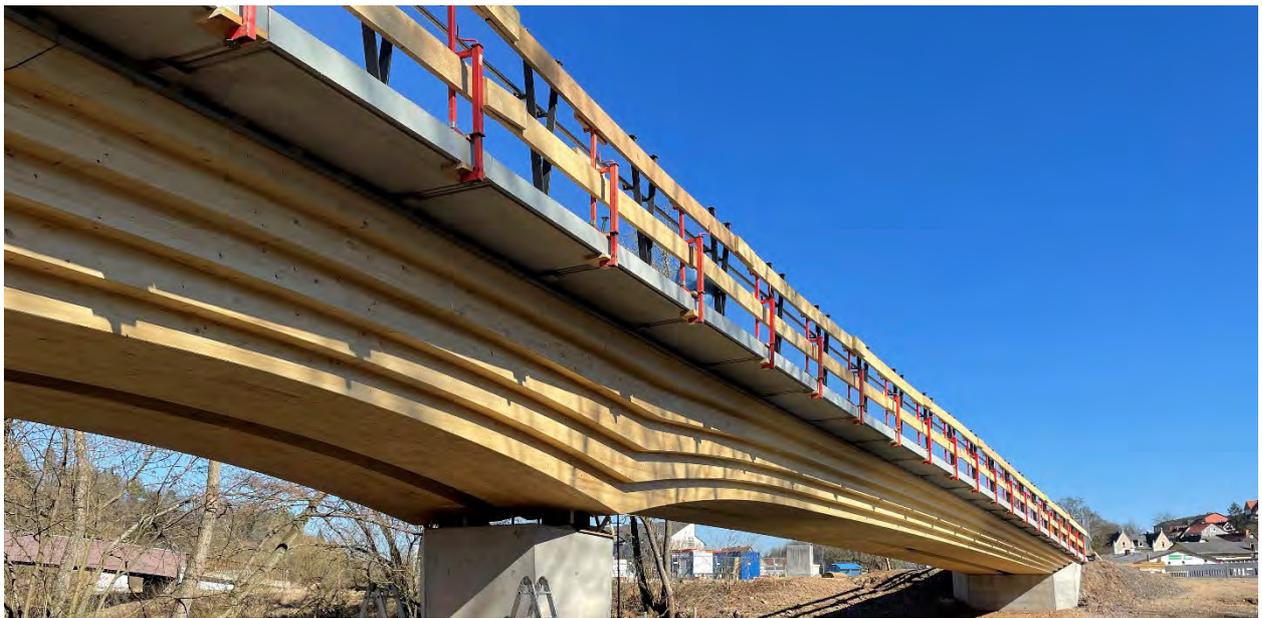
Figure 8: Bridge – Frankenberg (GER)

2022: Form follows static impact: timber design without cladding with correlating overhang of the concrete slabs.

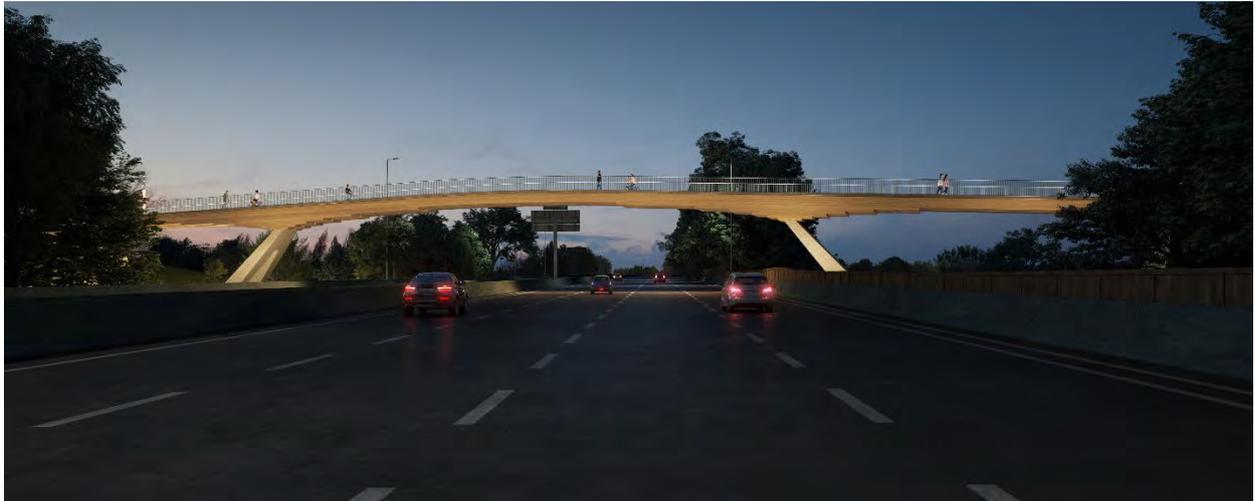
Figure 9: Bridge over motorway A1 Paris (FR)

In process: solid glulam structure well protected – and with fire resistance for over 120 minutes

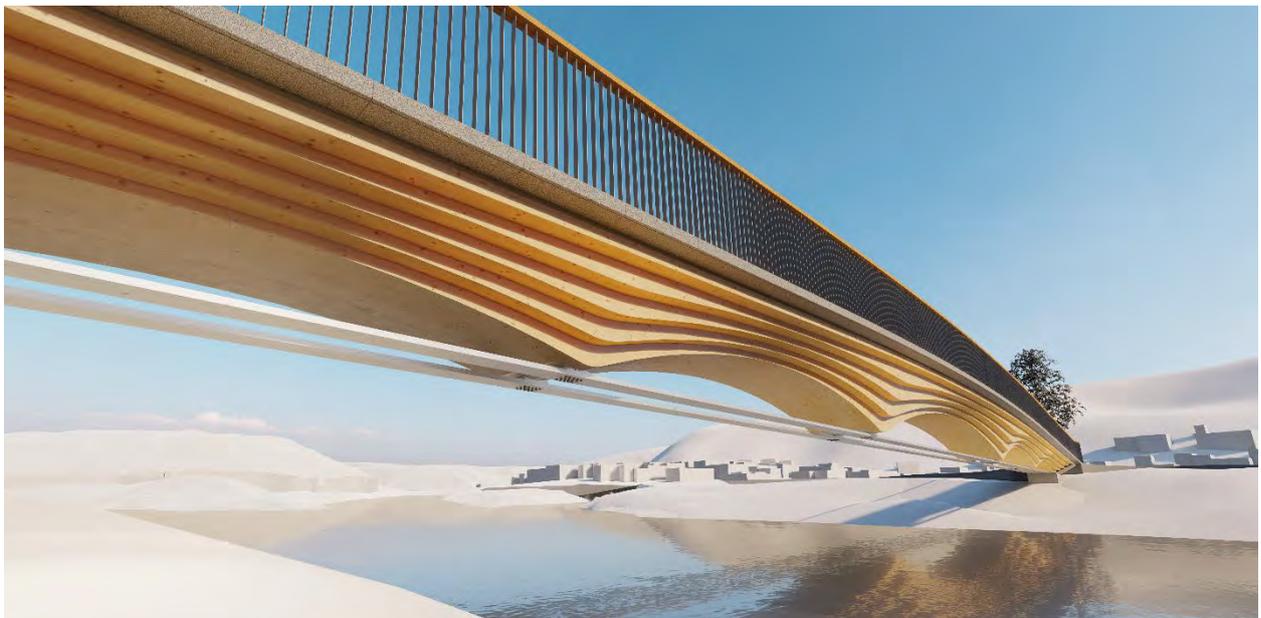
Figure 10: competition Bridge – Kinding (GER)

Competition design: under tensioned beam in neighborhood of a historical roman stone bridge

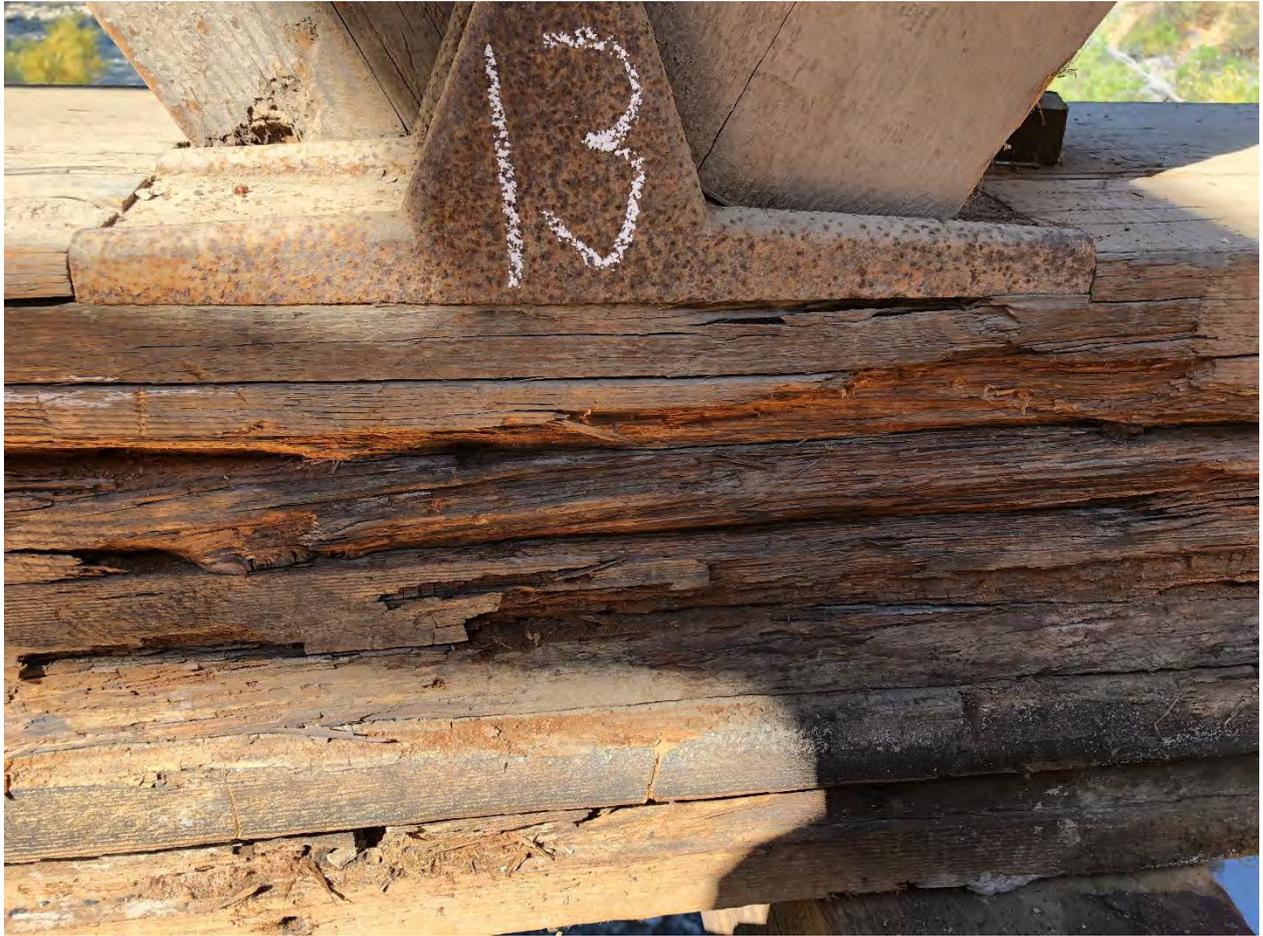
Figure 3 – Photograph of Bottom Chord Decay prior to repair (Lawrence Jones)

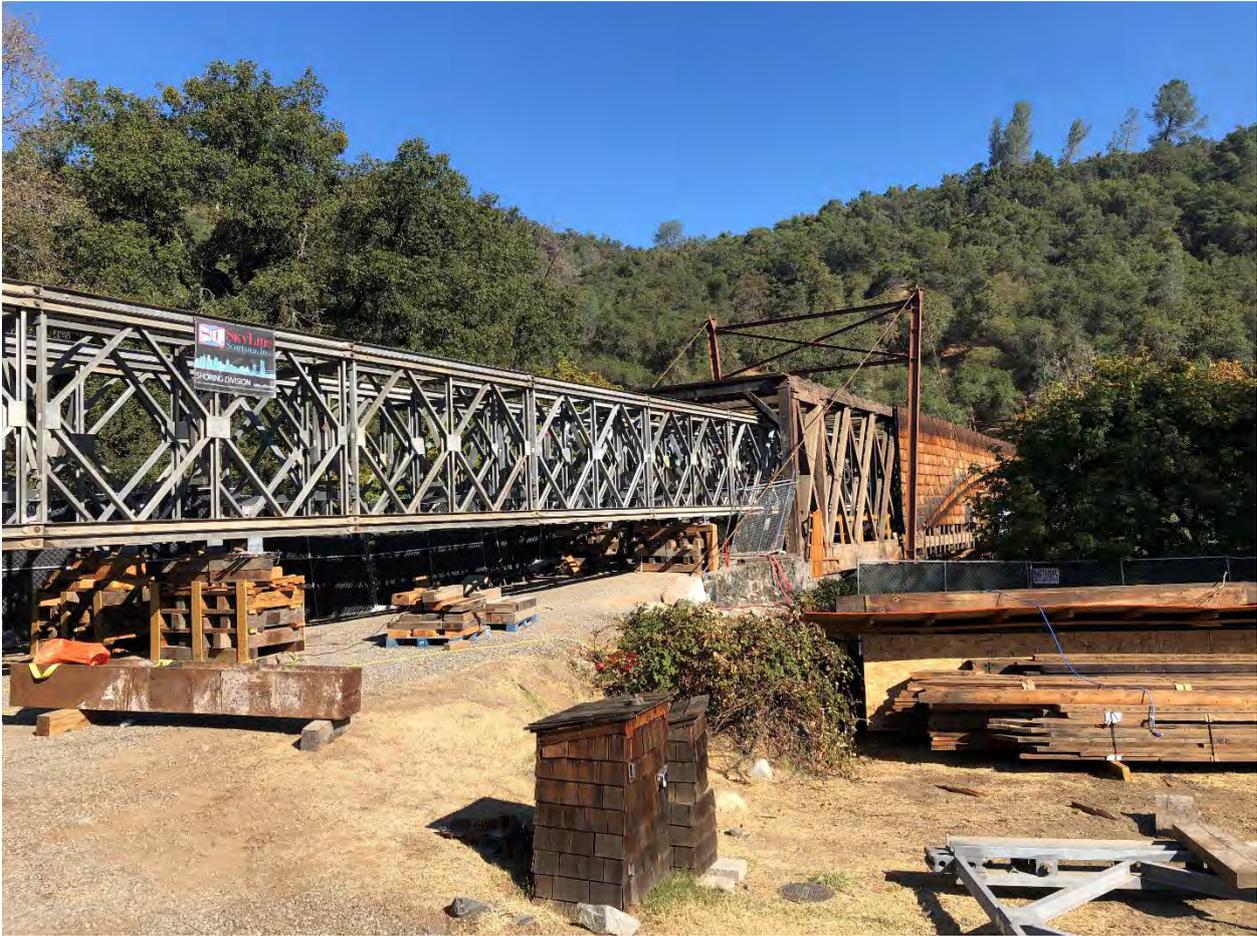
Figure 4 – Launch of shoring (Lawrence Jones)

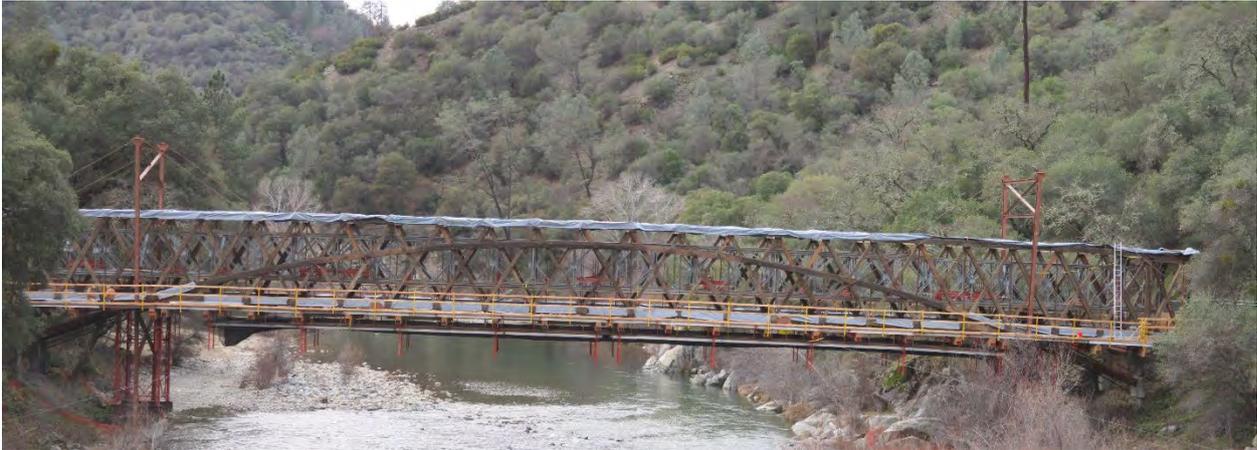
Figure 5 – Bare bridge with shoring installed (John Rebenstorff)

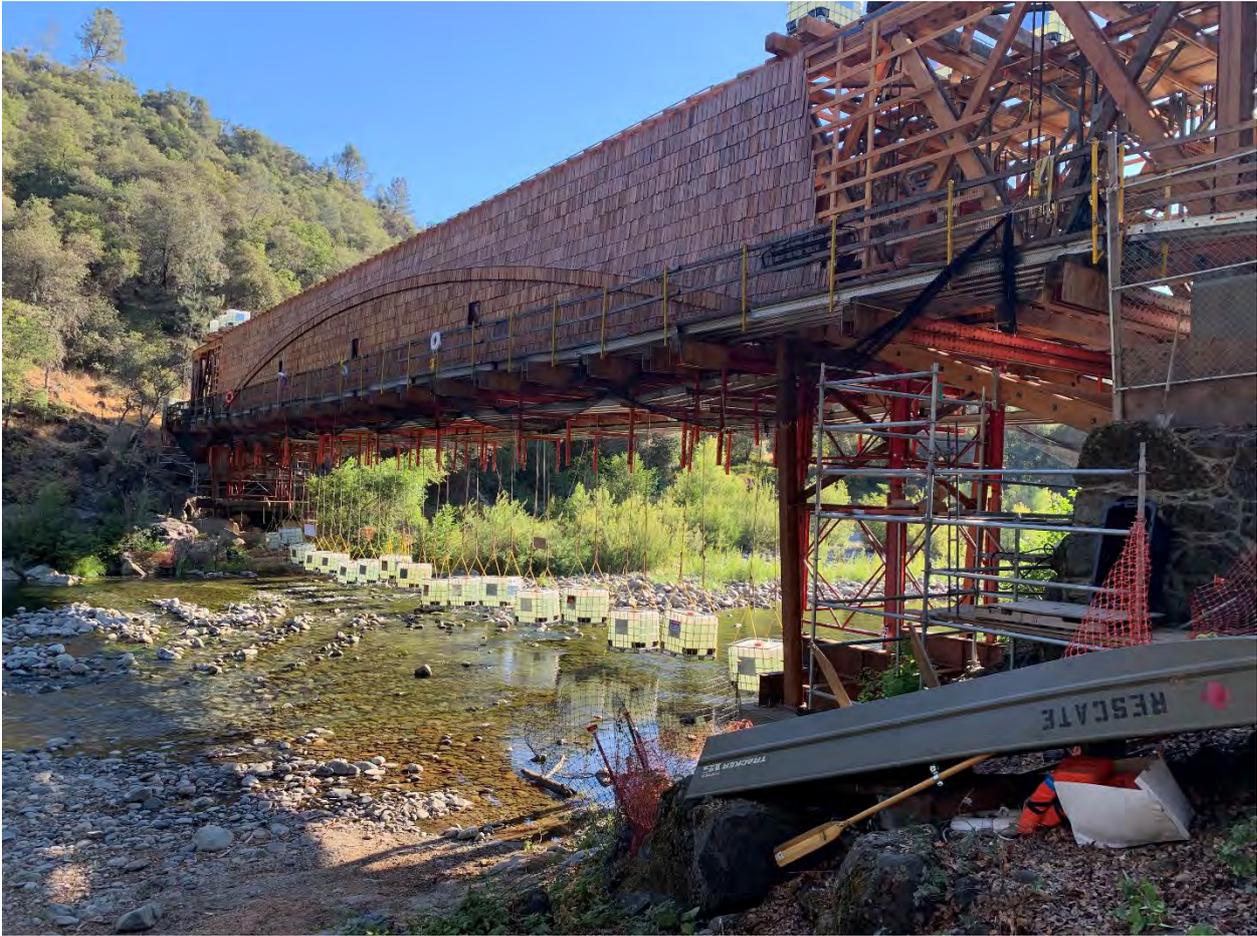
Figure 6 – Load testing bridge prior to shoring removal (Lawrence Jones)

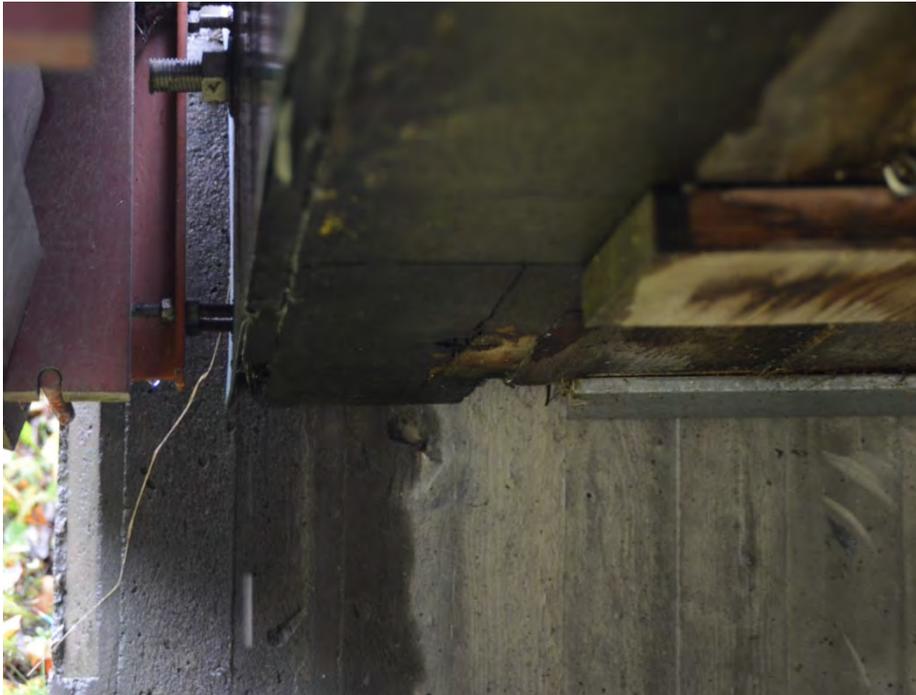
Figure 1. Wet outer beam from Klockarleden short.

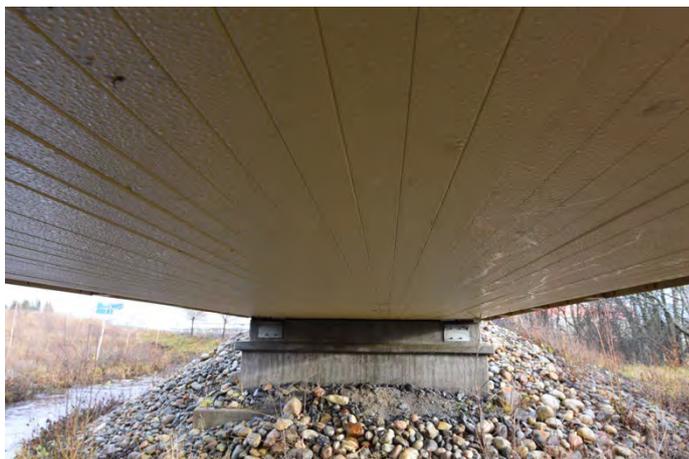
A pedestrian bridge equipped with four sensors. The bridge has increased level of surface moisture due to water condensing (Figure 2), which has led to cupping of the bridge deck.

Figure 2. Condensation on bottom of the bridge deck.

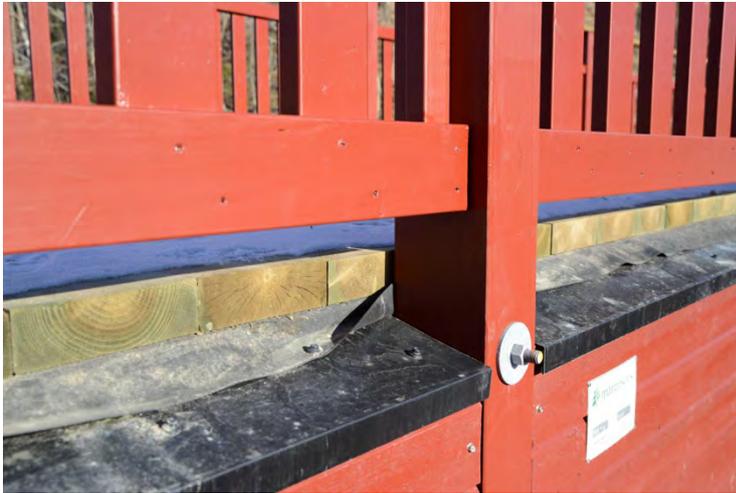
The bridge is a pedestrian bridge with timber decking of treated pine (Figure 3). The bridge has ten sensors factory installed. The manual measurements is showing a MC between 12-16% under the membrane.

Figure 3. Stress laminated deck with a thin rubber membrane and plank decking.

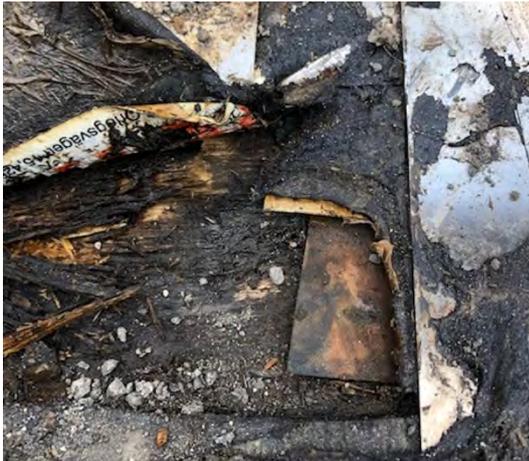
The Gislaved bridge is Sweden's largest road bridge in timber [4]. The bridge is equipped with 16 retrofitted sensors. This bridge shows the importance of acting fast when monitoring data show high moisture content. Elevated moisture content was determined in 2015 and with no actions taken by the owner, areas with severe decay were found during inspections in 2020. After removing the asphalt several problems were found. The membrane strip on the edge of the deck still had the protective backing on (Figure 6) resulting in no adhesion to the deck. The membrane strip joints were not welded which leads to water penetrating in under the drip edge and into the wood deck.

Figure 6. Detail of Gislaved bridge. Membrane strip not properly attached. Decayed wood is also visible.

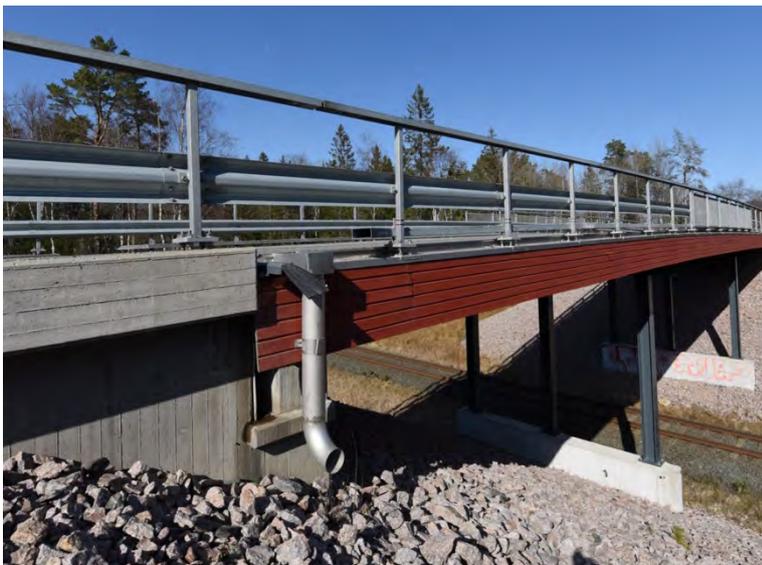
A road bridge spanning a railroad with ten retrofitted sensors. The timber deck from three inspections show expected MC where good detailing such as examples in Figure 7 is a contributing reason.

Figure 7. Good detailing of expansion joint drainage and down pipe.

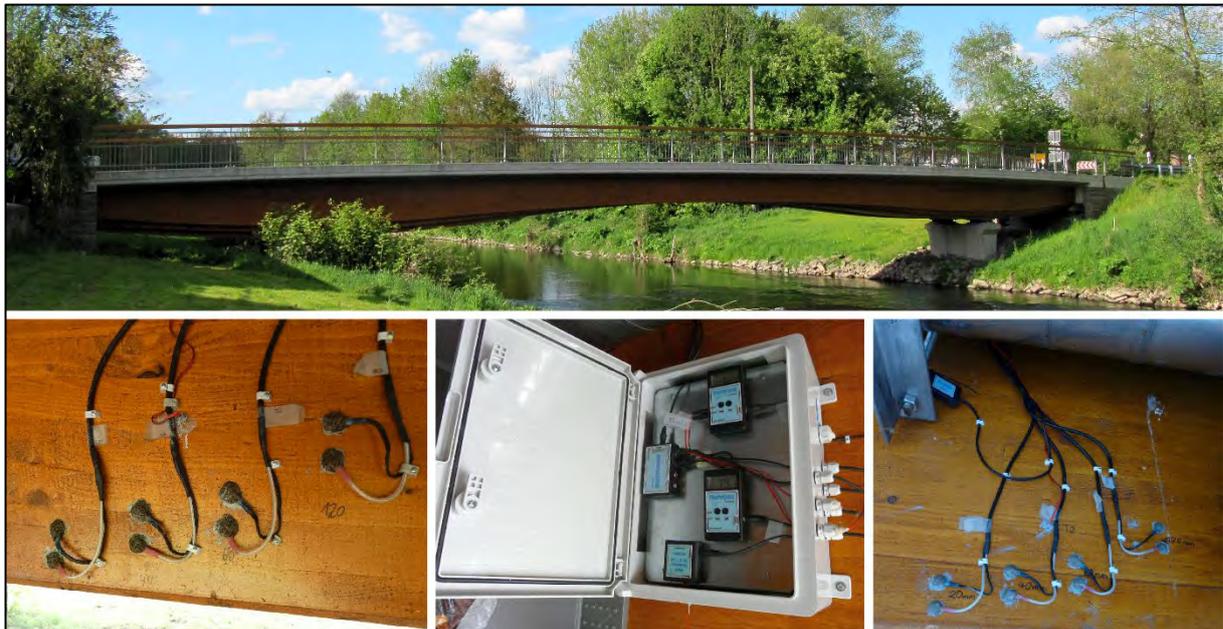
Figure 2: View of the TCC road bridge in Lohmar-Schiffarth (top of the image); measuring area over the foreland (bottom left); measuring equipment in an installation box (bottom centre); measuring area over the River Agger (bottom right of the image)

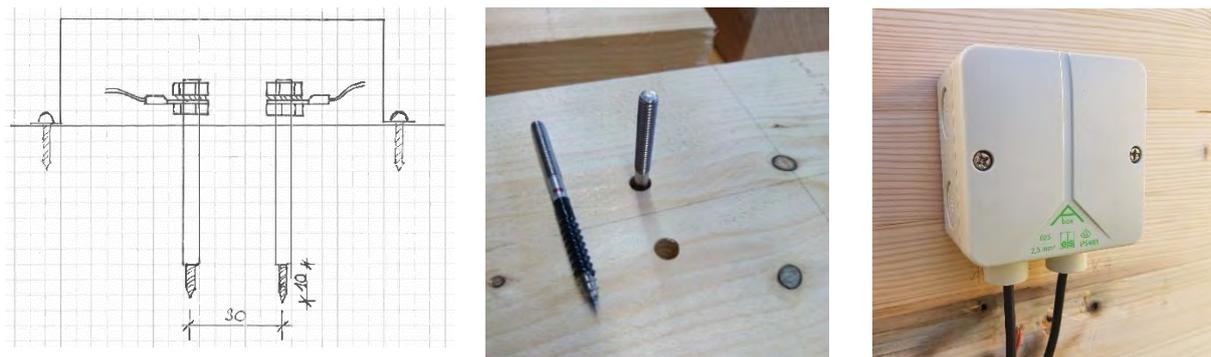
The choice and installation of electrodes should be done carefully, especially for objects subjected to outdoor climate, strong climatic variations, or direct weathering. Due to the shrinkage and swelling of the wood, normal wood screws or nails may have no or poor contact with the wood or the cable. Both lead to falsification of the resistance measurement and mostly indicate lower wood moisture contents than in reality. The use of hanger bolts and a protective box has proved to be successful, cf. Figure 3. The hanger bolts must be insulated with suitable material except for the tip. The cables are fixed directly to the hanger bolt with nut and locknut. The shrinkage and swelling of wood have almost no influence on the required good electrical contact between wood and electrode. All metallic parts of the electrodes should be made of stainless steel, if possible, [11].

Figure 3: Principle sketch and photos of the installation of the hanger bolt electrodes and protective box, [11]

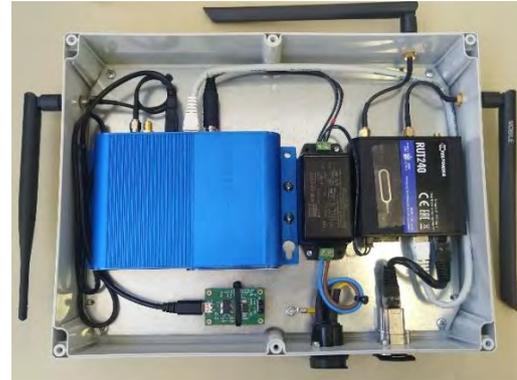
Figure 7: Gateway to use and control several sensor nodes

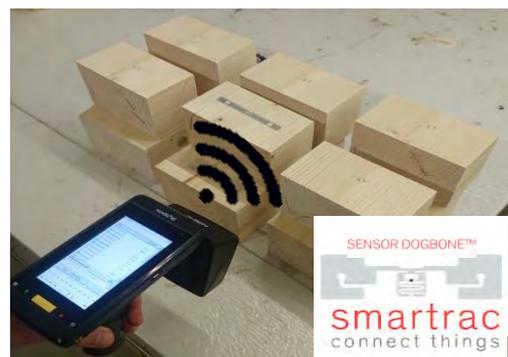
Figure 9: Simultaneous measurement of several RFID tags installed in the wood specimen

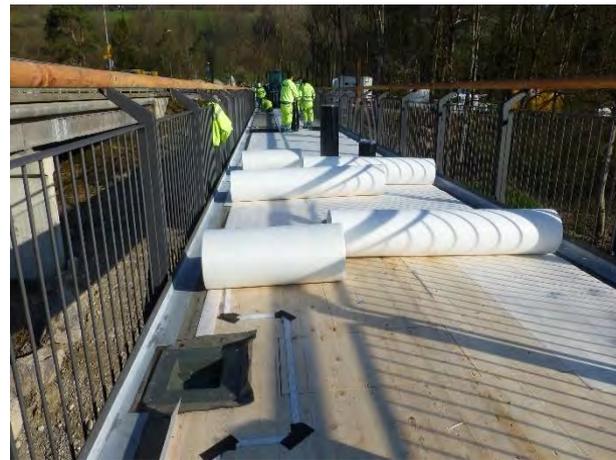
Figure 14: Sensors on the wooden panel and laying of the glass fleece and PBD seal

The foot and cycle path bridge between Rapperswil and Auenstein was equipped with sensor tapes cf. Figure 13 and Figure 14. The monitoring system monitors the possible leakage of the waterproofing and additionally records climate data, material temperature and wood moisture, Figure 13. The on-site measuring unit evaluates the measurement data and sends it to a cloud so that it can be retrieved worldwide at any time using a browser. Warnings and alarms are triggered when critical values are reached.

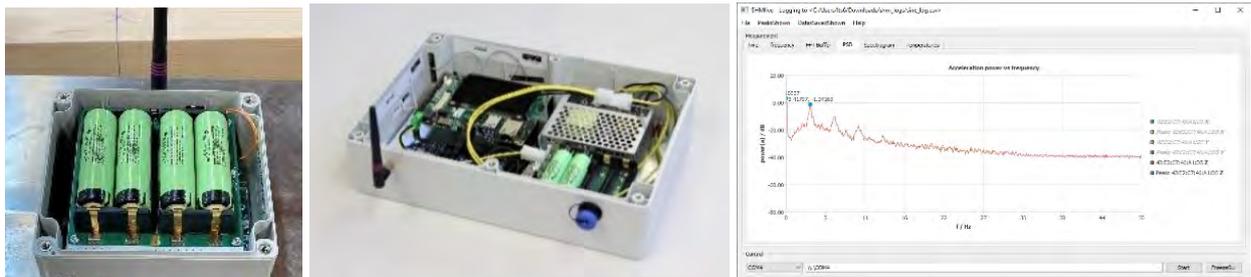
The departments AHB and TI jointly developed a stand-alone vibration measurement system consists of several sensor nodes and a powered HUB, Figure 16. Each sensor node includes the 3-axial acquisition of the accelerations and the wireless data transmission (via BLE - Bluetooth Low Energy - up to 100 m) of the measurands directly to a PC or the HUB. They are battery-operated (runtime 0.5 year) and easy to install and handle. Several nodes can be integrated into one measuring system by the HUB at the same time. The raw data is stored locally and sent to a time series database. The hub controls and monitors the sensor nodes. Problems such as short interruptions in the connection to the sensors are handled correctly, so that long-term use is ensured. A specially developed software is used to control the sensor nodes and visualize the acceleration data. The sensor data can be displayed in the time domain as well as in the frequency domain, Figure 16 right. This makes it possible to determine the natural frequencies.

Figure 16: Sensor node with 3-axis acceleration sensor below the battery pack (left), HUB (center) and FFT analyses of the frequencies (right)

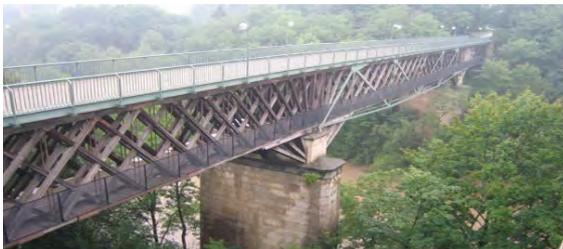
Figure 1: Trussbridge Kempten (GER)

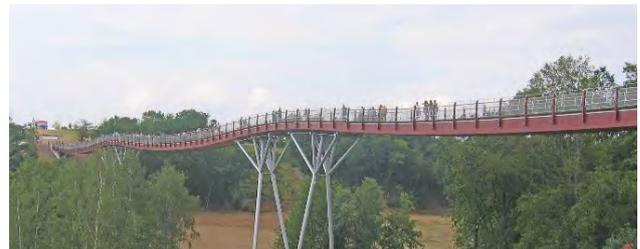
Figure 2: Stress-Ribbon-bridge Gera-Ronneburg (GER)

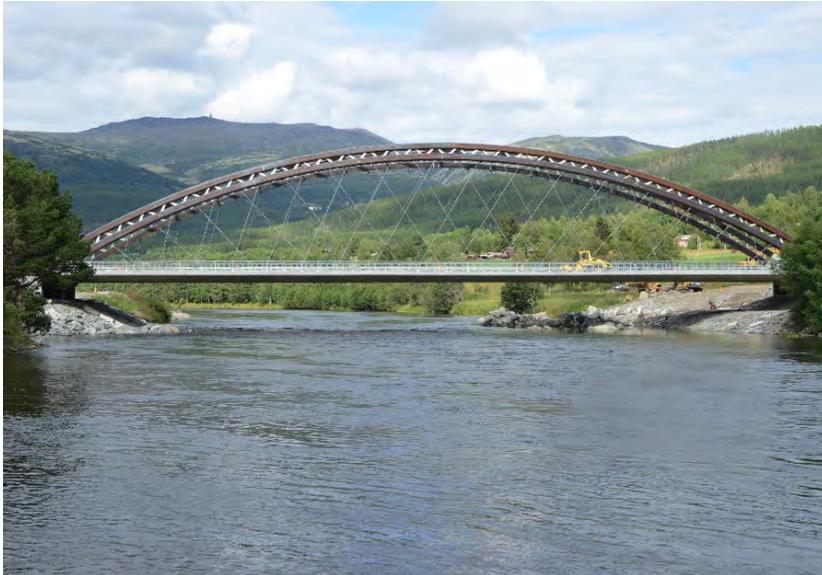
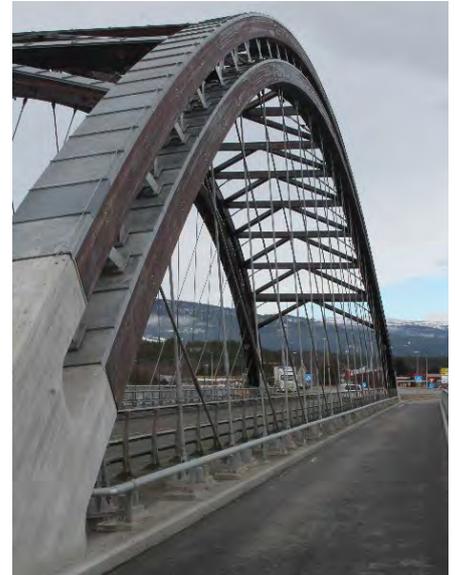
Figure 17: Steien road bridge, Alvodal. 88 m free span!
