International Conference on Timber Bridges ICTB2021^{PLUS}

Conference Proceedings

International Conference on Timber Bridges ICTB 2021^{PLUS}
Conference Proceedings
9 - 12 May 2022

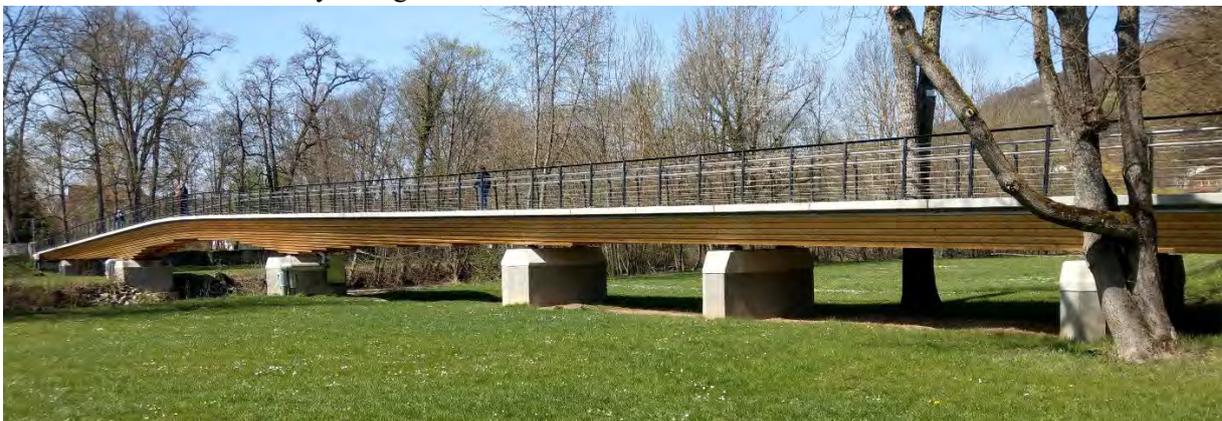
The pedestrian bridge in the spa park in Bad Mergentheim, built in 2020, connects the spa park area with the city over the river Tauber, see also Fig 3. The load-bearing structure of the bridge consists of two parallel block-glued glulam (GLT) superstructure beams with variable height. The bridge girders are supported on a total of 8 RC-abutments; the total length of the bridge is around 90 metres. The largest partial span then crossing the river is 30 m. The deck of the bridge is made of pre-cast concrete slabs resting on cross girders. Fig. 3 shows a view of the bridge structure. Figures 4 and 5 show a side view and the cross-section build-up, respectively, of the GLT superstructure.

Figure 3: View of the Kurpark Bridge in Bad Mergentheim

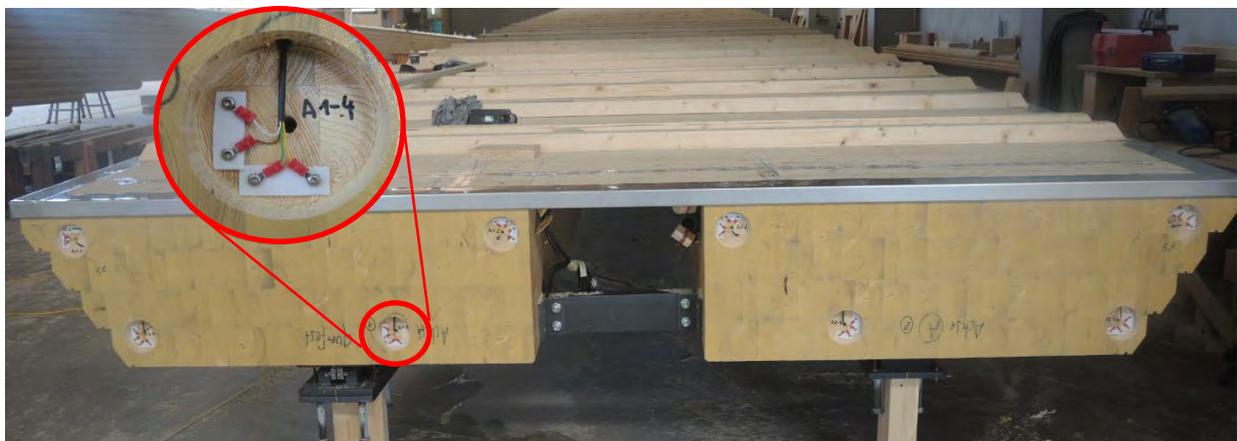
At the two end abutments (locations A and H), each of the superstructure GLT beams has 4 measuring points installed at the end grain face whereby each point includes 2 moisture content sensors measuring at depths of 40 mm and 65 mm. At the abutments on both sides of the river (locations C and D), three measuring points exist, two on the side surfaces of the glulam beams and one on the upper side of the beams, directly below the sealing coat. At the apex of the bridge (area C&D), a further 4 measuring points are placed laterally on the glulam beams on the north side of the structure which is expected to be the area with the highest moisture input.

Figure 6: Cross-sectional end grain face view of the superstructure GLT block girders with 2x4 measuring points, each with 2 pairs of electrodes for moisture measurement

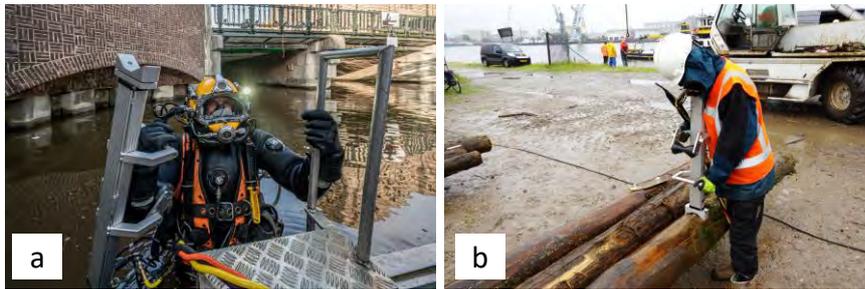
Micro-drilling measurements fall within the non-destructive techniques used for wood inspection, commonly used for trees or electrical poles. From the measurements, it is possible to obtain a resistance profile which can give information about the annual rings of a tree and the density of the investigated section [16]. In Amsterdam, micro-drilling was initially used as an innovative inspection method to assess the level of degradation, by performing underwater measurements on the head on wooden foundation piles which were in the soil and completely under the water table. However, a drilling measurement on the head of the pile was not sufficient to predict the status of the material along the length. Therefore, in this study, a IML-RESI PD 400 tool (Fig. 4) was used to assess the level of degradation, performing micro-drilling measurements in different cross-section along the length of 12 extracted wooden foundation piles. For under-water measurements on piles under the bridges, the machine was adjusted by the manufacturer. The acquired data is used to investigate the feasibility to predict the decay in different parts of the pile. The comparison between the measurements carried out in-situ and those performed on extracted specimens is not presented in this paper, since in-situ micro-drilling belongs to a running project that will be subsequently reported. Thus, for the research conducted in this paper, only the IML tool for above-water measurements was used. The measurements were performed in the TU Delft laboratory, allowing to estimate the soft shell by micro-drilling on heads, middle-parts and tips of all the investigated piles. In this way, the decay level along the length of each pile could be studied.

Figure 4: Micro-drilling measurements: a) underwater measurements on wooden piles; b) measurements after piles extraction.

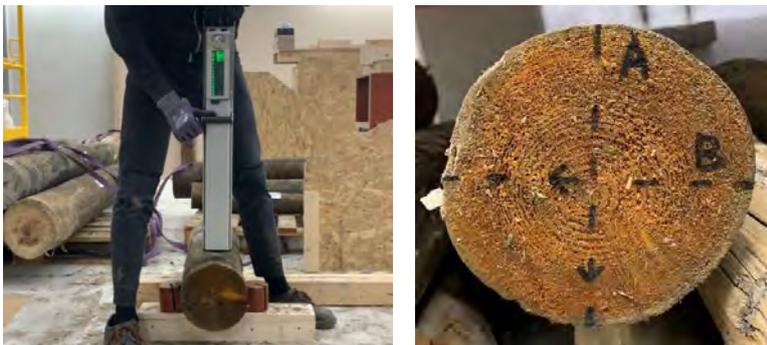
Figure 5: Micro-drilling measurements performed on a pile segment before the compression test.

During micro-drilling, a drilling needle is pushed into the cross-section with a drill speed of 2500 r/min and a feed speed of 150 cm/min. The drill bit used for the measurements is 400 mm long, with a thin shaft of 1.5 mm in diameter and a 3.1 mm wide triangular shaped cutting part, with hard chrome coating. The acquired data, recorded every 0.1 mm of the drilling depth, was plotted as resistance vs distance, resulting in a wave plot in which amplitude displacements coincided with changes in density and moisture content [17], [18]. Once the 12 piles were subdivided in segments, two micro-drilling measurements were performed through the cross-section of each segment, approximately 90 degrees to each other and 300 mm from the head of the specimen (Fig. 5). These measurements were performed before testing the specimens in compression, therefore it was possible to inspect the material status right before the test. The resistance profile (Fig. 6) was obtained from putting together the two drilling measurements performed through the cross section. By observing the resistance profile, it was possible to distinguish the annual rings, with maximum amplitudes, corresponding to latewood rings, and minimum amplitudes, representing early-wood. Isolated peaks or lower values could be observed in resistance profiles, on the one hand caused by wood knots and other high-density anatomical variations of the material, on the other hand caused by piths and cracks in the cross-section. The possible decay in the cross-section was estimated on the basis of a new definition of the soft shell, defined as the outer decayed layer of the cross section. To this end, an average drilling resistance was determined from the resistance profile. The starting and ending point of the soft shell was manually calculated with the intersection between the average drilling resistance decreased by 30%

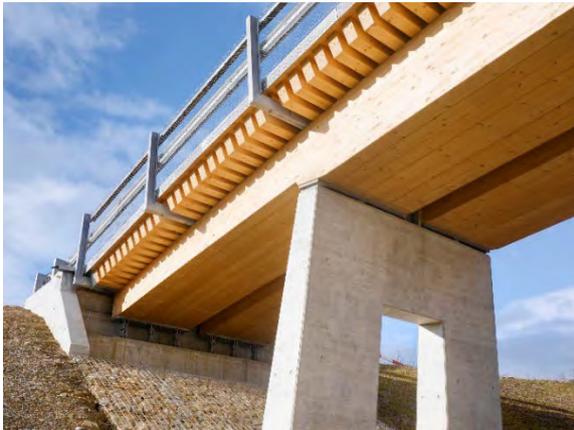
Figure 1: Bridge Horen Switzerland, block glued glulam members as main structural elements, Source: BFH, Switzerland

There was the question especially for large glulam members as produced by block-gluing about the impact of ambient climate variations on the moisture induced stresses and possible failure. Block glulam beams form wide cross-sections by gluing single glulam beams to each other. They are used as, e.g., main structural elements for timber bridges, see Figure 1. Therefore, cross sections of practical dimensions were classified regarding the assumed ambient climate in service by numerical simulations that showed the moisture content and gradient over the cross section. Finally, the moisture induced mechanical response was simulated using a coupled moisture diffusion and mechanical model. The results were summarized to a practical advice for the dimensioning.

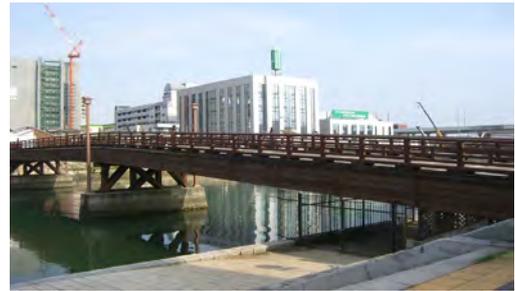
Figure 1. Tokiwa Bridge; subject of this study

The purpose of this study is to evaluate vibration serviceability of timber pedestrian bridges based on experiment and analysis. The subject bridge is Tokiwa Bridge, a large scale three spans continuous girder made by bongossi wood material and constructed at 1995 in Kitakyushu City in Japan as shown in Fig.1. The design geometry is: bridge length: 84.4 m, maximum span length: 31.0 m and clear width: 6.0 m.

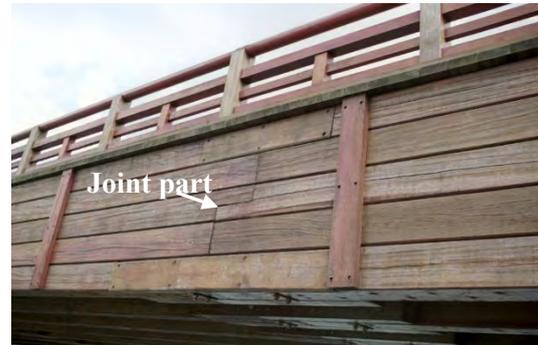
Figure 5. Outside of joint part

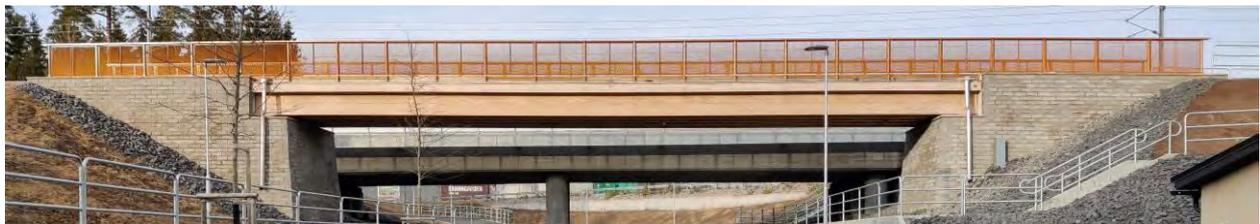
The bridge is a single-span pedestrian timber bridge situated in Växjö, Sweden, see Figure 1. The bridge is 26.1 m long in total with a span of 25 m. The loadbearing structure consists of five longitudinal glulam beams (165x1170 mm) with a top flange made of a stress-laminated timber (SLT) deck with a thickness of 315 mm and total width of 4005 mm, see Figure 2. The connection between the SLT deck at the top flange and the longitudinal beams is achieved with friction due to the pre-stressing force from 43 steel bars running through the deck. Five crossbeams (115x540 mm) are installed at 5 locations between the longitudinal beams with a c/c of 6 m along the bridge. The crossbeams are connected to the longitudinal beams with angle irons. Steel bars also are installed at the lower flange of the longitudinal beams at the same locations as the crossbeams to prevent lateral deflection of the longitudinal beams. All the structural timber parts of the bridge are made of glulam with strength class GL30c. The finished bridge have railings which extend 7.65 m from the bridge deck boundary edges as well as an asphalt layer with a constant thickness of 75 mm. The asphalt layer is a preliminary layer without the final camber with a 2 % slope seen in Figure 2. The asphalt is termed PGJA 11 in the Swedish norm which consists of mastic asphalt (MA) with a nominal maximal aggregate size of 11 mm and polymer modified bitumen (PMB).

Figure 1: An overview of the finished bridge.

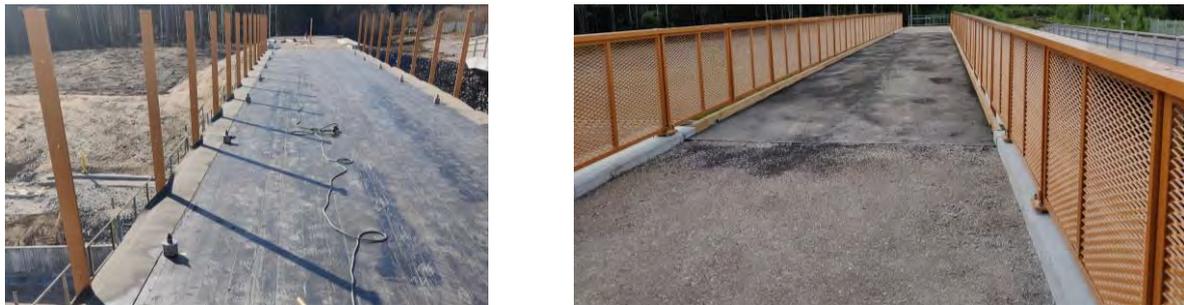
- Stage 1) Timber structure including longitudinal beams, SLT deck and crossbeams.
- Stage 2) Timber structure and railings.
- Stage 3) Timber structure, railings and asphalt during warm conditions.
- Stage 4) Timber structure, railings and asphalt during cold conditions.

Figure 3: The bridge during and after construction. Left: Stage 1 with only the timber structure. The vertical flat bars for the railings were present on the bridge. Right: Finished bridge (stage 3 and 4) with timber structure, railings and asphalt.

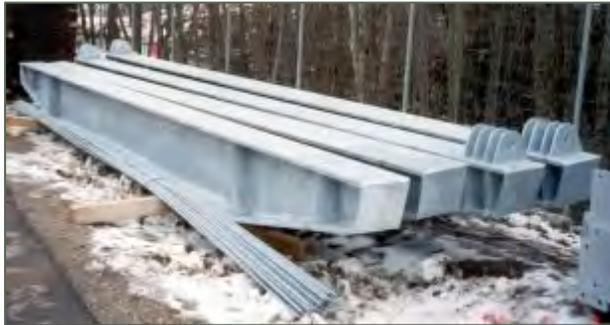
Figure 1: Hot dip galvanized cross beams with fixing lugs for suspension post attachment

Traditional timber bridges were provided with cross beams of timber, but modern traffic loading with heavy wheel loading required cross beams of significant depth with respect to the shear force capacity. Cross beams made of steel, however, showed to be far more efficient, and today steel material is the primary option for cross beams on timber bridges on roads with vehicle traffic.

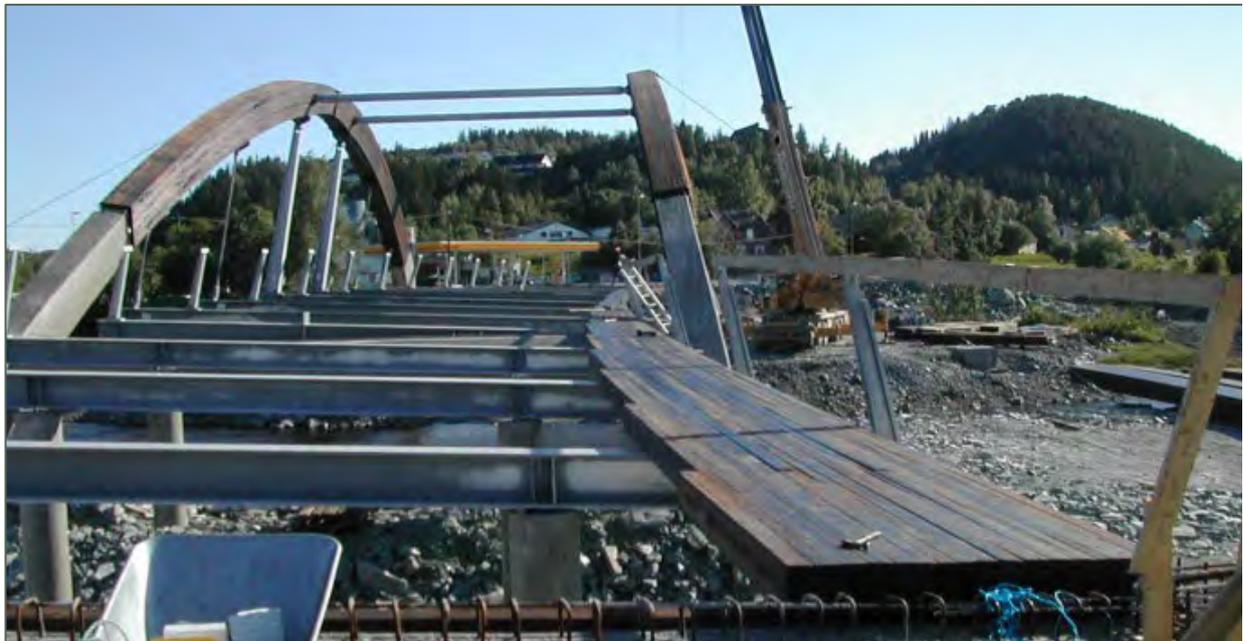
Figure 2: Stress laminated deck of sawn timber on steel cross beams (Måsørbrua)

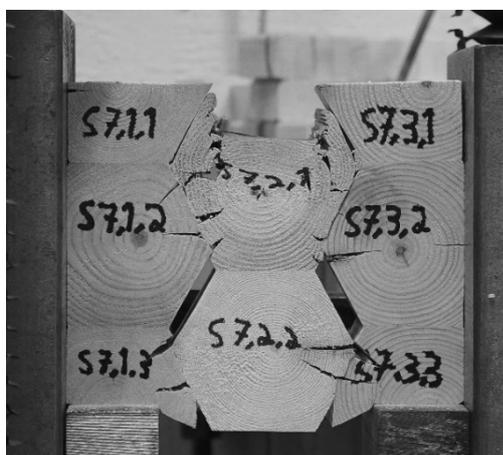
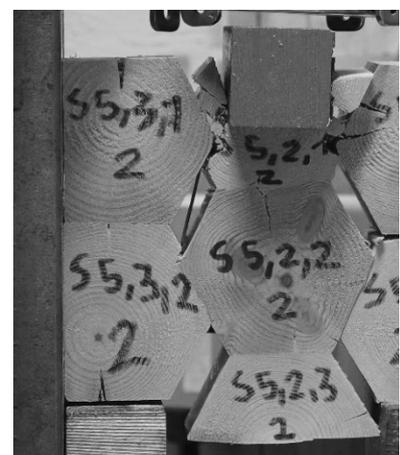
Figure 6: Shear test failure of oblique interlocked lamellae [2]

Tests have shown that if using hexagonal shapes as shown in figure 4 the failure mechanism was very much ductile and no brittle shear failure was observed on any tests. In the tests the lamellas were totally restrained sideways, which might impact especially the friction between lamellas. Still, the failure mode was clearly compression perpendicular to grain from the loading block. Only after considerate deformations flexural stresses perpendicular to grain resulted in tension stresses. This came to some surprise since interlocking in shapes often has been said to be doomed due to the low rolling shear capacity of timber. This is probably dependent on the angle of the interlocking, but for the hexagonal shape clearly not an issue.

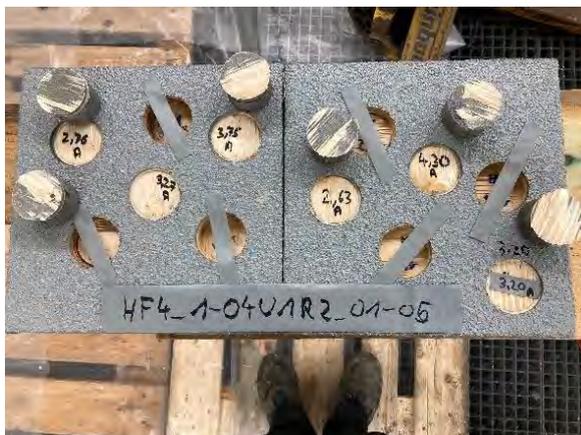
System 2 and 4 showed failure between wearing layer and topcoat, after storage in water. Systems 1 and 3 had the failure level in the CLT.

Pic.1: Adhesion test sys-

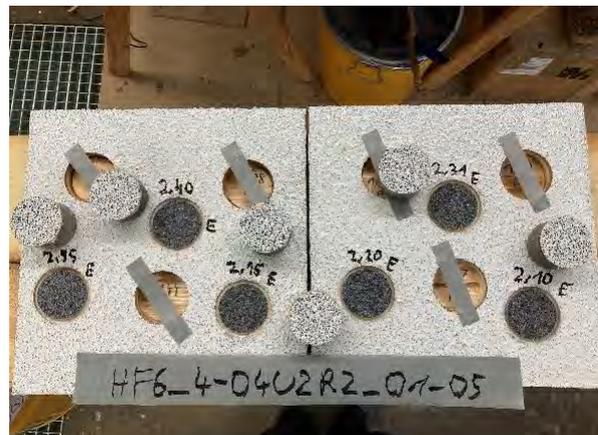
Pic.2: Adhesion test sys-

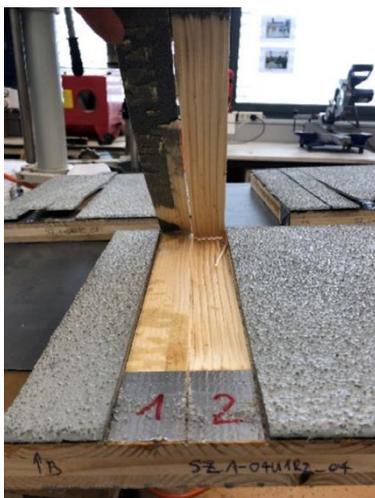
Pic.3: Peel test, System 1

Even if both systems show almost the same peel resistance System 1 is the preferred technology, due to the failure level in the CLP plate.

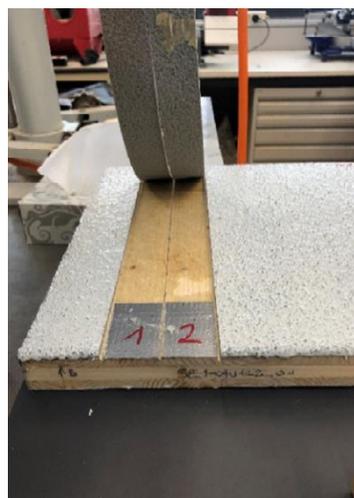
Pic.3: Peel test, System 4

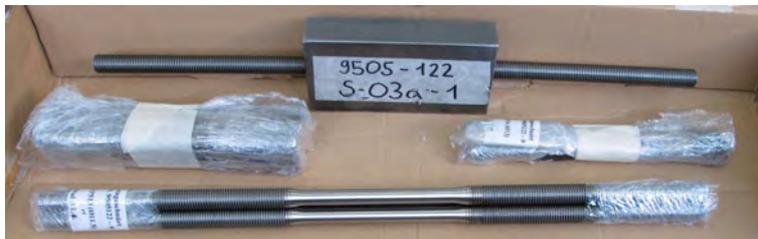
Figure 2: Steel specimens; connection with internal thread (top) and machined threaded rods (bottom)

For the connection, a metric internal thread was chosen, which was cut into the narrow side of a 30 mm thick plate made of steel S355J2. The threaded rods made of duplex stainless steel were machined to a defined diameter over a certain length in accordance with the building practice when bonding-in according to the standard of the GSA Technology [10]. This zone, called “constriction zone” was 110 mm long with linear transitions to the full rod diameter over a length of 15 mm on both sides. Specimens with constriction zones of three different diameters (11.5 mm, 12.0 mm, 12.5 mm) were prepared. Finally, only the specimens with the smallest constriction diameter were tested because these three specimens already exceeded all expectations. Also in terms of connections, four different variants were planned to be tested. But even here, the most economical option already provided satisfying results.

By previously determining the factor Y (Figure 1), mixed mode failures in the main test series should largely be avoided. Therefore, a first test series was carried out on pure steel specimens without adhesive bonding. In order to determine the fatigue strength, the “Mechanical Systems Engineering” laboratory at the Empa carried out single-step fatigue tests and load increase tests on M16 threaded rods and their connection to a steel part. (Figure 2).

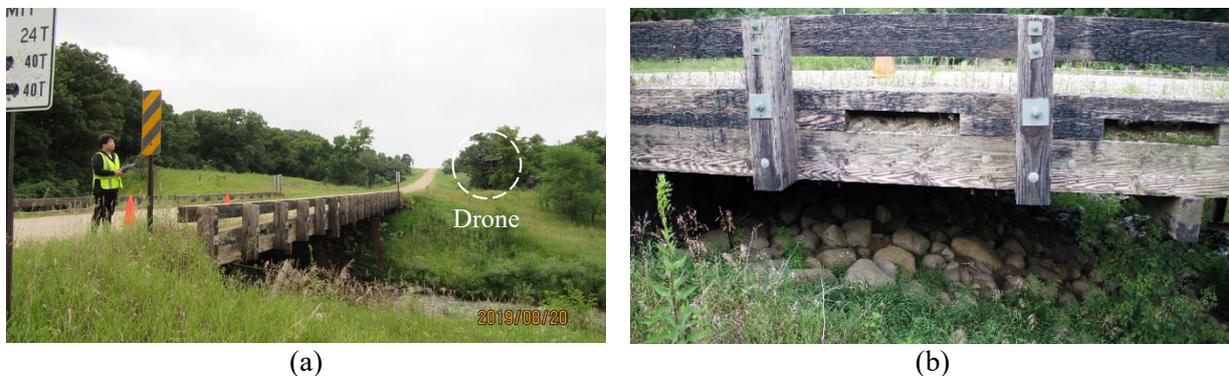
Figure 1: Bridge inspection: (a) drone-aided bridge inspection and (b) inspection images captured by DJI Matrice 210.

In recent years, drone technology has gained traction in several studies [6–8, 14–17, 21–29] as a supplementary bridge inspection approach. Despite a burgeoning interest in using drones in bridge inspections, some issues have arisen related to the image quality during drone-aided inspections. To address this image quality issue, the grayscale image enhancement algorithm in MATLAB [18] and image property adjustment technology [17, 25] were applied. For evaluation of the algorithms, DJI Matrice 210 inspected an existing timber slab bridge located in Minnesota on August 20, 2019. The inspected bridge was built in 1987, and the type of bridge is a three-span, timber slab bridge having a structure length of 31.1 m and a deck width of 10.36 m. According to the NBI condition rating system, the deck, superstructure, and substructure were recently evaluated to be in good condition exhibiting minor defects but with no structural issues [9–11]. The bridge inspection was performed on the east side, west side, and underneath the deck, as shown in Figure 1a. A representative defect due to weathering observed on the east side of the bridge can be depicted in Figure 1b. Although the defect on the bridge element is observed using inspection images obtained from the drone, the defect measurement may be impeded due to unclear boundaries with some type of deterioration such as weathering. To resolve this issue, two image processing technologies, grayscale image enhancement technologies available in MATLAB [18, 19] and image property adjustment technology [17, 25], were considered. Adaptive histogram equalization technology among the grayscale image enhancement technologies adjusts the contrast on specific small regions, known as tiles, in the image. During this processing, the histogram of the tile approaches a specified contrast histogram. In the last step of processing, bilinear interpolation is performed on neighboring tiles to remove the tile boundaries. On the other hand, the image property adjustment technology can improve the visibility of inspection images with adjustment of various image properties including brightness, contrast, and sharpness.

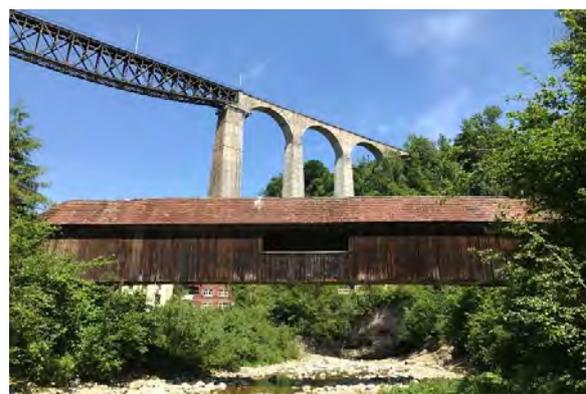
Figure 2: Timber, iron and stones (masonry). Kubel-bridge (1776) with a span of 30 m in the first plane and Sitterviadukt (1910) with a length of 365 m and a maximum span of 120 m. With 99 m this is the highest railway bridge in Switzerland. Picture: R. Widmann

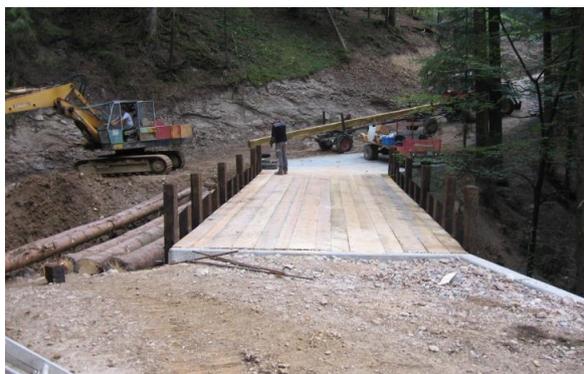
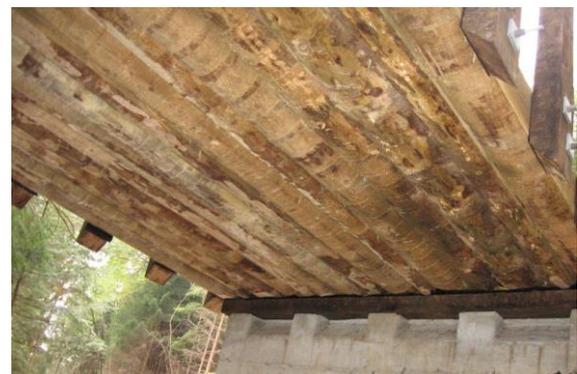
Figure 3: Modern interpretation of early log bridge by Prof Gehri. Untere Hürlisegg Bridge – Eggwil BE – constructed in 2009. This comes close to the historic "Schlagen einer Brücke", which refers to "Schlagen eines Baumes", in English cutting a tree/trunk with an axe. The wood was locally cut and processed on-site in order to arrange it as a bridge (deck) for forest-traffic. Pictures: E. Gehri

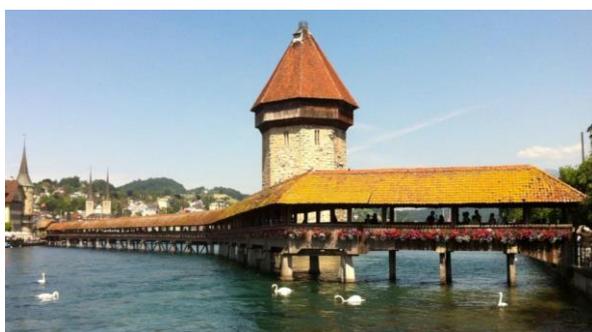
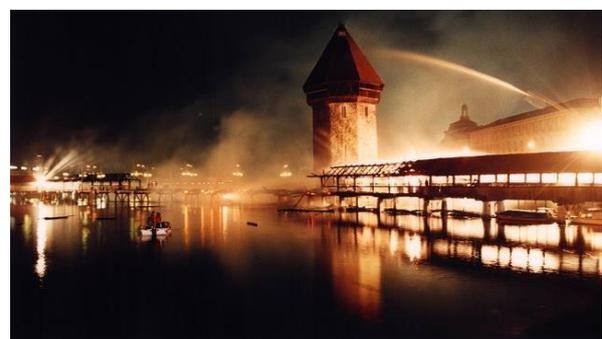
Figure 4: Renowned Kapellbrücke in Lucerne, central Switzerland with a total length of 205 m. This is the oldest existing bridge in Switzerland (1365). It almost completely burnt down in 1993 and was rebuilt in 1994. Pictures: R. Widmann and sgkgs

Since the reliable span of a wooden beam was limited to six to ten meters, intermediate supports made of stone or wood had to be installed for wider rivers/spans. Probably the oldest yoke bridge in Europe is the famous Kapellbrücke in Lucerne with spans of approx. 7.65 m (Figure 4).

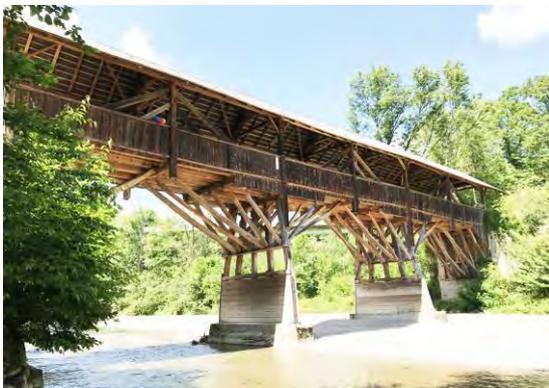
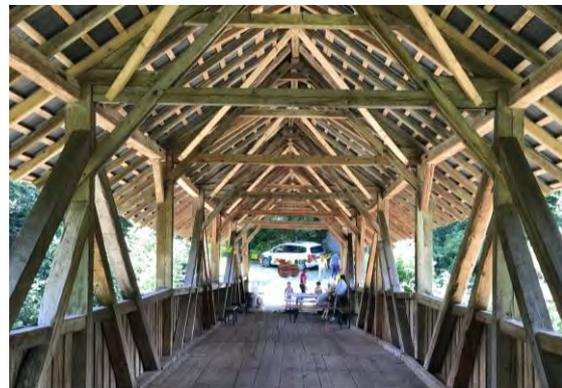
Figure 5: Letzibrücke from 1853 crossing the river Necker in Canton Thurgau. This is an example for a composite truss frame. Since 1969 a pre-tensioned concrete bridge close to the timber bridge takes the road traffic. The picture on the right shows how historic timber bridges can be used in Switzerland nowadays. Like many others they can be, e.g. rented for events like weddings or birthdays. This possibility of use contributes to the fact that the local population often has a strong emotional bond with "their" wooden bridge and thus also takes care of the structure. Pictures: R. Widmann

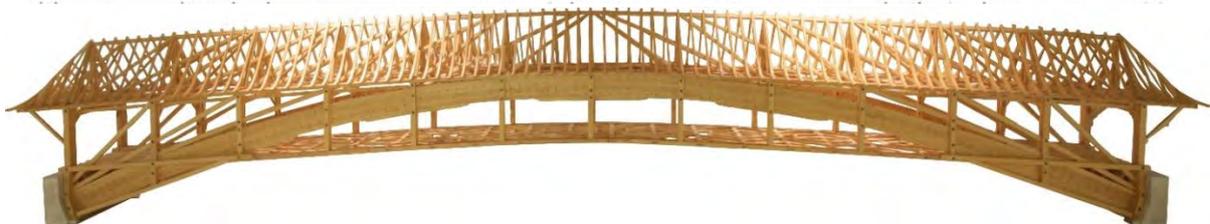
Figure 7: The other very important and renowned bridge of Hans Ulrich Grubenmann is the Wettingen bridge crossing the river Limmat with a span of 61 m. The bridge was opened for traffic in 1766. At this stage, the transition from combined polygonal struts and post constructions as used in Schaffhausen to an arched structure was performed. For the transfer of shear forces the single lamellae had to be spanned together. It is not clear, how it was realized. In the shown model (Zeughaus Teufen), as well in the original (?) model in Aarau, it has been realized by bolts whereas the drawing shows the use of braces. Pictures: B. Nebel, R. Widmann

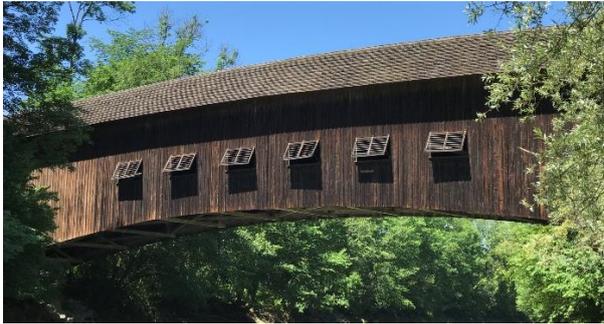
Figure 8: Bridge at Hasle-Rüeggsau BE crossing the river Emme. Built in 1839, it has a span of 58 m and thus is very similar to the Grubenmann Bridge in Wettingen, Picture: R. Widmann

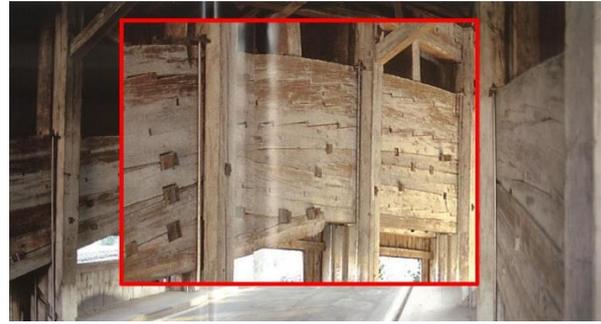
Figure 9: Another Emme bridge (in Schüpbach) with an impressive 49 m span and similar construction as Hasle-Rüeggsau and Wettingen bridges. The picture shows nicely the technics used to create an arch with interlocking tooth-shaped recesses in the lamellae and/or hardwood dowels for the transfer of shear forces within the arch. Picture: E. Honegger (A. Steurer) [6]

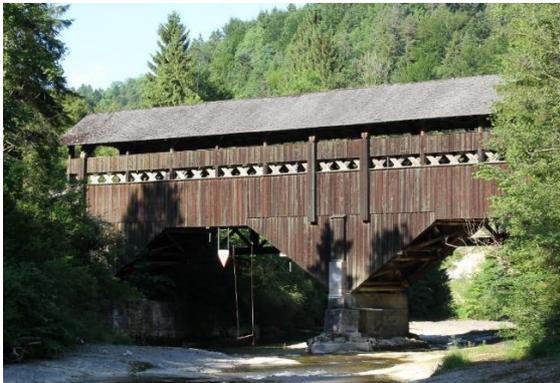
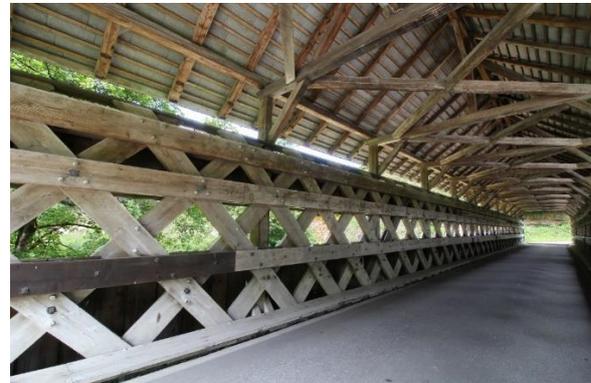
Figure 10: Necker Bridge Anzenwil SG from 1863 with its main structural elements being Town lattice trusses. The bridge spans 46 meters (with the addition of an intermediate support) and was under road traffic load until the year 2000, when a modern concrete-steel hybrid bridge was set next to it. The new bridge carries the main traffic load and leaves the slow traffic to the old timber bridge, Pictures: R. Widmann

They were supplemented by the lattice trusses developed in the USA at the beginning of the 19th century based on the designs of Ithiel Town ("lattice truss") and William Howe. Numerous bridges in Switzerland were built using this method, of which some impressive bridges still exist today, e.g. between Vaduz and Sevelen (Howe truss) over the Rhine and over the Necker (Town lattice truss) in the Canton of Sankt-Gallen.

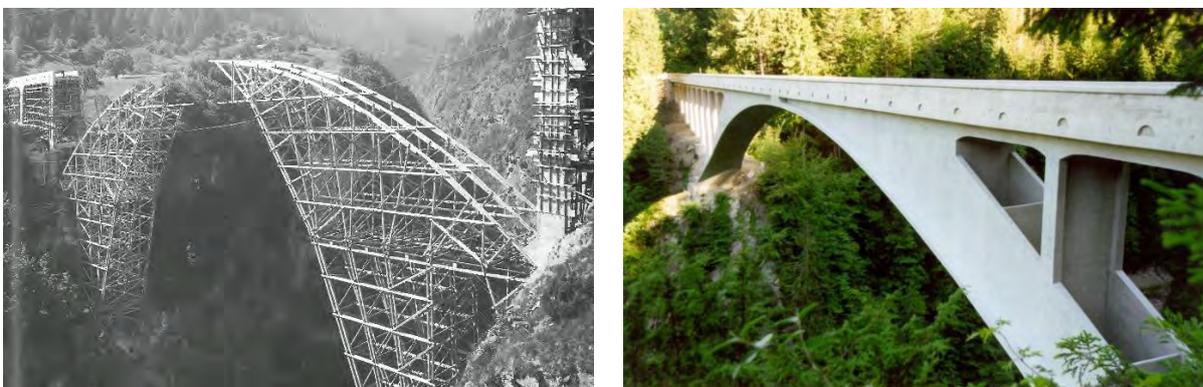
Figure 12: Renowned Salginatobelbrücke in Schiers, Graubünden, Eastern Switzerland by Robert Maillard (concrete structure) and Richard Coray (timber scaffolding) 1929-1930. These pictures highlight the transition of the role of timber in bridge constructions from being the dominant permanent solution in the past to serving as a temporary auxiliary construction. Pictures: L. Gianadda, R. Widmann

With the beginning of industrialization and the associated construction of railways and efficient roads, however, more and more bridges were built first of iron, then steel and concrete. Thus, the construction of (large) wooden bridges was strongly pushed back. In addition, numerous existing wooden bridges were destroyed and replaced by supposedly more efficient bridges made from modern building materials. After all, wood was still used in bridge construction for installations and scaffolding and formwork (Figure 12).

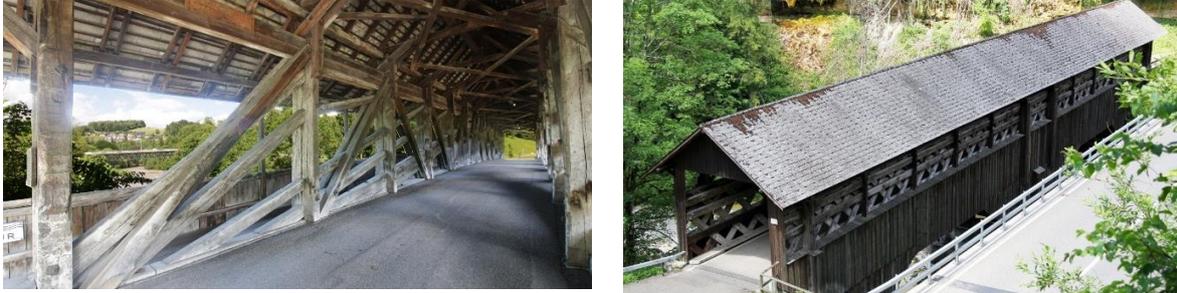
Figure 13: Examples for timber bridges in Switzerland that lost their initial primary purpose as the main traffic bridge to their modern siblings. Left hand side shows the Lüthisburg bridge with length of 58m and its replacement can be seen in the background. Right hand side is the bridge from Figure 10 with its younger sibling just sitting next to it. Both timber bridges are well preserved and still serve for pedestrians and bicycles and in the Lüthisburg bridge can also be rented for event. Pictures: L. Gianadda, R. Widmann

However, since the middle of the 1950s, a rethink has started. Numerous "Hüslibrücken" have been thoroughly renovated and placed under monument protection in order to preserve them for posterity. A few were left next to new concrete bridges as unused "siblings" (Figure 13).

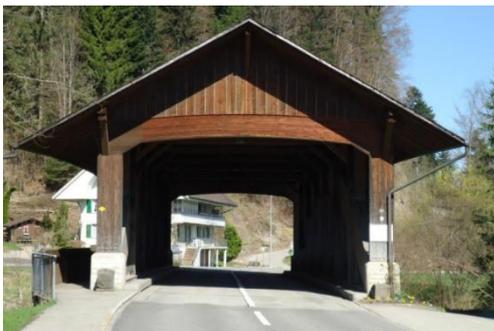
Figure 14: Dörfli-Bridge, Eggiwil, Canton Bern, built 1985, Span 30.6 m, Live load 28 Tons, Type Covered arch bridge, Design: H. Vogel and Prof. Gehri, ETH Zürich, Pictures: Archiv K. Schwaner.

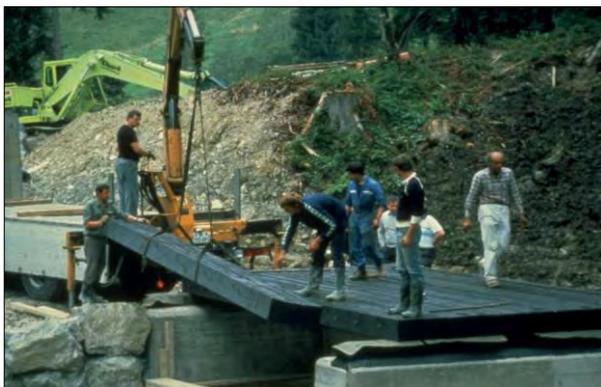
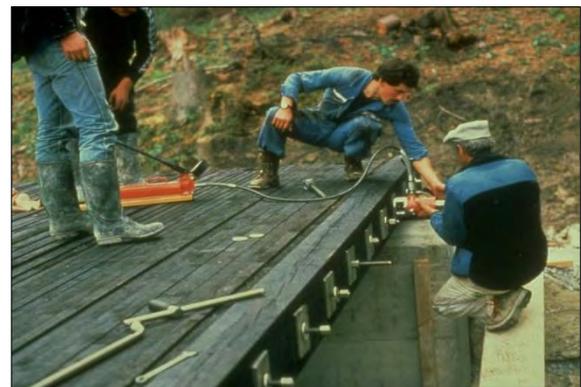
Figure 17: Forestry-Bridge-Typ with Stress Laminated Timber Deck Plates, Design: Prof. E. Gehri, Pictures: Archiv K. Schwaner.

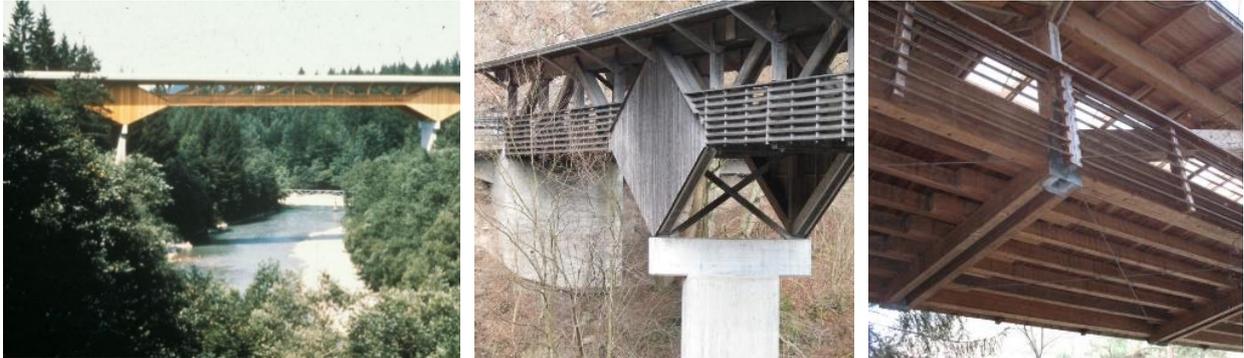
Figure 18: Cycle Path Bridge over Simme near Reutingen/Wimmis, Canton Bern, built 1989, Length 108 m, /Span 27/54/27 m, Type Covered truss bridge, Design: J. Natterer, Pictures: Kolb. Schwaner.

In addition to the road bridges, numerous footpath and cycle path bridges continue to be built in wood. An impressive example is the bridge over the Simme near Wimmis, Canton Bern. Julius Natterer used open lamella formwork instead of closed formwork. This type of cladding is widely accepted for the protection of wooden bridges. It is open and transparent and offers views for people of different sizes. Technically, it ensures excellent drying capacity for the protected components.

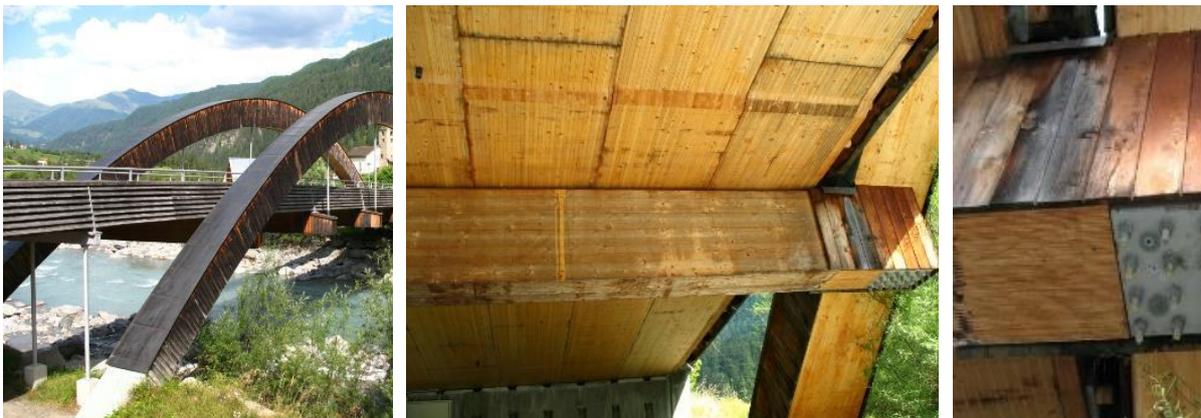
Figure 19: Bridge San Nicla, Canton Graubünden, built 1993, Length/Span: 47,8/39 m, Live load 28 Tons, Type Arch Bridge, Design: A. Mayer, Sent, A. Deplazes, Chur, Prof. E. Gehri, Pictures: BFH

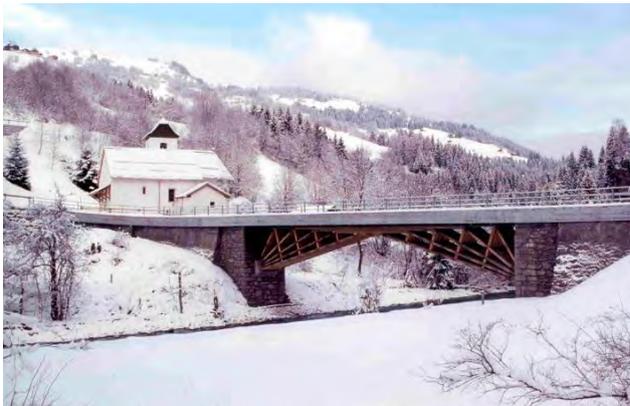
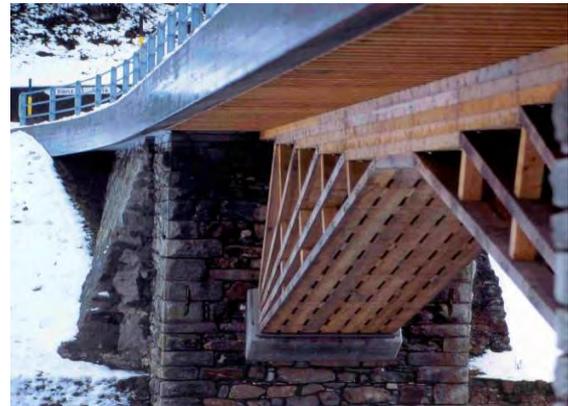
Figure 20: Glenner-bridge, Graubünden, built 2002, Length 34,6 m, / Span 24,6 m, Live load 4x75 Tons, Design: Conzett, Bronzini, Gartmann AG, Chur, Pictures: Graubündenholz, Landquart/LIGNUM

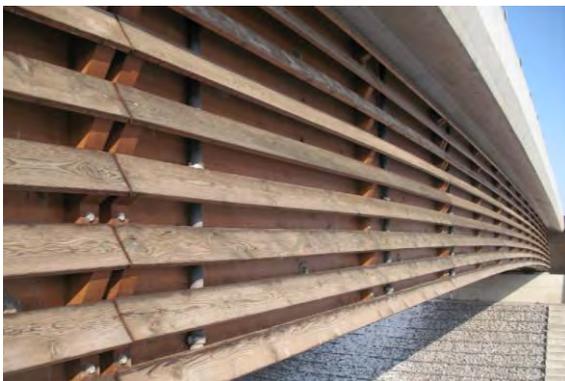
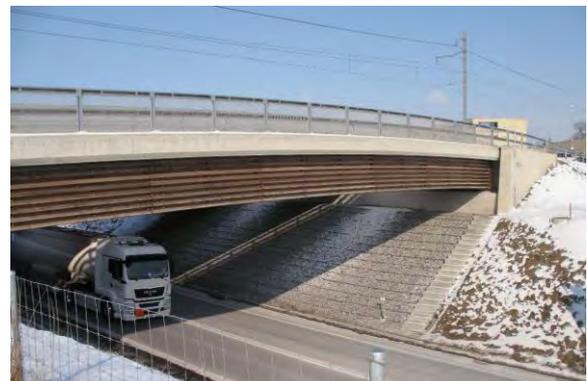
Figure 21: Planchy, Bulle, built 2005, Span 25,9 m, 40 tons, Vial SA, Le Mouret, Pictures: BFH

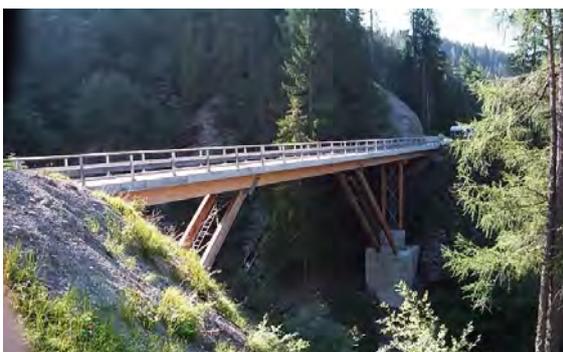
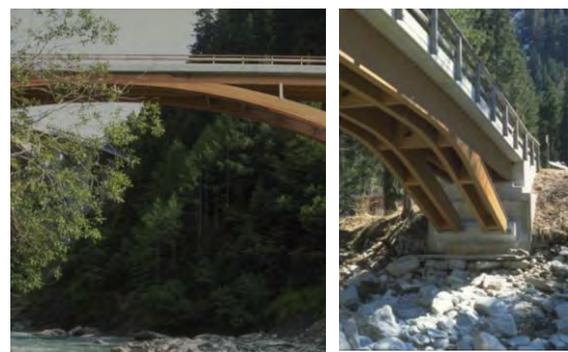
Figure 22: Ronatobelbrücke in Furna, Graubünden, Timber-Concrete-Composite, built 1991; Span 12-12-13,75-12,25 m; 28 tons, Engineers Buchli + Joh. Fromm, Picture: Andrea Bernasconi HES-SO Yverdon/LIGNUM

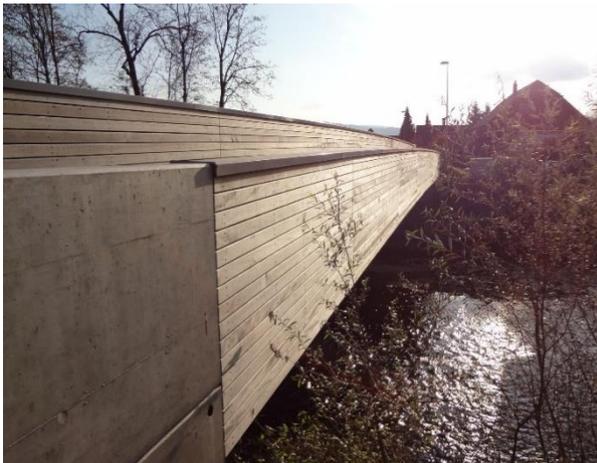
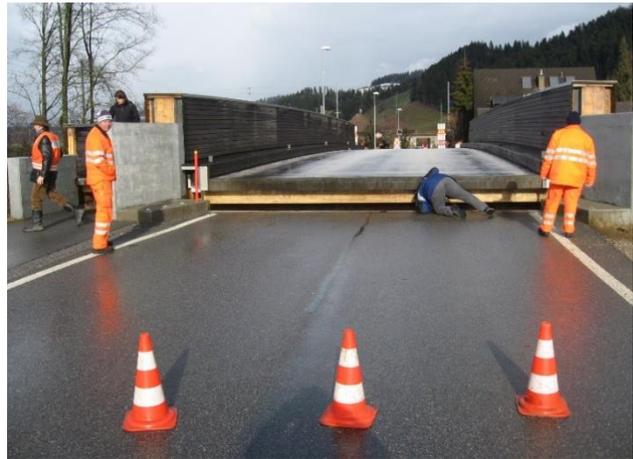
Figure 24: Obermattbrücke, Canton Bern, built 2007, Through Bridge, vertically adjustable (70 cm) bridge when high water, span: 32 m live load 40 tons, Design: Paul Grunder AG, Täufen, Pictures: BFH

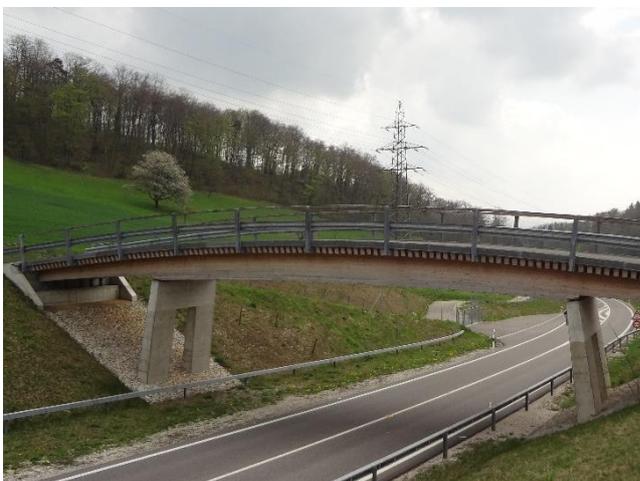
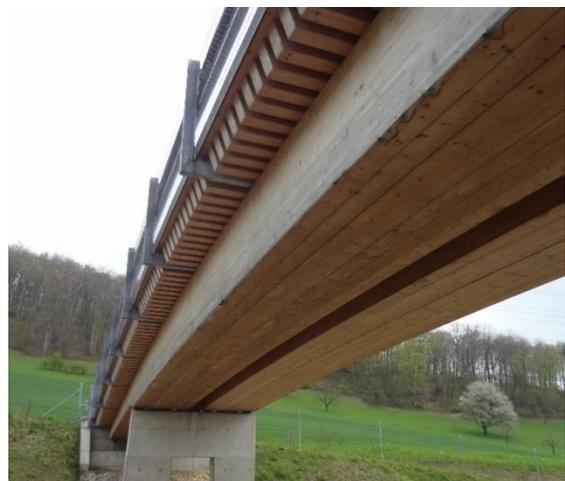
Figure 25: Horenbrücke, Canton Aargau, built 2008, length: 30.87 m, span: 6,25 – 17,32 – 7,30 m, 40 tons, block glued girder bridge, Design: Makiol + Wiederkehr, Beinwil, Wilhelm+Wahlen, Aarau, Zimmermann Architekten, Aarau, Pictures: A. Müller BFH

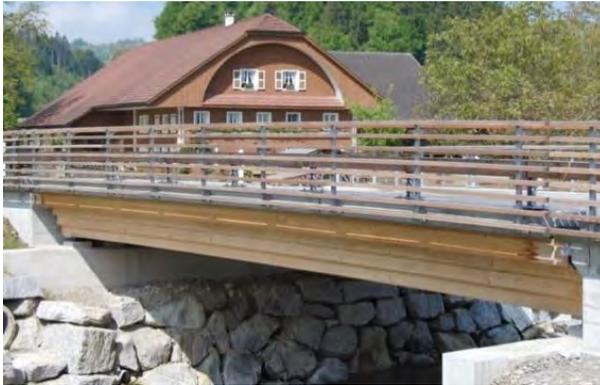
Figure 26: Luthernbrücke, Canton Luzern built 2010, Lenght: 13,55 Span: 13.05 m, 40 tons, block glued girder bridge, Design: E. Winkler & Partner, Luzern, Makiol + Wiederkehr, Beinwil, Picture: Makiol + Wiederkehr

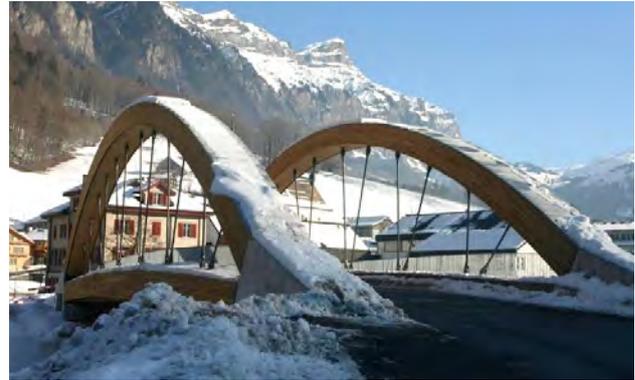
Figure 27: Kirchenbrücke Muotathal, Canton Schwyz built 2009, Lenght: 34,00 m Span: 33,40 m, 40 tons, arch bridge, Design: Pirmin Jung, Rain, BPP Ingenieure, Schwyz, E. Imhof, Luzern, Picture: BFH

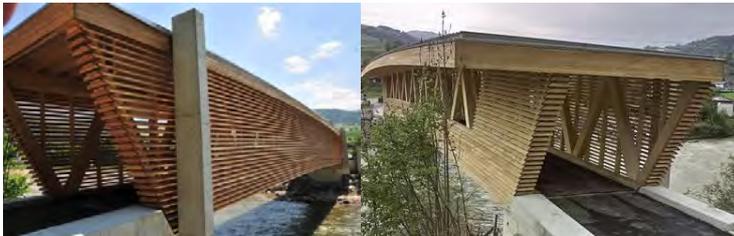
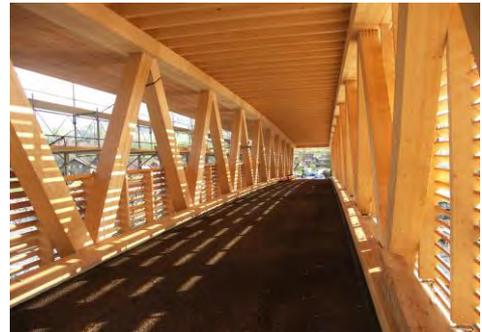
Figure 28: Enningerbrücke, Malters, Canton Luzern, built 2010, Lenght: 46,0 m Span: 42,0 m, 28 tons, truss bridge, Design: Pirmin Jung, Rain, Emch + Berger WSB AG, Luzern, Pictures: Kolb, Pirmin Jung Ingenieure

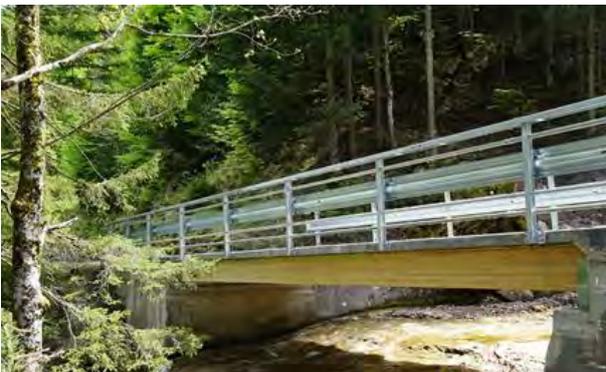
Figure 29: Fruttlibrücke in Arth, Canton Schwyz built 2020, Span: 10,45 m, 40 Tons, Timber-UHPC composite structure, Design: Edgar Kälin, Einsiedeln, Neue Holzbau AG, Lungern, Prof. E. Brühwiler EPFL Lausanne [15], Pictures: E. Kälin

In the meantime, ultra-high performance fibre composite (UHPC) has found its way into timber bridge construction. The combination of wood and UHPC is promising. The material combination of timber with decks made of UHPC has already been used several times, especially in shear composite (wood-UHPC composite construction) in the new construction of wooden bridges (2018 Gletschersand bridge in Grindelwald, 2020 Fruttli bridge near Rigi Fruttli) [13].

In contrast to the mastic asphalt structure, the UHPC layer serves to increase the load-bearing capacity of the roadway slab. With a roadway slab made of UHPC, 3 layers (waterproofing, protective layer, surface layer) can be replaced. According to [14] Brühwiler (2017), a UHPC layer thickness of 30 mm is "liquid-tight" up to an expansion of 1.2 ‰.

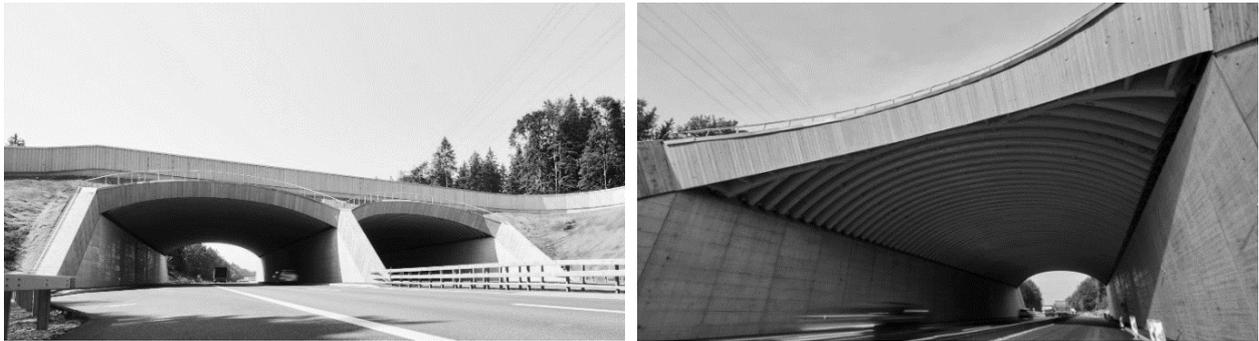
Figure 2 Photos of the completed bridge

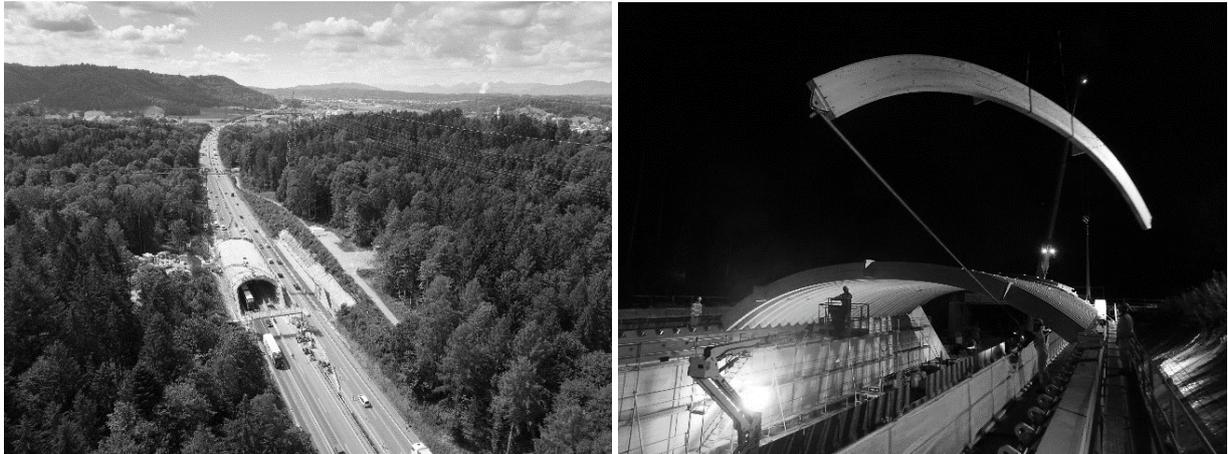
Figure 8 Assembly of the individual trusses between the portal modules.

Due to the complex work on the portals, they were pre-assembled as modules on a nearby company site and transported to the construction site and assembled by special transport. The intervening trusses were erected individually, the secondary supporting structure and the veneer plywood were then assembled. As the last night work process, the portal cladding and the portal railing were mounted so that the sealing work could be carried out during the day.

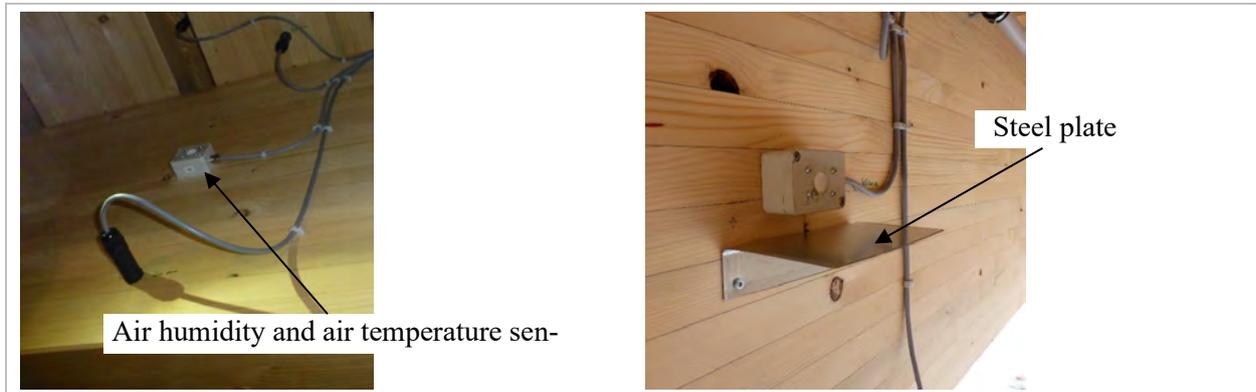
Figure 4 Air humidity and air temperature sensor (left) and steel plate as radiation protection (right).

The measurement of humidity and temperature is made with the same temperature and humidity sensor as the one with which the wood climate is determined. This is placed in a plastic box, which is connected to the outside air through a hole. The box is protected from radiation of heat/cold towards the underlying roadway by a steel plate.
