International Conference on Timber Bridges ICTB2021^{PLUS}

Conference Proceedings

International Conference on Timber Bridges ICTB 2021^{PLUS}
Conference Proceedings
9 - 12 May 2022

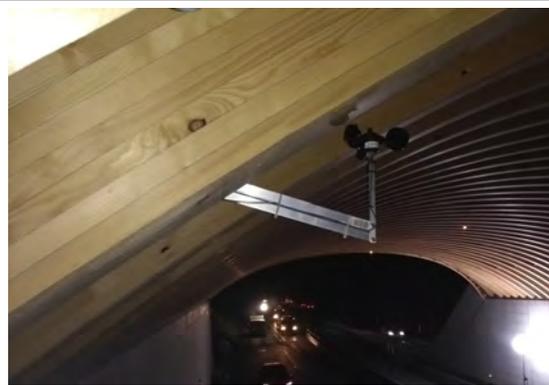
Figure 6 Cup anemometer to detect movement of the air due to the traffic

The measurement of spray cloud is carried out with rain sensors. If water lands on the surface of the beams, this is detected as spray cloud by the rain sensors. The air exchange due to the traffic in the structure is measured with a cup anemometer. Both systems were not calibrated and are used for qualitative comparisons of changes in the conditions within the wildlife bridge such as more or less air circulation.

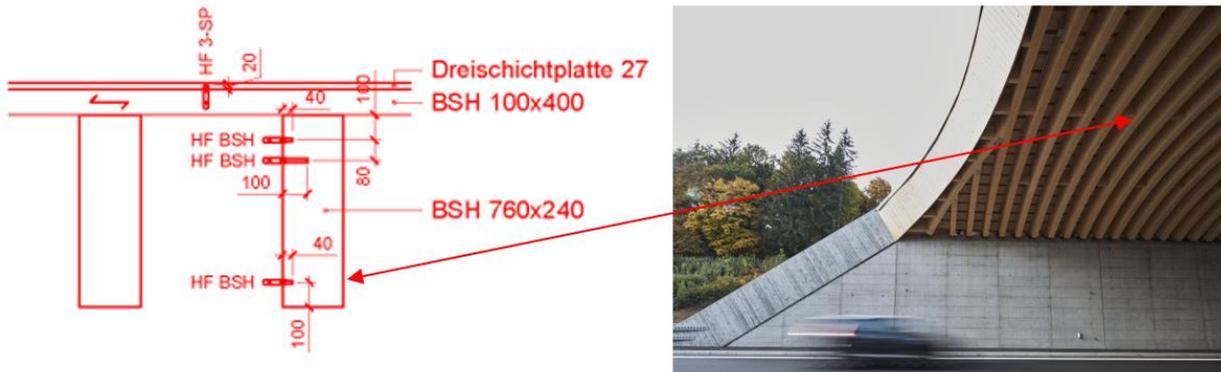
Figure 2. Detail showing the position of the moisture sensors in the wooden elements (glue laminated timber).

Figure 1 shows an overview of the locations where temperature and humidity sensors are located on the inside of the wildlife crossing. A detail of the sensor positioning is shown in Figure 2.

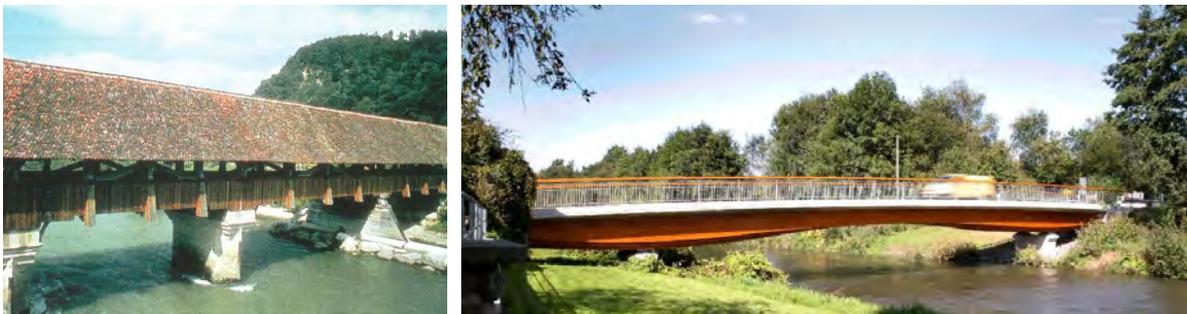
Figure 1: Timber bridge with roof near Gümmenen (CH), built in the 15th century [1] (left) and TCC bridge across the river Agger in Lohmar with 28 m midspan, built in 2014 [2] (right).

In the case of covered wooden bridges, which were built more and more often in Europe from the 13th century and onwards, a roof served as protection against the weather. Figure 1 (left) shows an example of a covered pedestrian bridge over the river Saane near Gümmenen (CH) [1]. Even today there are still many very well preserved covered wooden bridges. For innovative TCC bridges, the concrete deck, which extends sideways over the timber cross-section, acts as structural timber protection (see Figure 1 (right)). Kerbs, roadway expansion joints and railings can be designed by using common constructional details for concrete bridges. The use of timber as a regenerative building material significantly reduces the total weight of the bridge compared to conventional concrete constructions. A high degree of prefabrication of the timber elements also allows for a significant reduction in construction time.

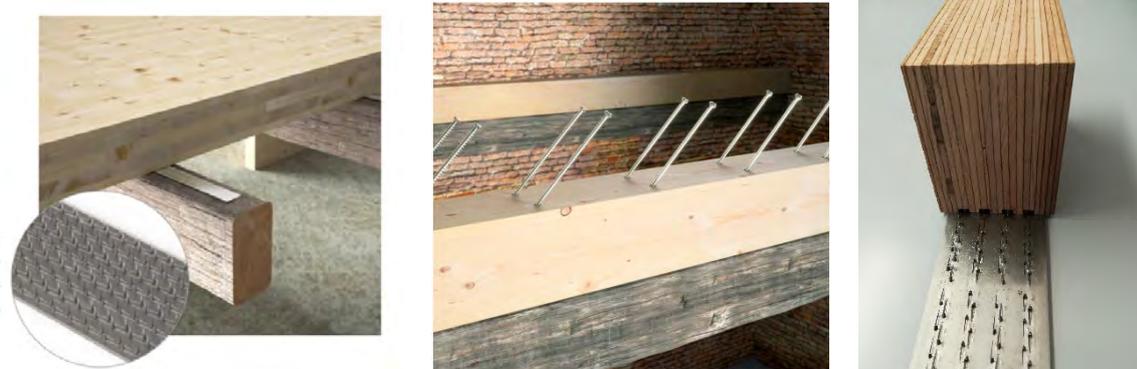
Figure 5: Use of sharp metal and alternative “traditional” methods using screws-tool to hammer the plates.

toothed parts that can be used to rest the protruding parts of the tool. According to this scheme, the tool can be made through a simple portion of hard wood with grooves corresponding to the teeth.

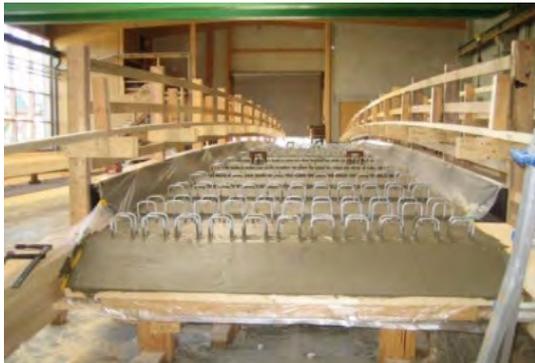
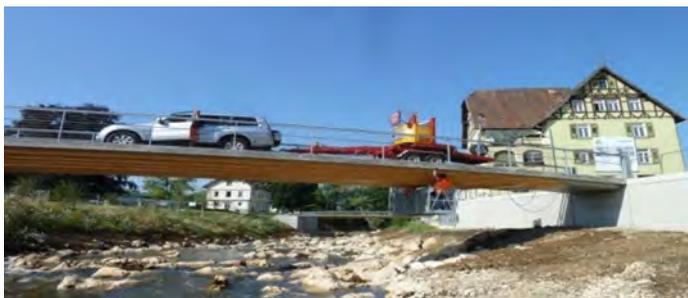
Fully integral – full height abutment
