Characterization and assessment of the mechanical properties of spruce foundation piles retrieved from bridges in Amsterdam

Abstract

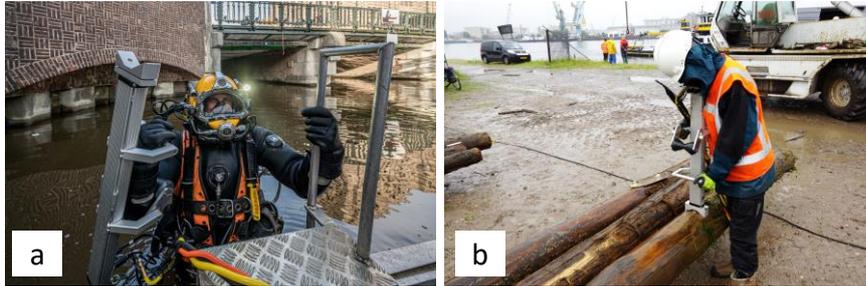
Figure 4: Micro-drilling measurements: a) underwater measurements on wooden piles; b) measurements after piles extraction.

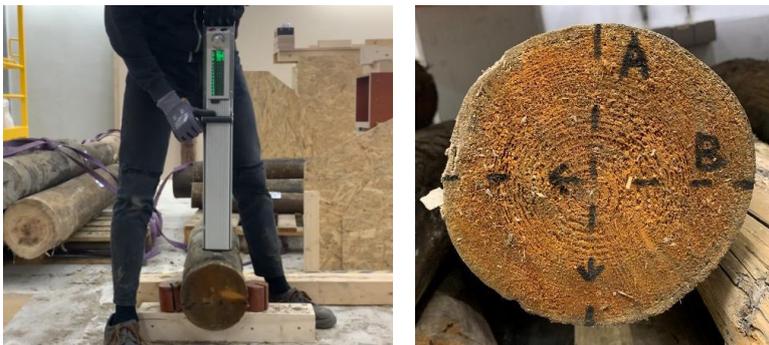
Figure 5: Micro-drilling measurements performed on a pile segment before the compression test.
