Effectiveness of structural protection measures for timber bridges – results of long-term moisture monitoring

Johannes Koch¹, Antje Simon, Markus G. Jahreis

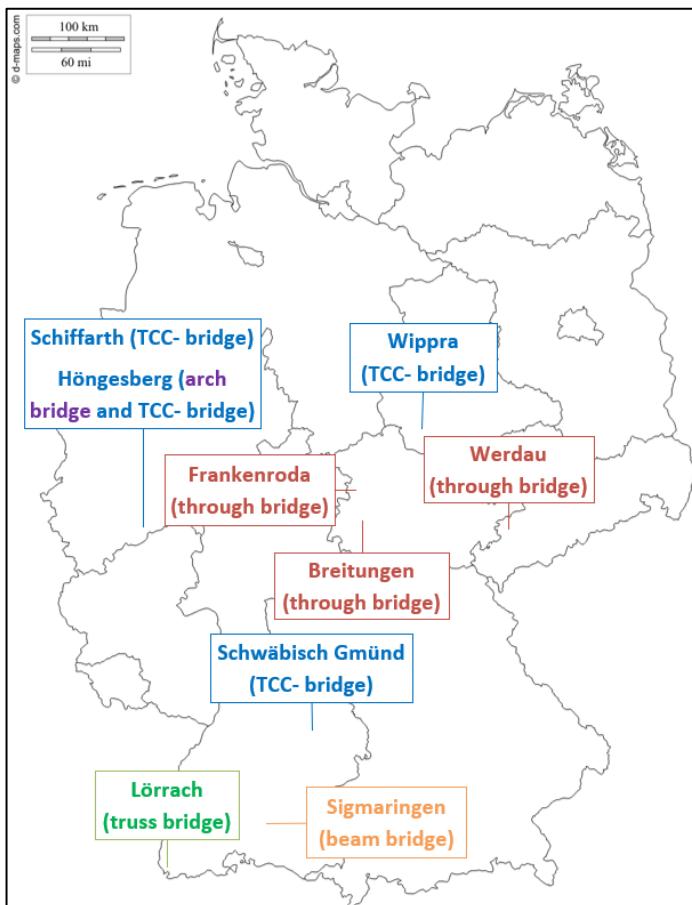
Figure 1: Location and construction type of the bridges within the “ProTimB” monitoring programme

The monitoring programme of structurally-protected timber bridges under “ProTimB” was unique with regard to both its systematic and scope in Germany. The timber moisture content and the ambient climate were recorded at nine protected timber bridges of different construction types throughout Germany, as shown in Figure 1 below. All bridges span a river and a part of the foreland, while one bridge in Lörrach additionally spans a highly-frequented, federal road. The first measurement system was implemented in August 2015 on a road bridge in Lohmar-Höngesberg. The other eight systems were implemented in the autumn of 2016. At the bridge in Lörrach, a second measuring system with additional measuring points was set up in 2018. The monitoring systems on five of the nine bridges were removed in summer 2019, at the end of “ProTimB”. Yet, the monitoring on the other four bridges that are located in Lohmar-Höngesberg, Lörrach, Wippra and Breitungen continues to the present time.

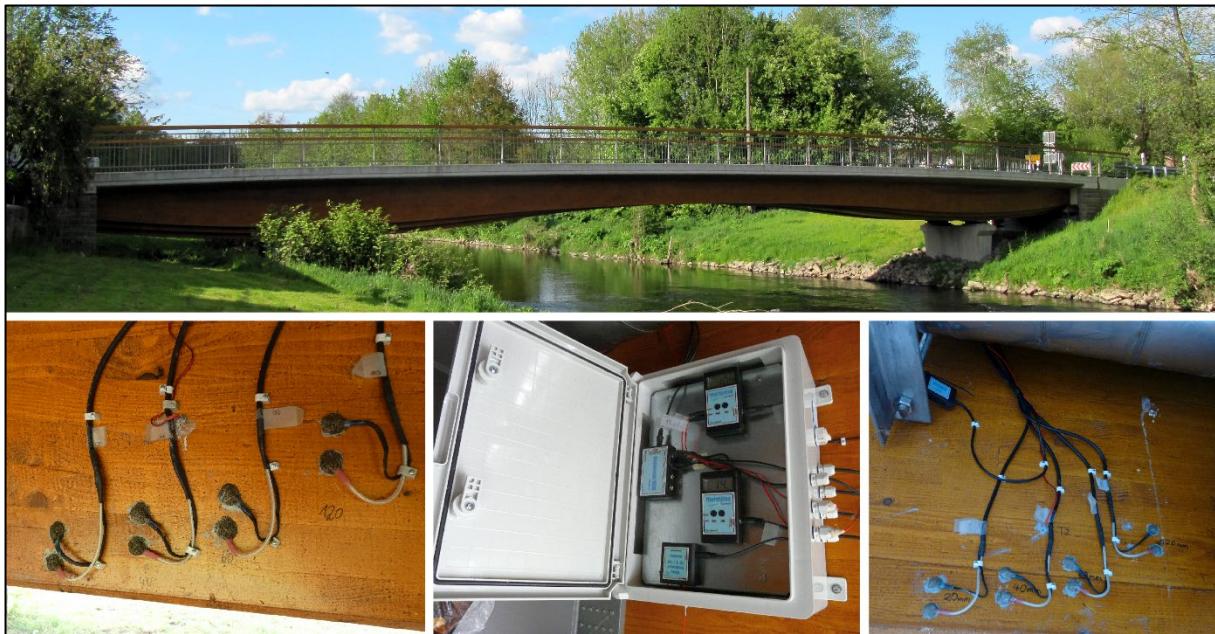
Figure 2: View of the TCC road bridge in Lohmar-Schiffarth (top of the image); measuring area over the foreland (bottom left); measuring equipment in an installation box (bottom centre); measuring area over the River Agger (bottom right of the image)

A system with eight pairs of electrodes was implemented at each structure to measure the electrical resistance of the wood, distributed over two or three measuring areas. In each case, there were measuring points with several measuring depths above the waters and in the foreland. Furthermore, the timber temperature, air temperature and relative humidity were also logged at each of the measuring areas. Figure 2 below shows the road bridge in Lohmar-Schiffarth with the implemented equipment and four pairs of electrodes at the two measuring areas.

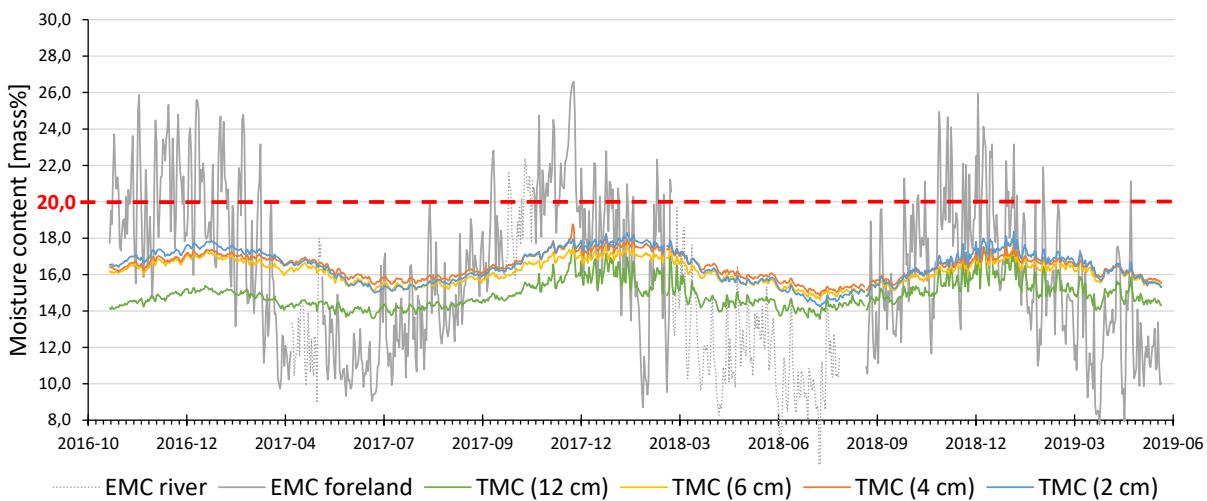
Figure 3: Daily mean values of equilibrium moisture content (EMC) and timber moisture content (TMC) at different measuring depths at the bridge in Lohmar-Schiffarth (measuring area: foreland)

Figure 3 shows the development of moisture content at the bridge in Lohmar-Schiffarth near Cologne at the measuring area above the foreland. The timber moisture content follows the equilibrium moisture content that represents the climate conditions with a time delay. The seasonal climate changes are clearly visible. It can also be seen that the timber moisture content does not exceed the limit of 20 mass% during the whole evaluation period from October 2016 to Jun 2019. Figure 3 is representative of the measuring results of the bridges in Schwäbisch Gmünd, Breitungen, Werdau and Frankenroda. At all of these, the timber moisture content remains below 20 mass%. Therefore, decay is not expected in the measuring areas. It should be taken into consideration that the measurements are only punctual and not distributed over the whole superstructures. However, the results show that the structural wood protection measures are effective.

However, it is also important to take the development of moisture content into account in shorter periods. As described above, 20 mass% should not be exceeded for longer than four months. Examples of the development of the timber moisture content and equilibrium moisture content on two bridges are given in Figures 3 and 4.

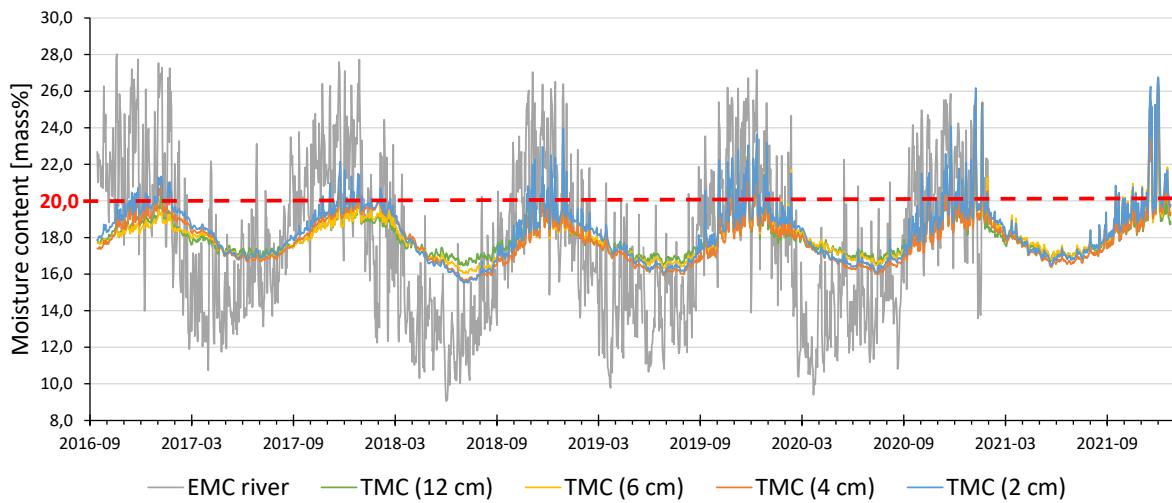
Figure 4: Daily mean values of equilibrium moisture content (EMC) and timber moisture content (TMC) at different measuring depths at the Birkberg bridge in Wippra (measuring area: foreland)

On the other hand, there are areas with exceeded moisture content in the winter periods, which is shown in Figure 4. This occurs at the bridges in Wippra, Lohmar-Höngesberg and Lörrach, as well as Sigmaringen in certain periods. In the graph it can be seen that the period of higher moisture level over 20 mass% is limited to three or four months per year. The wood usually dries back to an acceptable level after February. These short periods of higher moisture level are also acceptable in preventing the risk of decay.

Figure 4 shows that the moisture content is directly related to the climate conditions represented by the equilibrium moisture content. There are no unusual offsets on the graph. Thus, the continuously 2 mass% higher moisture level at the Birkberg bridge in a valley near to Wippra appears to be a consequence of the more humid and colder climate in the Harz mountains. The higher equilibrium moisture content for this location confirms this.

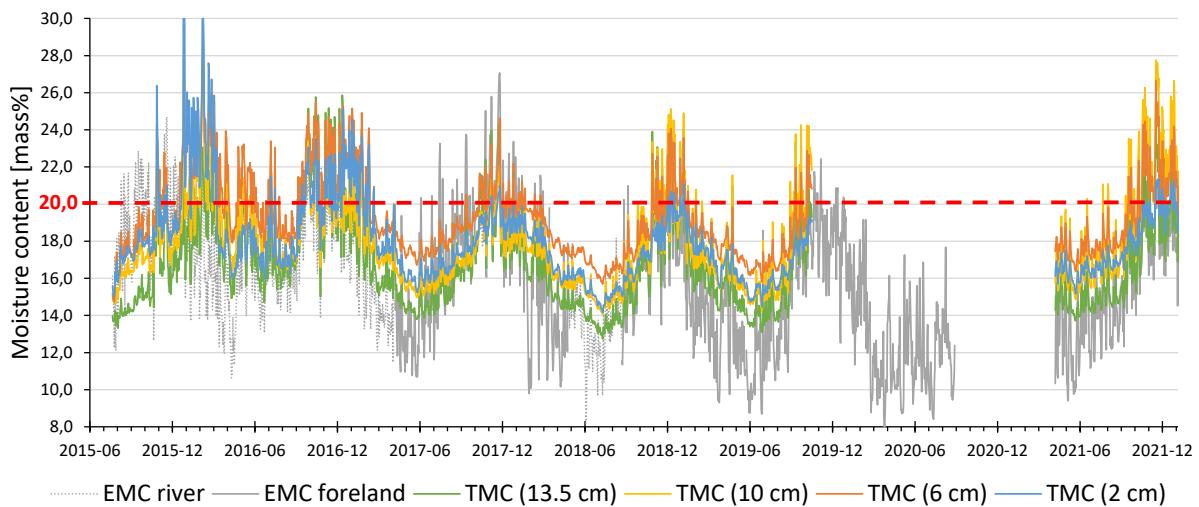
Figure 5: Daily mean values of equilibrium moisture content (EMC) and timber moisture content (TMC) at different measuring depths at the bridge in Lohmar-Höngesberg (measuring area: foreland)

The situation is different at the bridges in Lohmar-Höngesberg and Lörrach. In the first case, a high timber moisture level was already noticed in the first winter of the monitoring in 2015/2016. Specifically, it was then noted that an expansion joint situated above the measuring area had failed. This resulted in rainwater

running over the measuring points, meaning that, in certain cases, the measured timber moisture content reached a high value (Figure 5). As a first act to remedy this, cladding was installed to protect the wood from the rainwater. It is also evident that the moisture content is higher than 20 mass% during some winter months. This contrasts with the results of the measurements at the other two measuring areas above the river. In Figure 6 below, the graph shows shorter periods of moisture contents higher than 20 mass%. It is assumed that the rainwater creates a more humid climate in the measuring area above the foreland. Therefore, it is necessary for the failed expansion joint to be replaced as soon as possible.

In summary, the structural wood protection measures show positive effects at the observed bridges. Problems only occurred at two of the nine bridges. The failure of the expansion joint at the bridge in Lohmar-Höngesberg should be replaced as soon as possible in order to ensure the full functionality of the structural wood protection concept of this bridge. Only in the case of the bridge in Lörrach was the wood protection insufficient in its original design for the extraordinary exposure. This problem was identified by the monitoring and an innovative solution was developed.

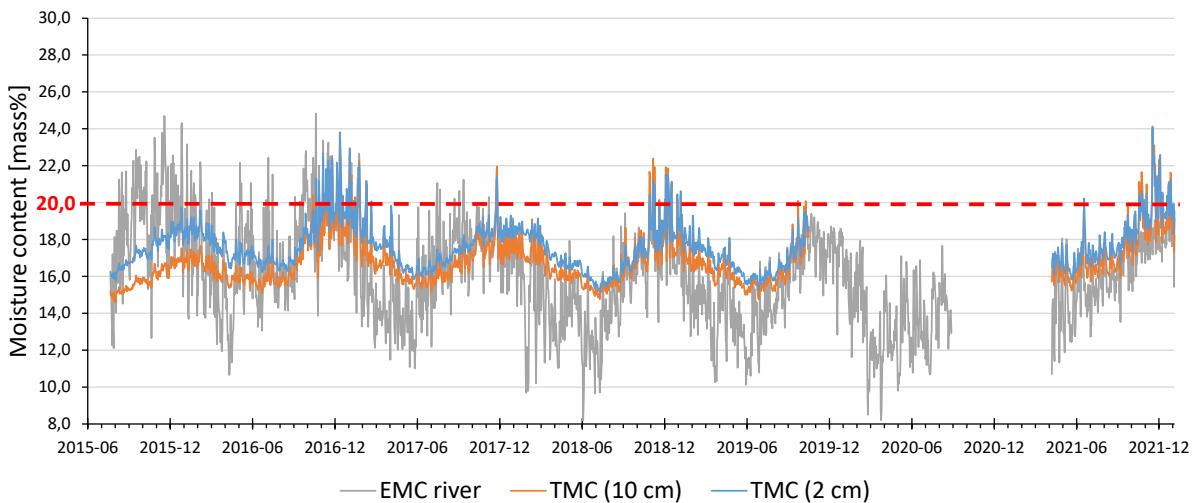
Figure 6: Daily mean values of equilibrium moisture content (EMC) and timber moisture content (TMC) at different measuring depths at the bridge in Lohmar Höngesberg (measuring area: river - arch bridge tension member)

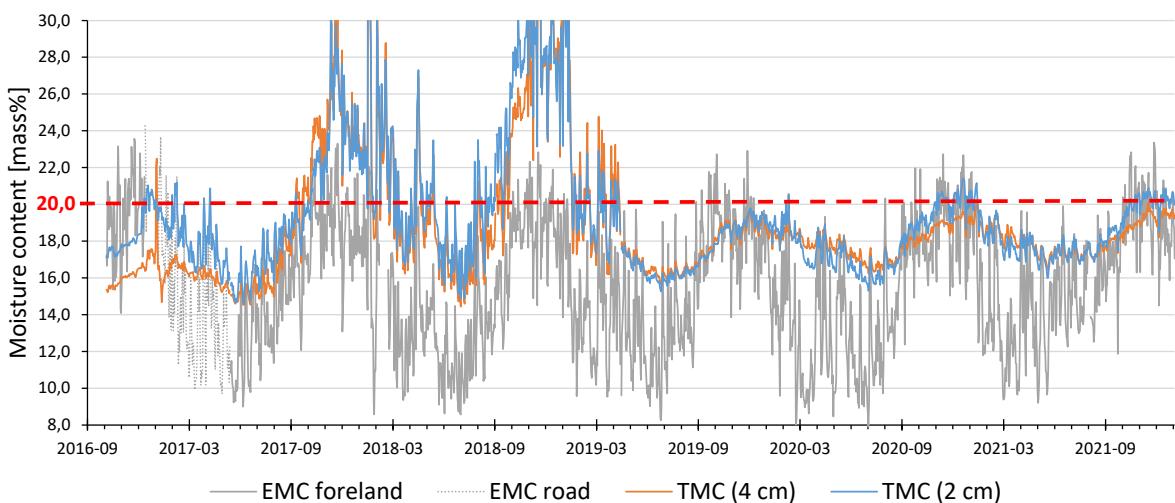
Figure 7: Daily mean values of equilibrium moisture content (EMC) and timber moisture content (TMC) at different measuring depths at the bridge in Lörrach (measuring area: foreland)

It can be noted that moisture monitoring at bridges or other structures can help to explore or monitor neuralgic points in the wood protection or waterproofing concept of a structure. Monitoring also proved to be a benefit for the future of the bridge in Lörrach. As the graph in Figure 7 shows, during the period between October 2017 and April 2019, moisture content reached a high level for a long time, sometimes beyond the fibre saturation point. It was found that the angle of precipitation is sometimes almost horizontal due to an unusual air flow in the valley where the bridge is situated. Despite the carefully-planned wood protection concept in accordance with the current standard specifications (see [8] [16]), the lower load bearing components of the bridge were regularly exposed to weather. Rain and snow penetrated the structure between the roof and the cladding (see Figure 8). This resulted in the lower chord of the truss being wetted. To solve the problem, a number of variants for improving the structural wood protection concept were investigated.

The preferred option was a sensor-controlled curtain that closes the gap between roof and cladding in times of precipitation [17].

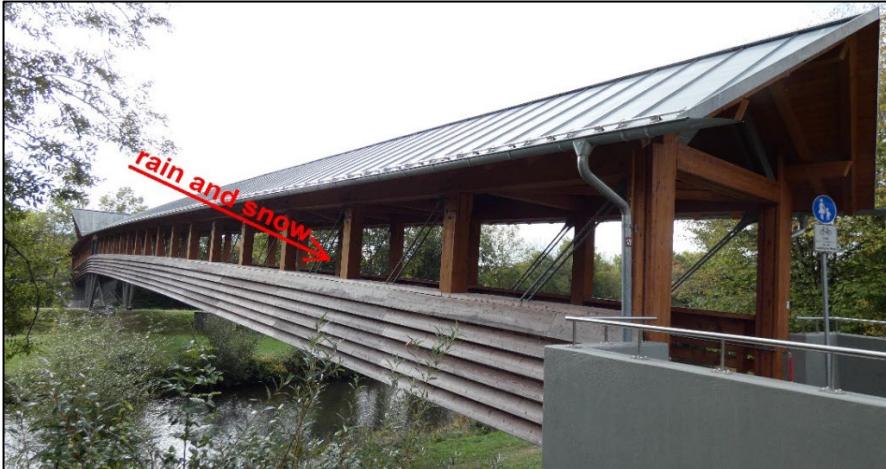
Figure 8: View of the bridge in Lörrach

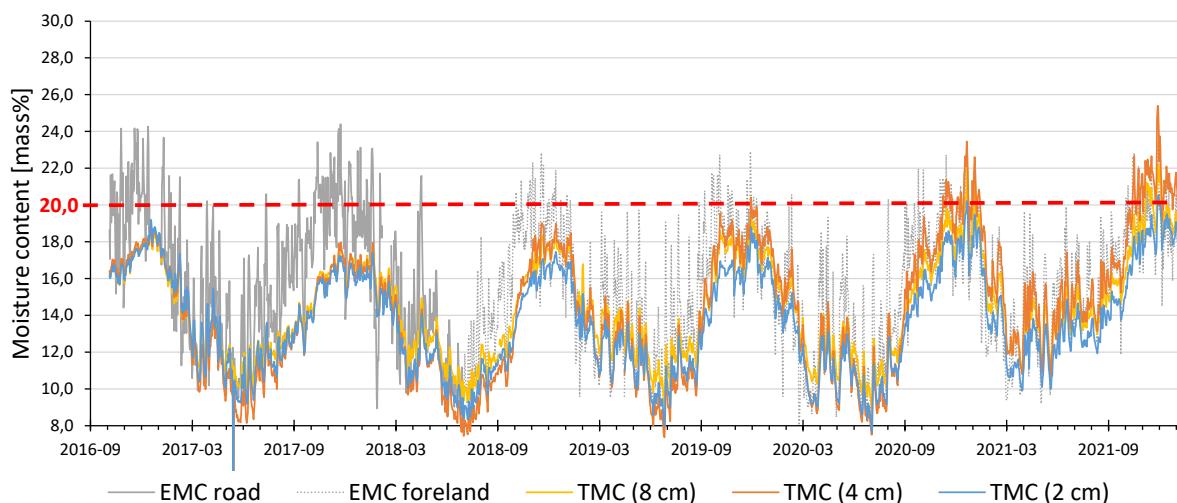
Figure 9: Daily mean values of equilibrium moisture content (EMC) and timber moisture content (TMC) at different measuring depths at the bridge in Lörrach (measuring area: road)

In addition to the fact that the bridge in Lörrach spans the river Wiese, it also spans a highly-frequented federal road. In order to investigate spray exposure from road traffic, an additional measuring area was set up above the road. The results can be seen in Figure 9 above. The mean value of the timber moisture content is 14.2 mass% for the whole evaluation period from November 2016 to January 2022.

Contrary to expectations, the wood moisture content is relatively low and even lower than at the other measuring areas, despite the spray exposure. Therefore, it seems that the spray is not a relevant factor for the moisture load of this structure. This assumption is supported by the results of a Swiss study, which found that the spray is almost irrelevant for the moisture content of timber components located at a distance of about five metres above a road [18]. Nevertheless, it is important to mention that only one bridge spanning a road was investigated in the “ProTimB” monitoring programme. Hence, further investigations should be conducted.
