Quality assurance of timber structures

Research report

Report Nr.	77FE-008098-V01
Contract Nr.	2016.17
Classification	Public
Date	24.01.2019
Client	Bundesamt für Umwelt BAFU Abteilung Wald, WHFF CH-3003 Bern
Address of the research unit	Bern University of Applied Sciences Institute for Timber Constructions, Structures and Architecture Solithurnstrasse 102, CH-2504 Biel 6 Tel / Fax +41 (0)32 344 03 41/91 www.ahb.bfh.ch
Authors	Bettina Franke, Steffen Franke, Marcus Schiere, Andreas Müller
Project Leader	Prof. Dr. Steffen Franke
Head of the Institute	Prof. Andreas Müller

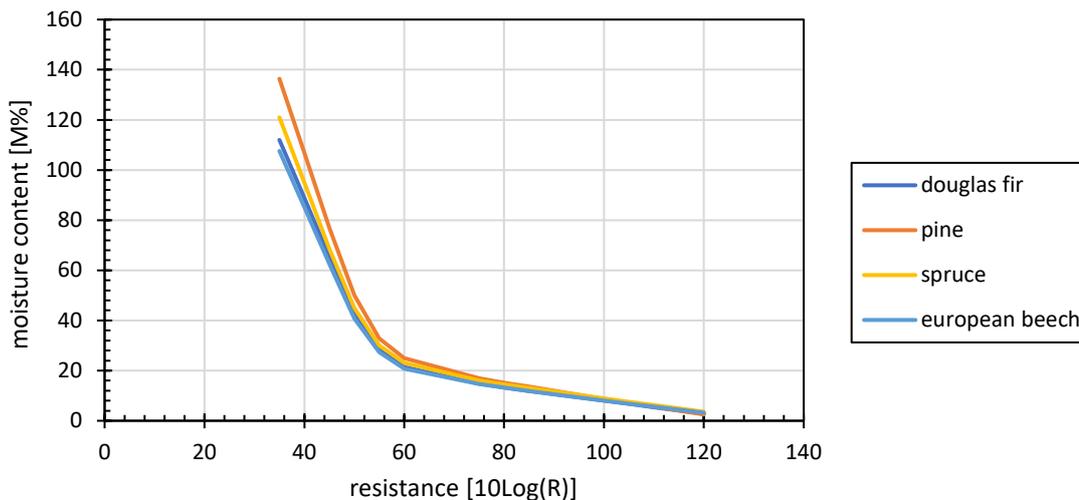
Figure 2: Illustration of resistance curves from electrical resistance to wood moisture content.

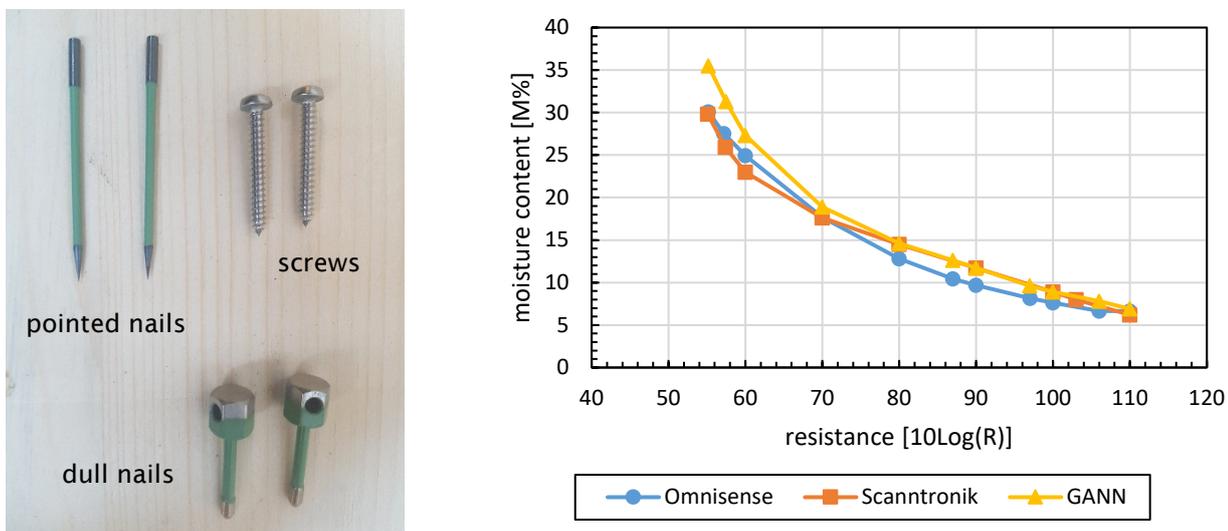
Figure 3: Electrodes used in the different equipment (right) and the conversion curves from electrical resistance to moisture content (left)

Whereas the moisture contents were generally measured using the equipment supplied by Scanntronik Mugrauer GmbH, moisture contents in the training facility of the ice hockey club of Davos (CH) were measured with the wireless sensors supplied by Omnisense®. Eight loggers powered by batteries were connected wireless with one gateway and could log and transmit both electrical resistance from about 6 M% upwards and two inputs for climate. Measured values are viewed online (paid service) and downloaded from a website to allow post processing afterwards. Moisture content is calculated directly and is valid for Douglas fir. Conversion for Norway spruce needs to be done afterwards. The electrodes suggested by Omnisense were screws. The electrodes and conversion parameters are shown in Figure 3.

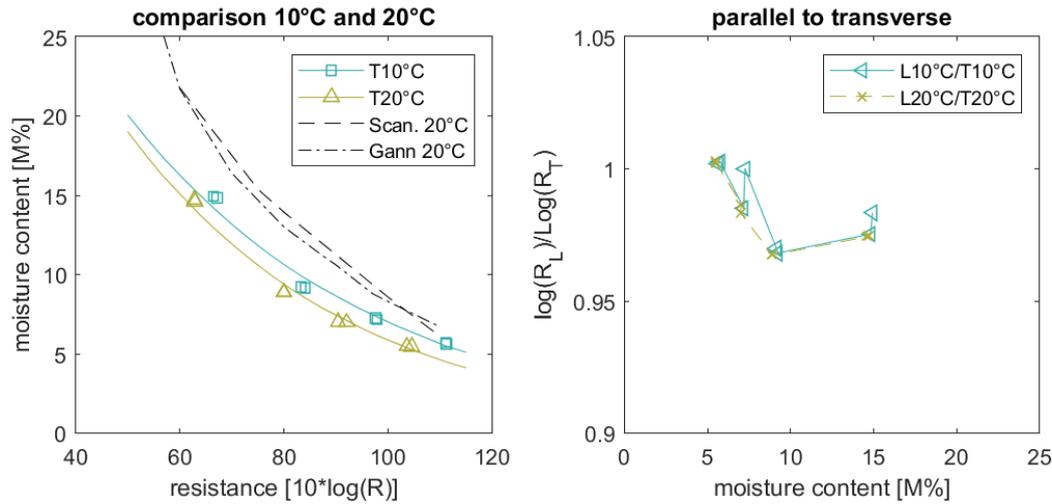
Figure 5: Measured resistance against moisture content transverse to the grain at 10 °C and 20 °C and the resistance curves for beech as programmed in the soft and hardware of Scantronik and Gann Hydromette M 4050 (left); relation between resistance measured along the grain and transverse to the grain (right).

Figure 5 shows that use of beech veneer can lead to significant over estimation of moisture content in the higher moisture content ranges, up to 5 M% in relative humidities of 83 %RH. The error is in the order of 2 M% in the low moisture content ranges. Determining the relation between resistance and moisture content on beech veneer proved to be necessary to allow a better determination of moisture content in the future.

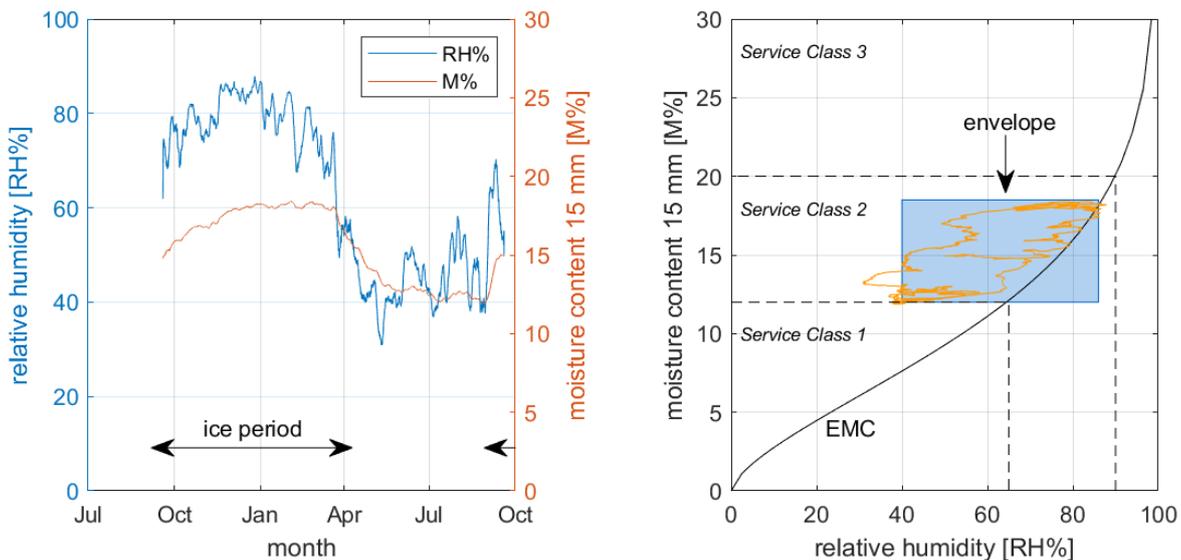
Figure 10: Example of data extraction of the data from ice rink B2 at measurement location M2 with the time series (left) and the comparison of relative humidity and moisture content at 15 mm depth (right); measuring data used from Gamper et al. (2014)

All the gathered time traces of moisture content and climate are shown in Appendix A. The measured data is analysed using the minima and maxima value over one year. This is done both for the wood moisture content and climate and presented as an envelope of the measure data. The developed envelopes can be used by practicing engineers and planners a support tool towards the design of a building. They also quickly allow to assess whether measured moisture contents are in ranges where the relative humidity is measured. Figure 10 shows the annual developments of relative humidity and moisture content over a year (left) and a comparison between the two (right). The moisture content was measured at 15 mm depth. The period where the ice rink is in operation is easily distinguished, i.e. from 1st September to 15th of April. The plotted data was filtered with a moving average filter.

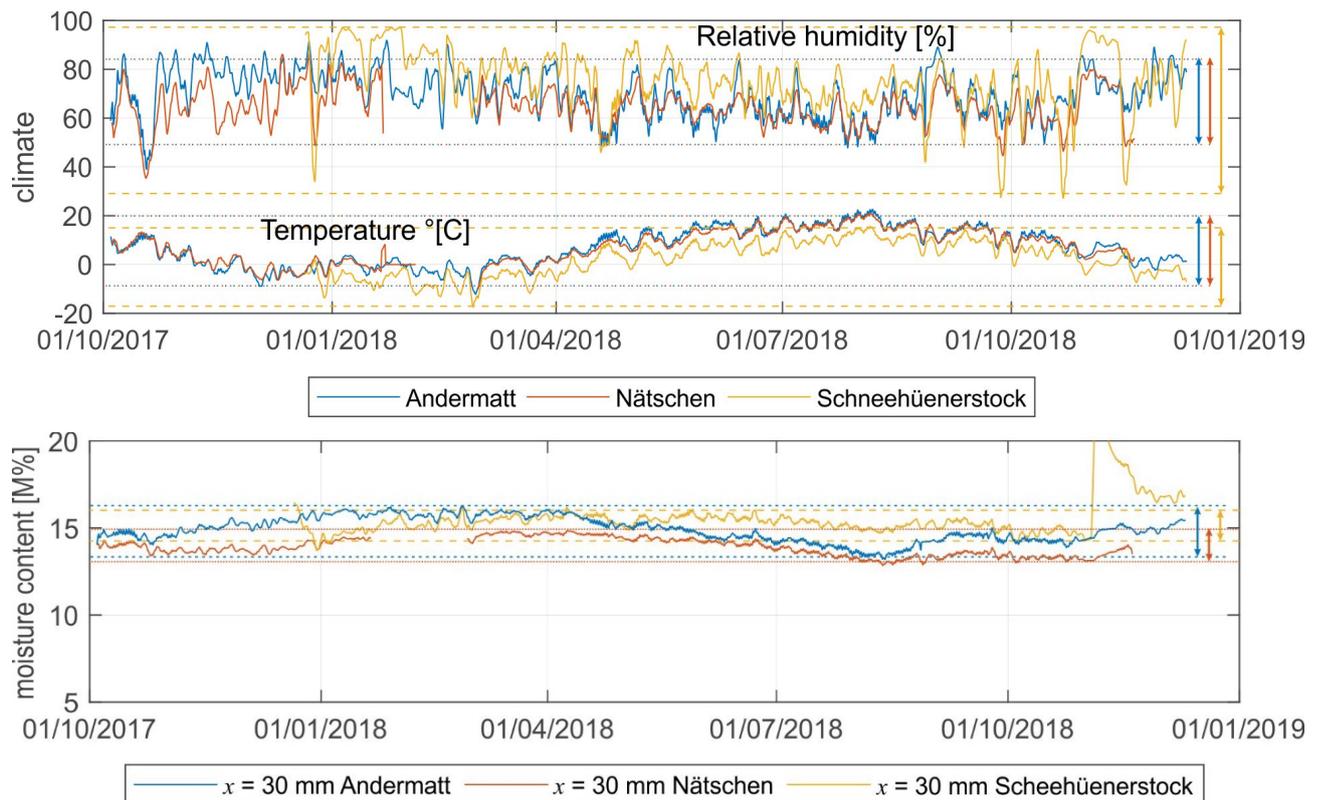
Figure 13: Climate and moisture content monitoring in the alpine region of Andermatt-Sedrun

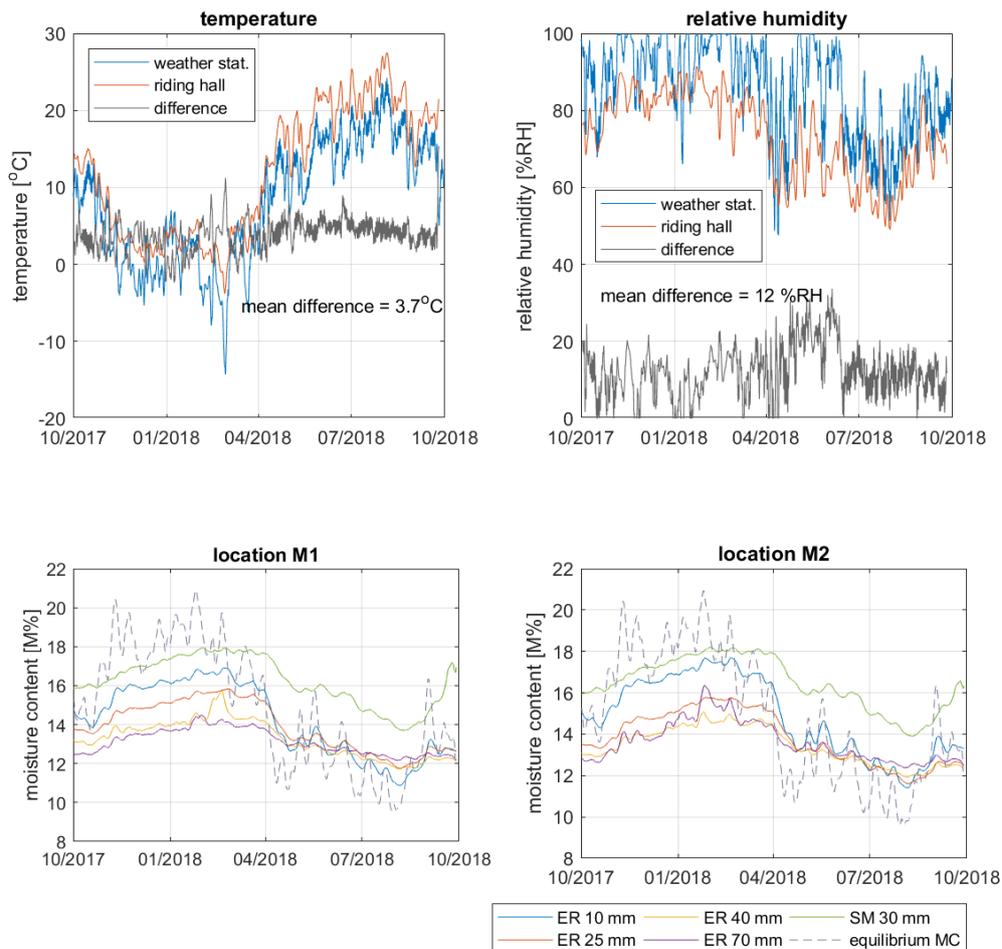
Figure 17: Moisture content monitoring in the riding hall in Einsiedeln close to the glass façade and more towards midspan in the riding hall of Einsiedeln using the electrical resistance (ER) at different depths and the sorption method (SM)

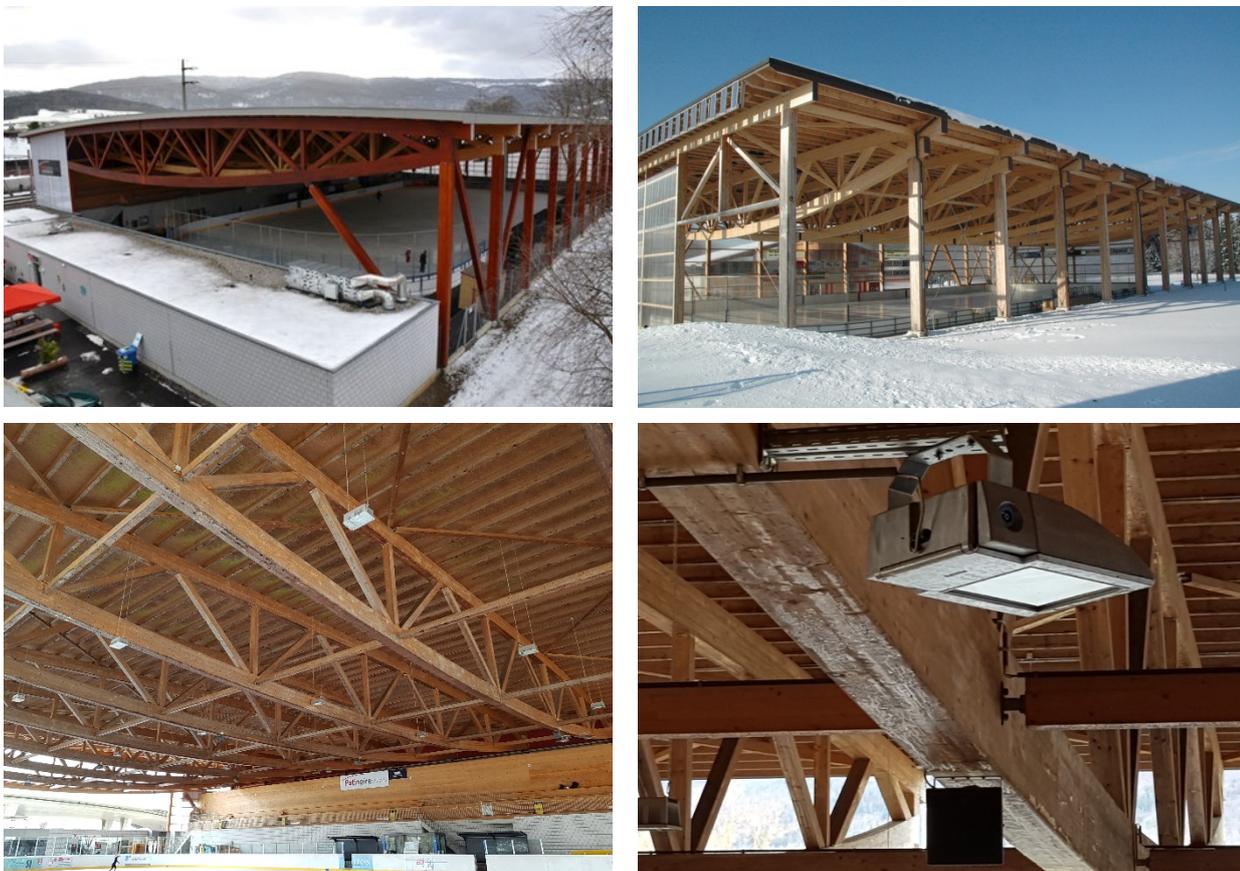
Figure 19: Pictures of the outside and inside of the ice rinks of Delémont (upper left) and Le Locle (upper right) (sources unknown) and pictures of the interiors of the Delémont ice rink with the ice formation on the downward facing surfaces of the load bearing members (bottom right)

Two partially open ice rinks of Delémont and Le Locle were instrumented in the Jura mountains of Switzerland, shown in Figure 19. The years of construction are 2011 and 2004, respectively. The objective is to investigate the impact of the surrounding meteorological climate, user profile, and environmental on the moisture content of the timber structure. The frame structure with truss member is nearly identical of both open ice rinks. The ice rink of Delémont is located on a lower altitude of 440 m a.s.l. than the one of Le Locle, at an altitude of 1000 m a.s.l.

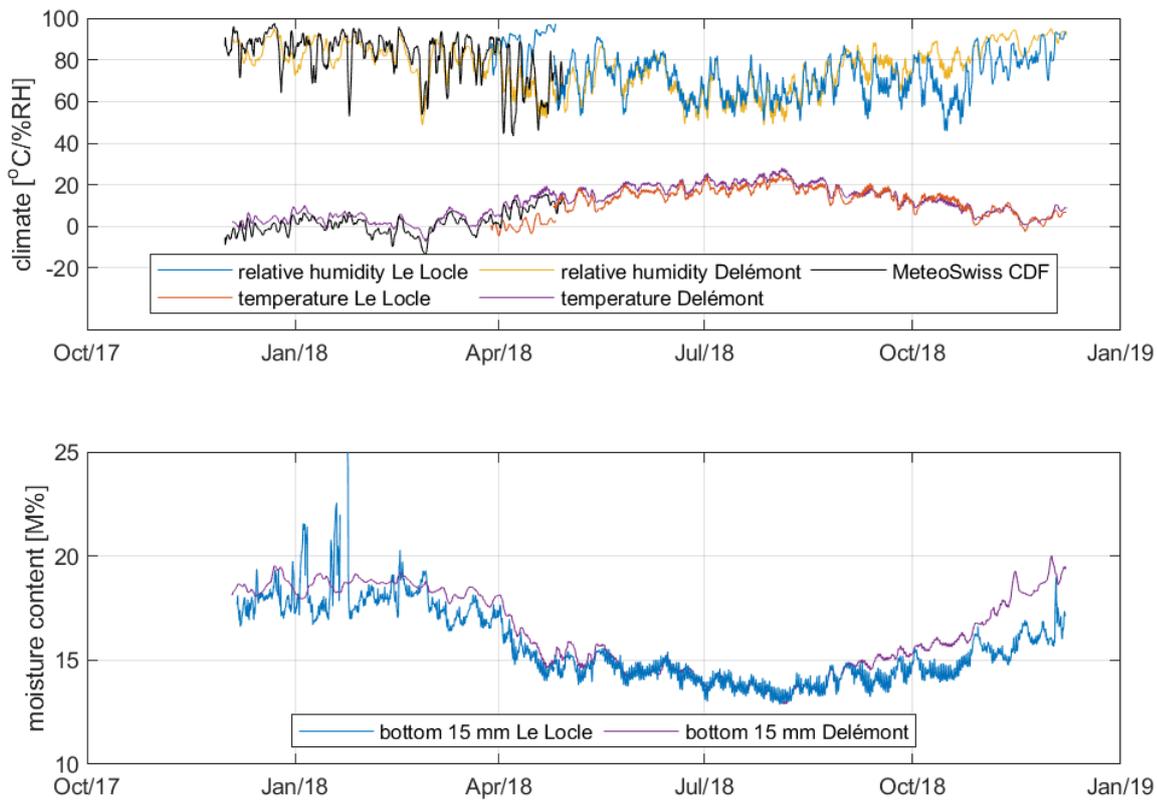
Figure 21: Measured climates and moisture contents on the bottom faces of the load bearing beams in the ice rinks of Le Locle and Delémont

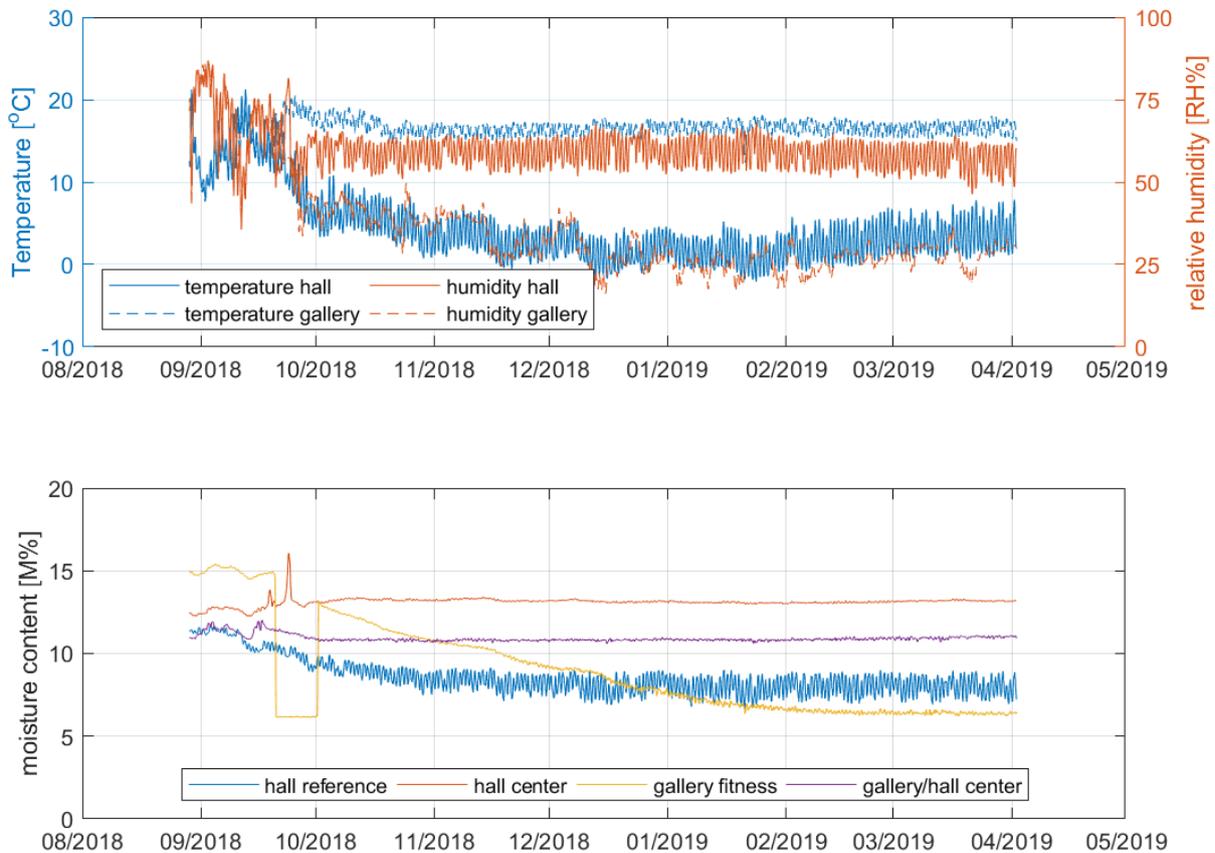
Figure 23: Summary of the measured climate and moisture content (depth of 15 mm) in the training facility of the Davos ice hockey club

A summary of the measured climate and moisture contents are observed in Figure 23. The figure shows the differences between the temperatures and relative humidities of the ice rink and fitness facility on the gallery. The moisture contents of the structure located above the ice is around 12 M% to 13 M%, except for the gage located above the tribune. The moisture content measured in the heated fitness facility reduces significantly. The development of moisture content in the load bearing member supporting the gallery seems to be little reason for concern (bottom plot) as moisture contents are between 9 M% and 12 M%. Two sensors temporarily malfunctioning due to a disconnected cable.

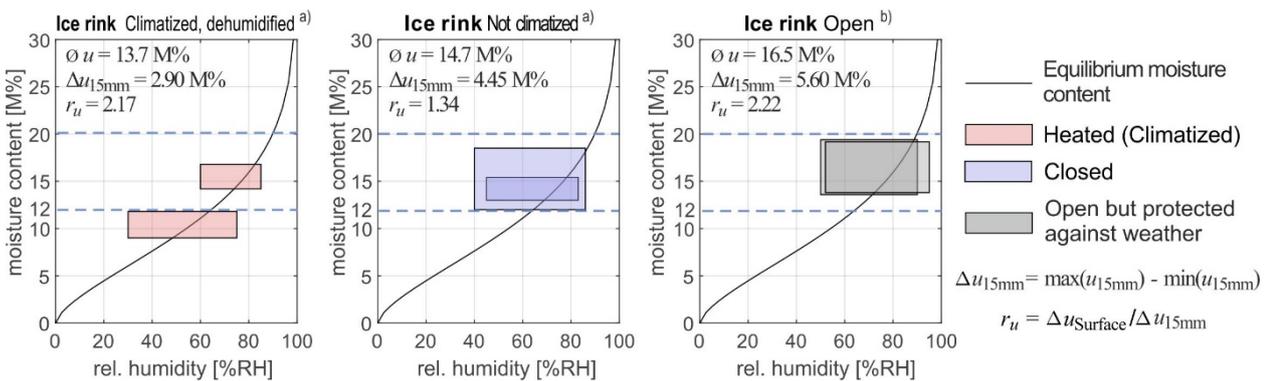
Figure 24: Envelopes of the moisture content for ice rinks, distinguished after operating service and construction type

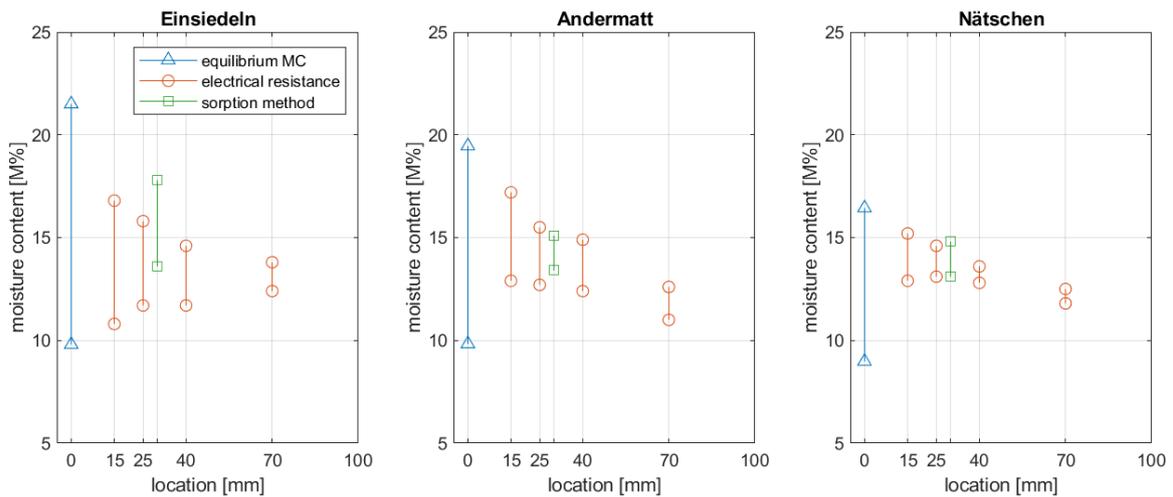
Figure 25: Moisture content measurements at different depths from the surface and different methods

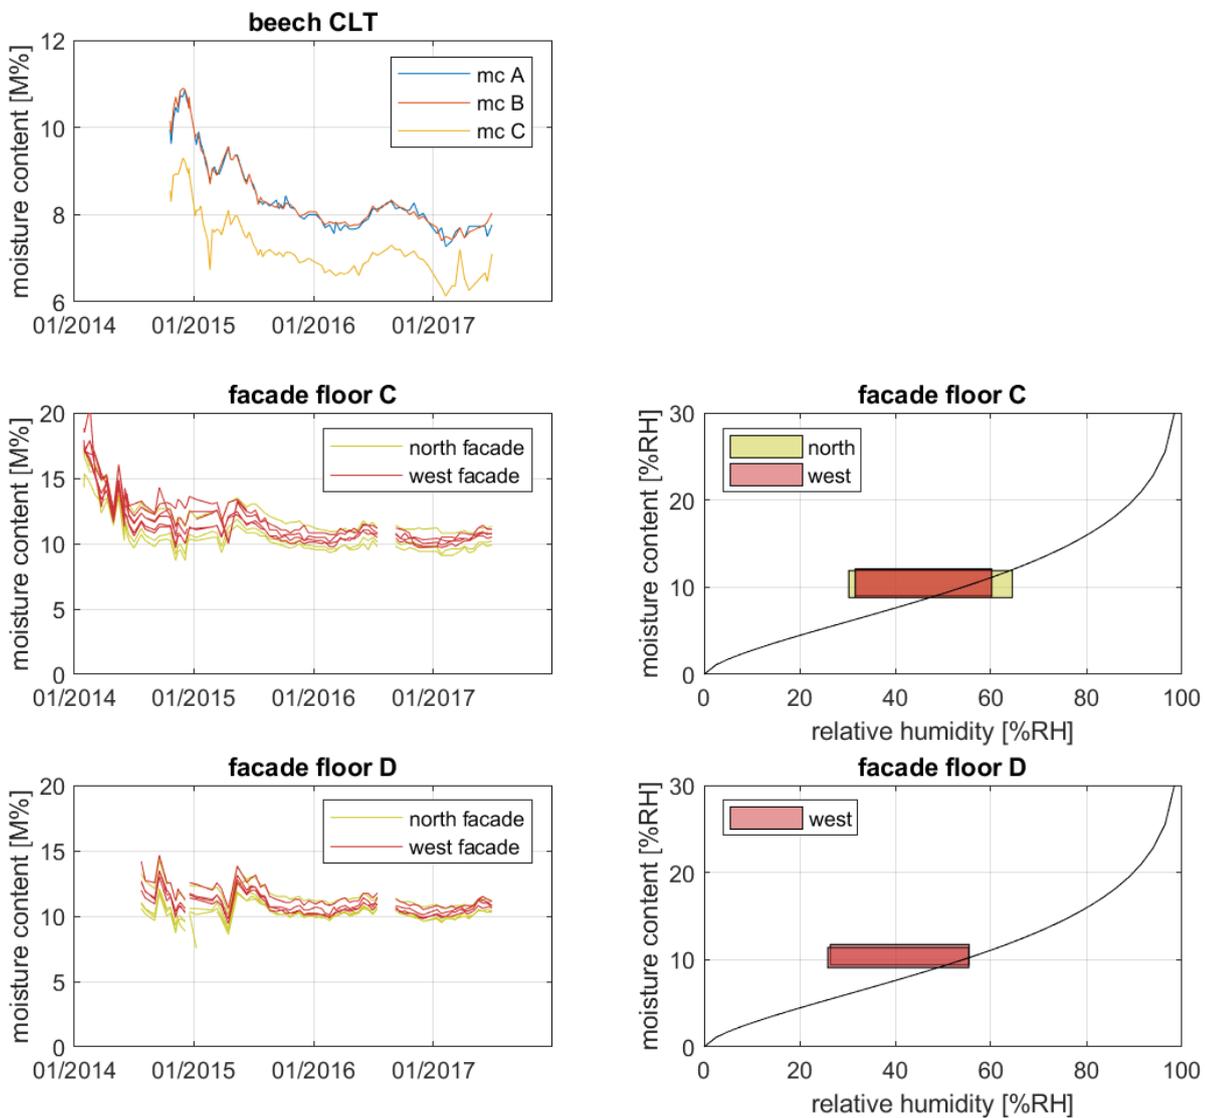
Figure 28: Monitoring results of the moisture content at House of Natural Resources, moisture content (left) and envelope curves for two sensors for west side and one sensor for north side (right)

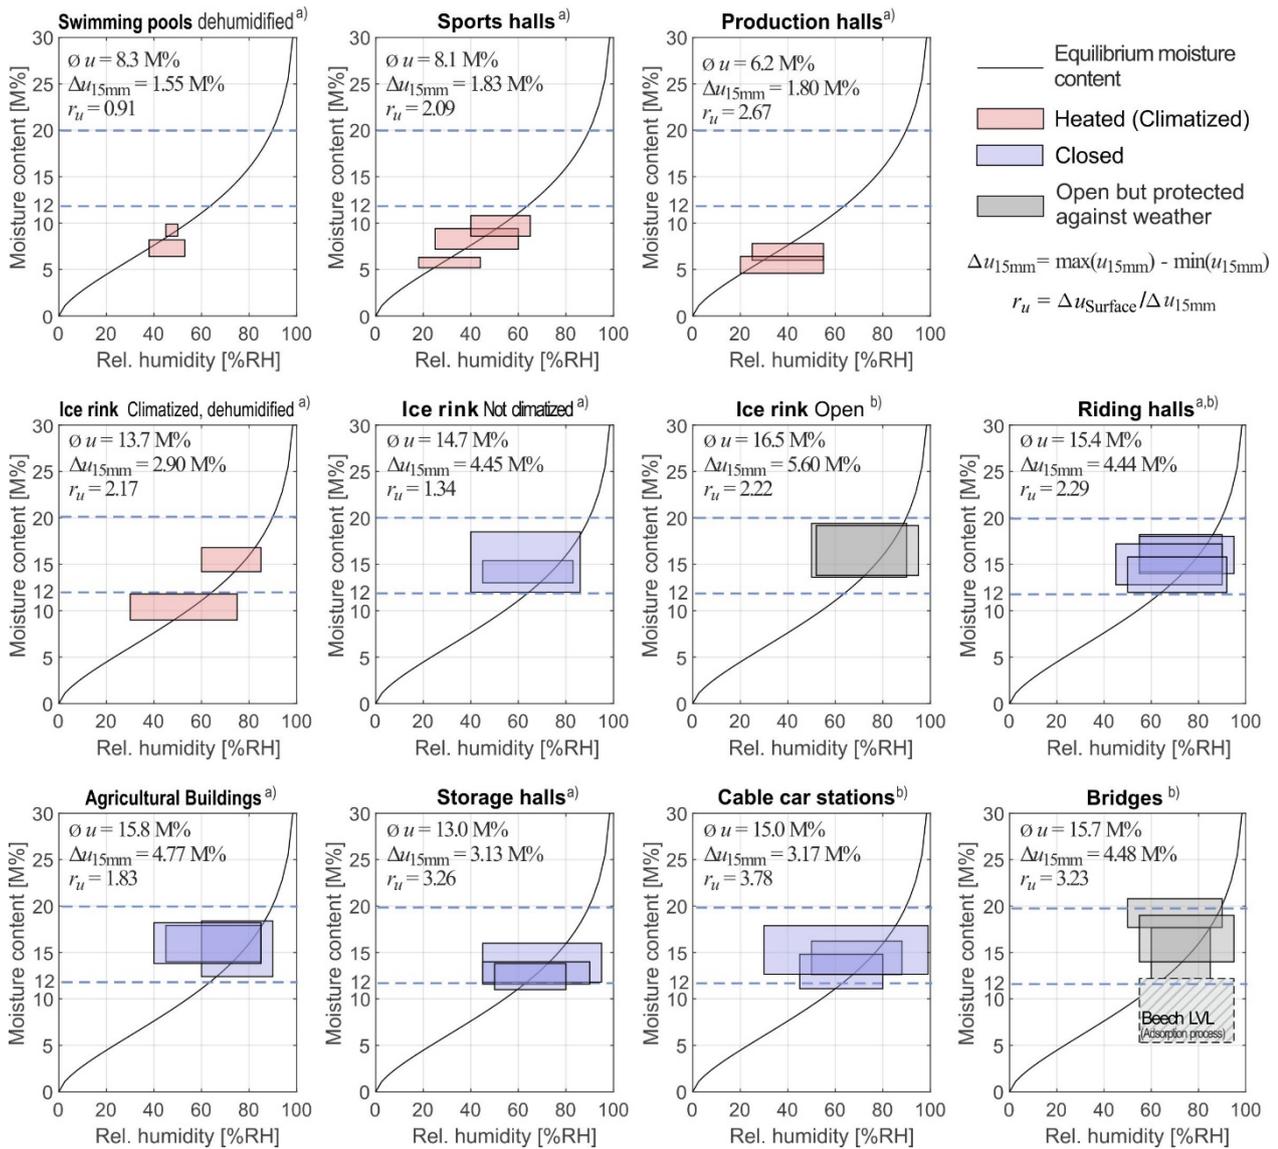
Figure 29: Overview of relation between the envelopes of measured relative humidity and measured moisture content at 15 mm depth from the surface

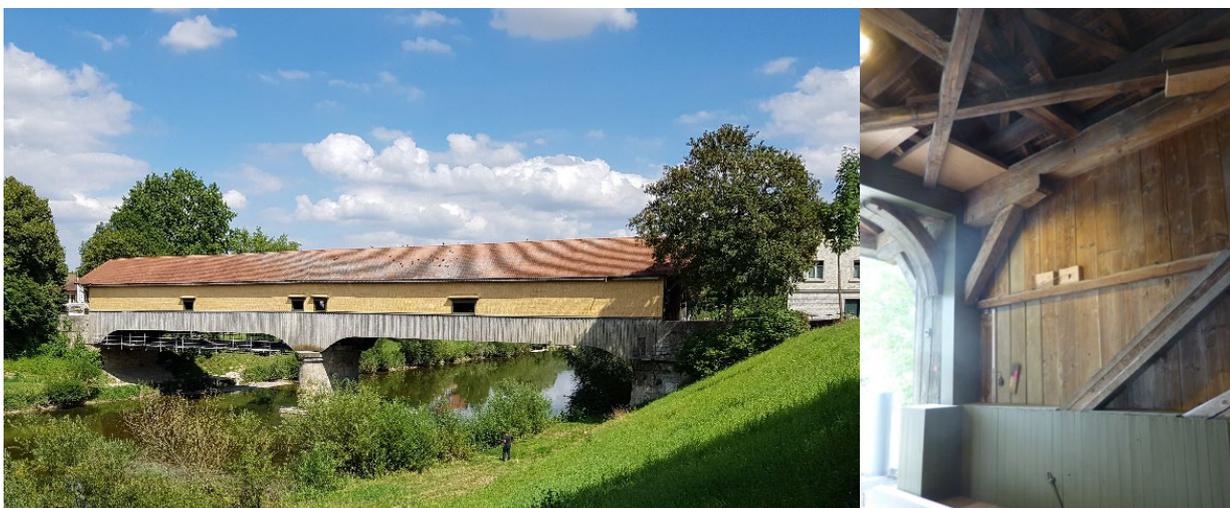
Figure 30: Bridge crossing the Thur in the village of Andelfingen with a view on the instrumentation and two dummy blocks on the north side of the bridge

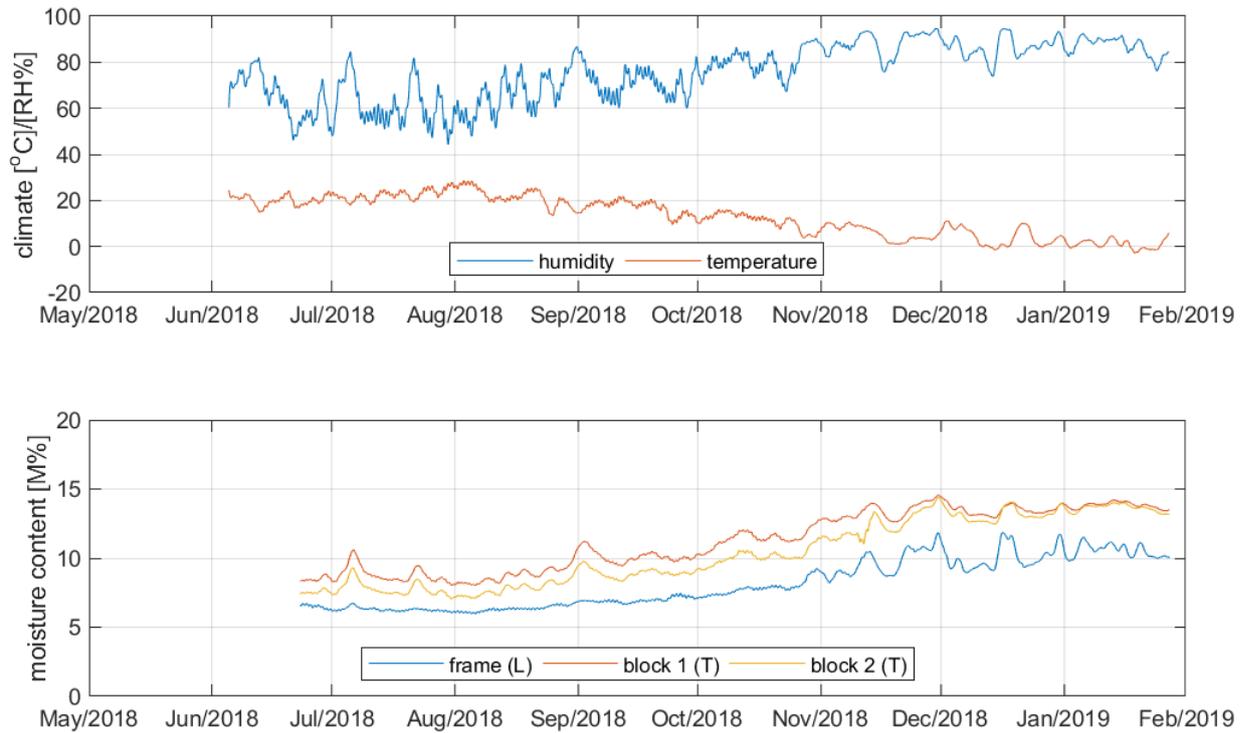
Figure 31: Climate and moisture content measurements made on the bridge of Andelfingen (L: longitudinal and T: transverse)

A summary of the time traces of the measured climate and moisture contents are seen in Figure 31. The instrumentation was performed in the beginning of June 2018. A malfunctioning Gigamodul was replaced two weeks after initial instrumentation. The moisture content at instrumentation is very low due to the low moisture content, around 7 M%, the beech veneer is usually delivered in. During autumn, moisture contents increase faster in the uncoated block members than in the coated load bearing members. Note that the moisture content measurements on the load bearing members were made in longitudinal direction to the grain, those on the uncoated blocks transverse to the grain. The corresponding equations are developed in Section 2.2.8.

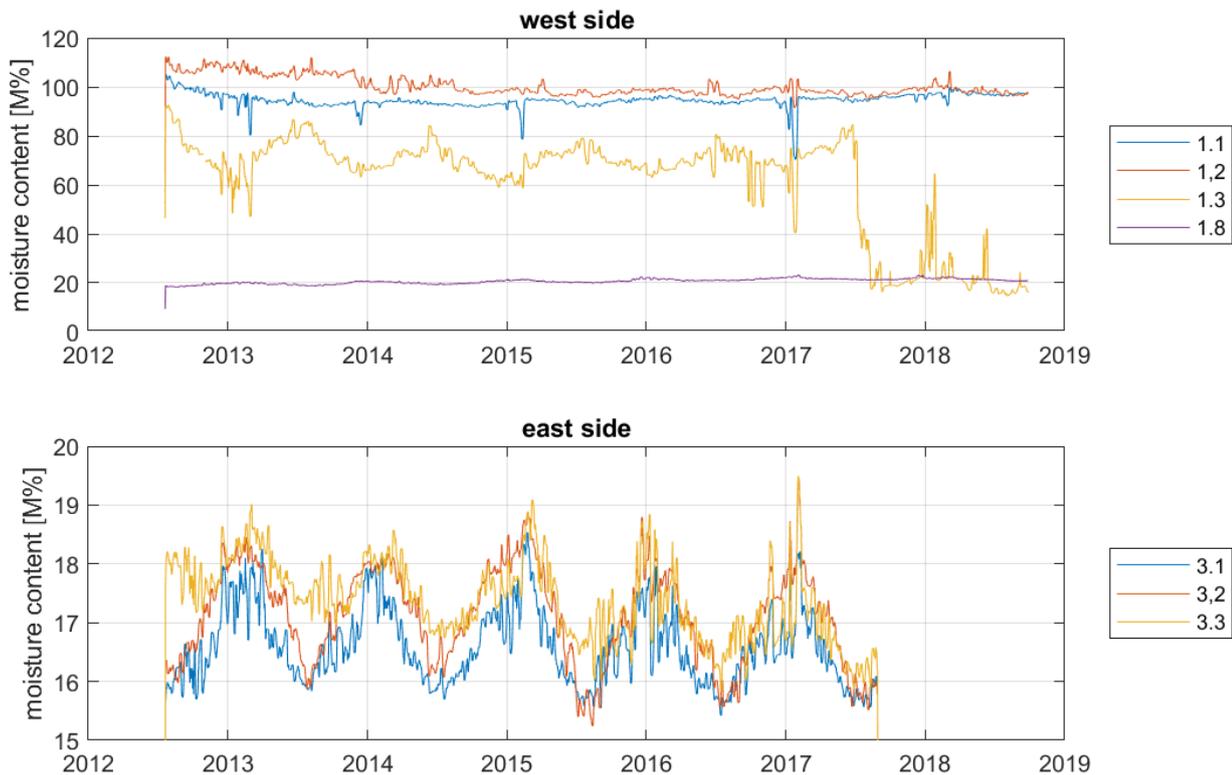
Figure 34: A summary of the moisture content measurements made on the Bubenei bridge

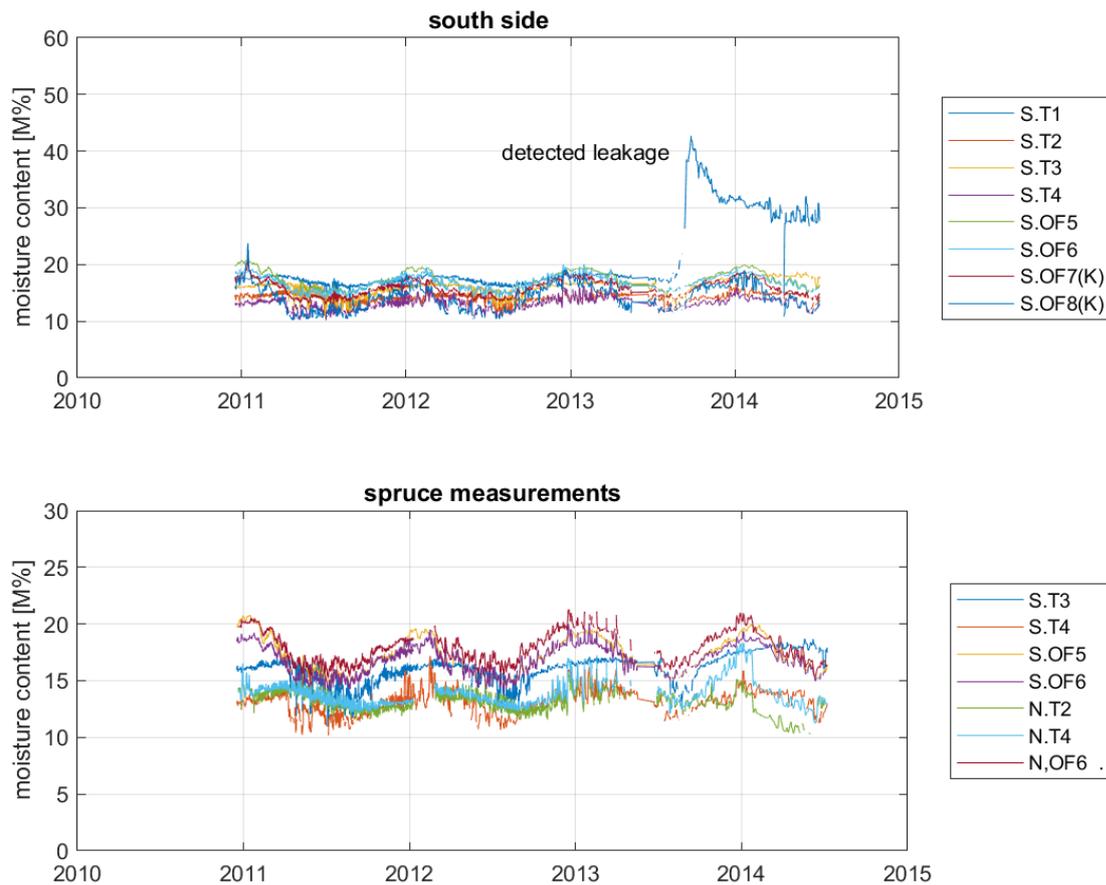
Figure 35: A summary of the moisture content measurements made on the Obermatt bridge where a leakage could clearly be detected thanks to the installed monitoring system.

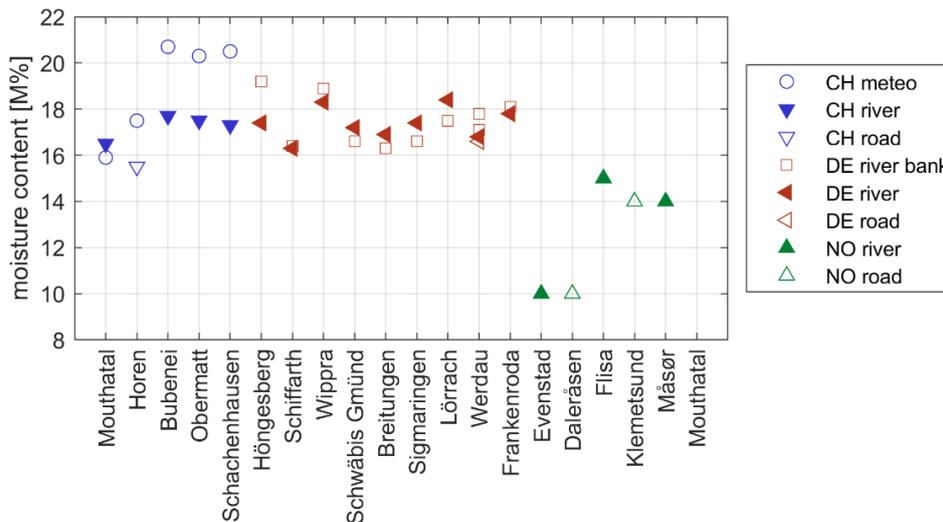
Figure 37: Visualization of measured moisture content in bridges over water and road in Switzerland, Germany, and Norway. Plotted values are averages of available data.

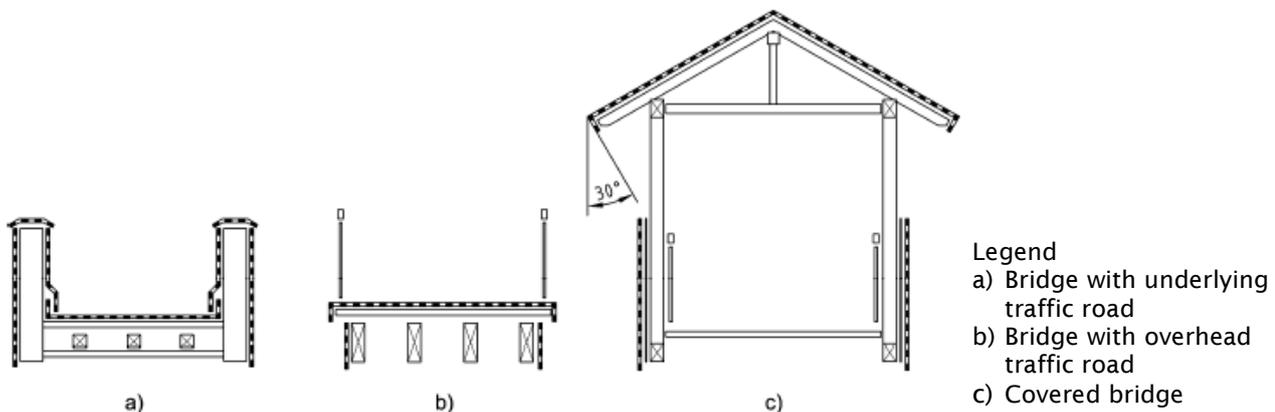
Figure 38: Structural classification of timber bridges, protected bridges according to DIN EN 1995-2/NA:2011

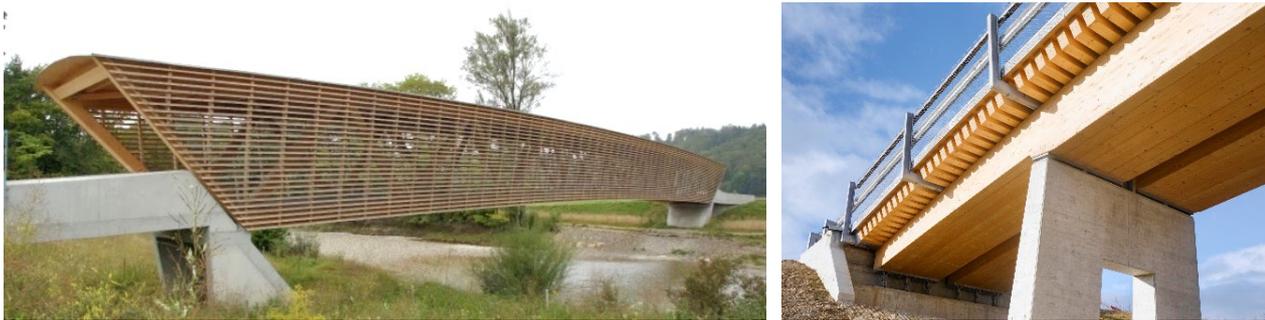
Figure 39: Bridge Neumatt with protected truss system using gladding (left) and Bridge Horen with weather protection by structural overhang

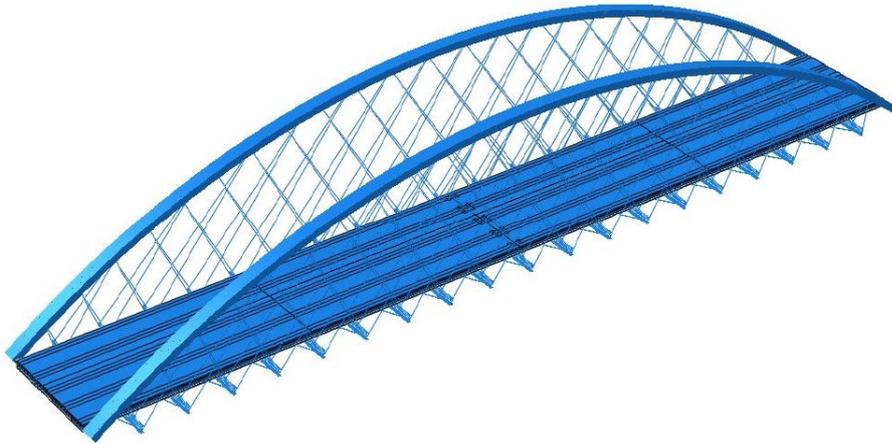
Figure 40: Structural model of a study for a 111 m massive arch bridge with a spoked cable configuration for the road deck (Pousette et al. 2017)

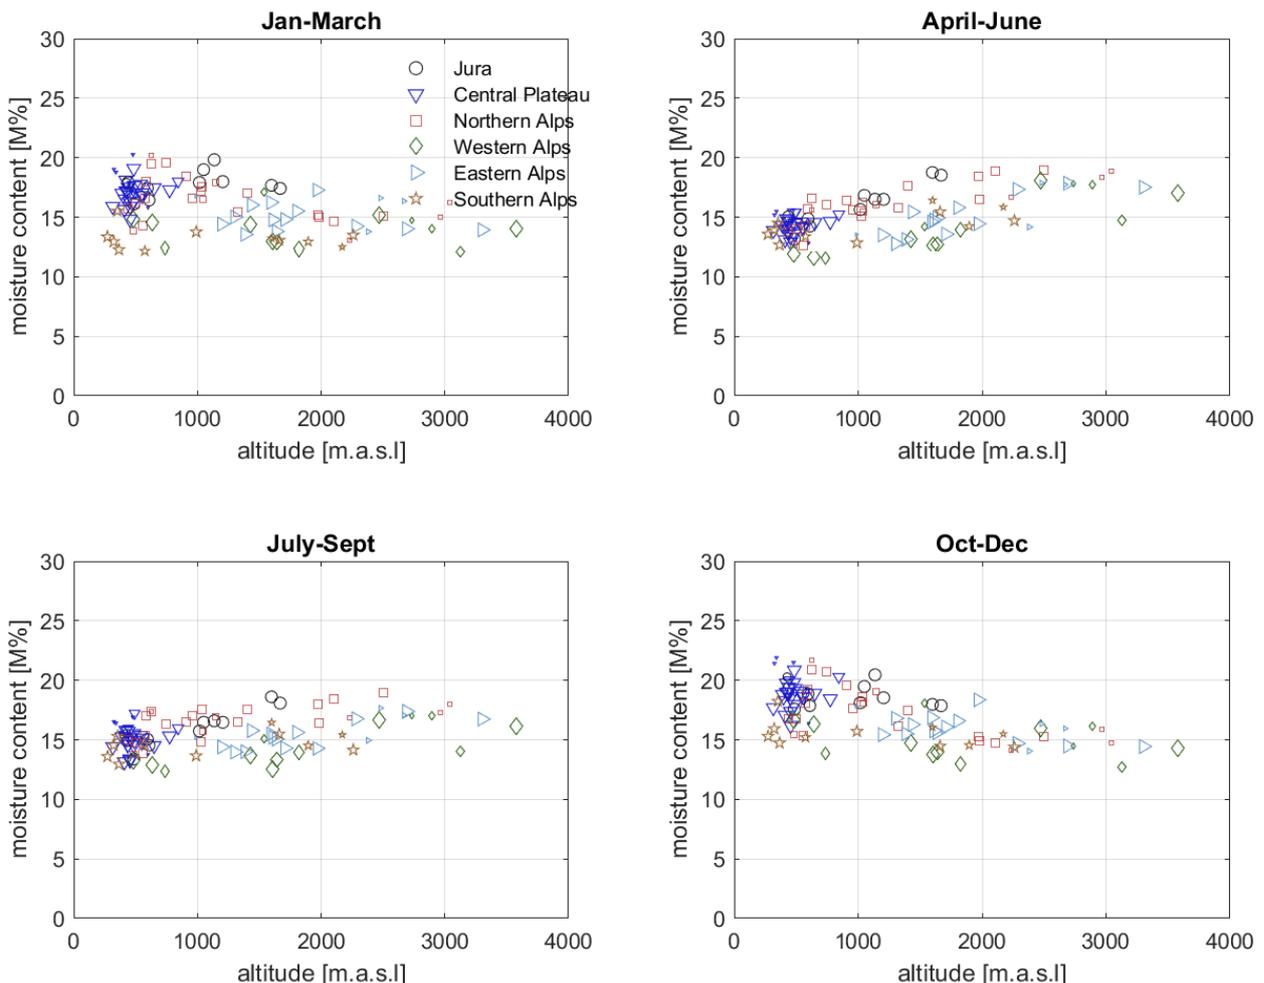
Figure 45: Dependency of moisture content on season, location, and altitude

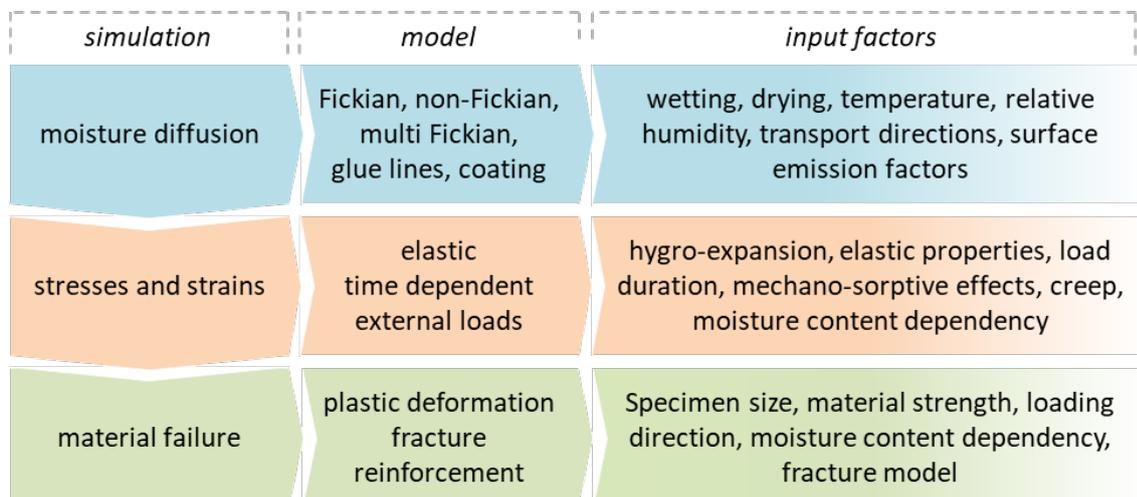
Figure 47: Schematic model of modelling moisture induced stresses and following failure of (local) material

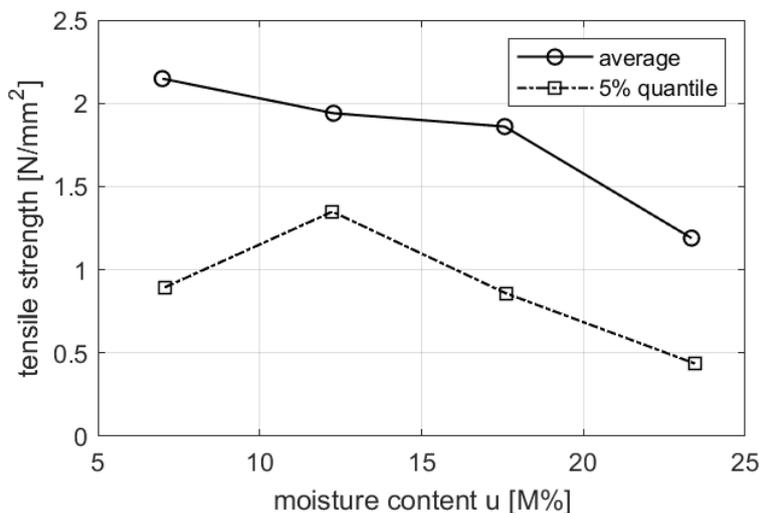
Figure 52: Measured strengths perpendicular to the grain depending on the moisture content by Möhler and Steck (1980) on specimens with a cross-section of 30 mm x 30 mm

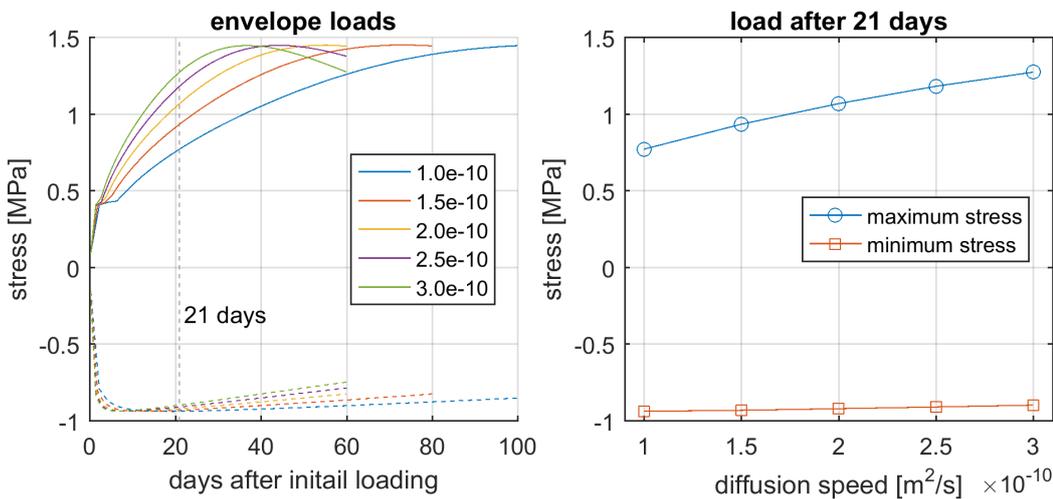
Figure 54: Development of moisture induced stresses in a 200 mm wide cross-section loaded by a stepwise moisture increase of 6 M%

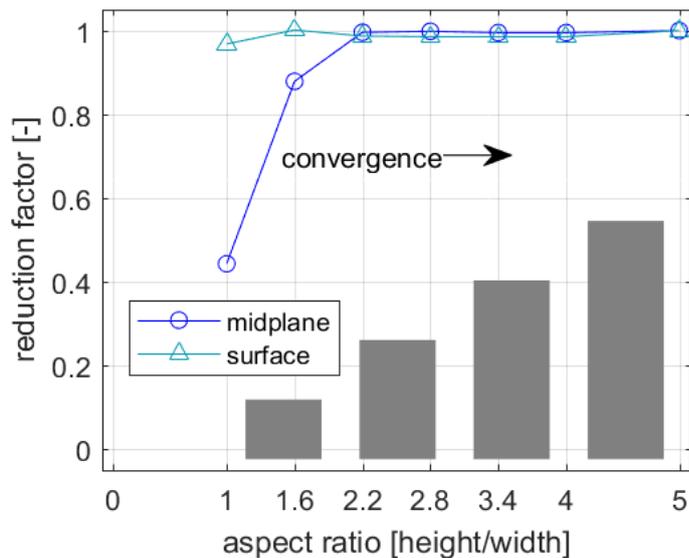
Figure 60: Effect of aspect ratio on stress levels on the surface and midplane of a glulam cross-section

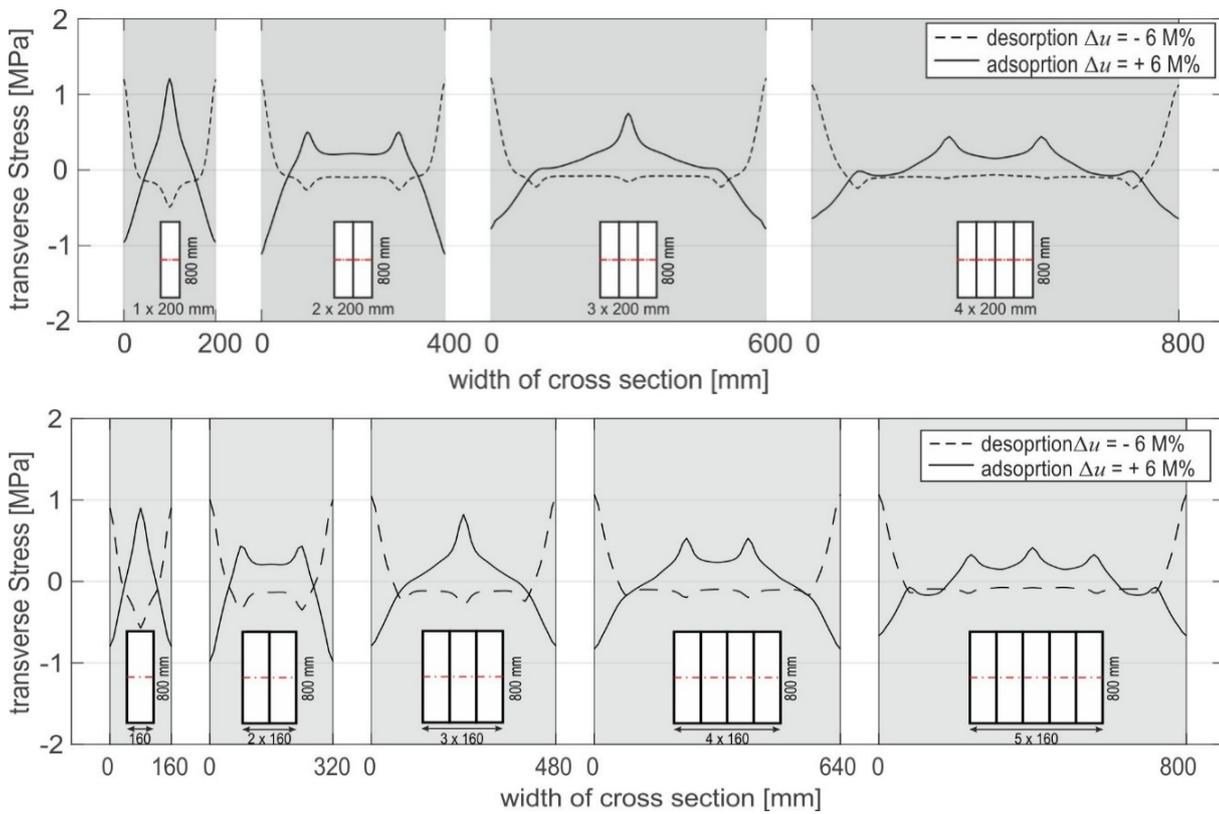
Figure 61: Transverse stress depending on the width of the cross-section, step load
