Quality assurance of timber structures

Research report

Report Nr.	77FE-008098-V01
Contract Nr.	2016.17
Classification	Public
Date	24.01.2019
Client	Bundesamt für Umwelt BAFU Abteilung Wald, WHFF CH-3003 Bern
Address of the research unit	Bern University of Applied Sciences Institute for Timber Constructions, Structures and Architecture Solithurnstrasse 102, CH-2504 Biel 6 Tel / Fax +41 (0)32 344 03 41/91 www.ahb.bfh.ch
Authors	Bettina Franke, Steffen Franke, Marcus Schiere, Andreas Müller
Project Leader	Prof. Dr. Steffen Franke
Head of the Institute	Prof. Andreas Müller

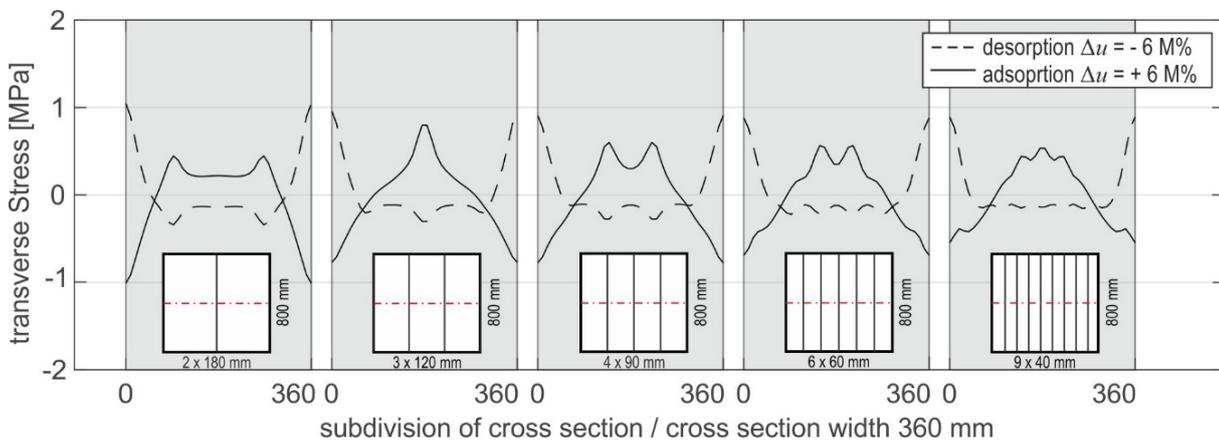
Figure 62: Transverse stress with different number of beams used in a same cross section width, step load

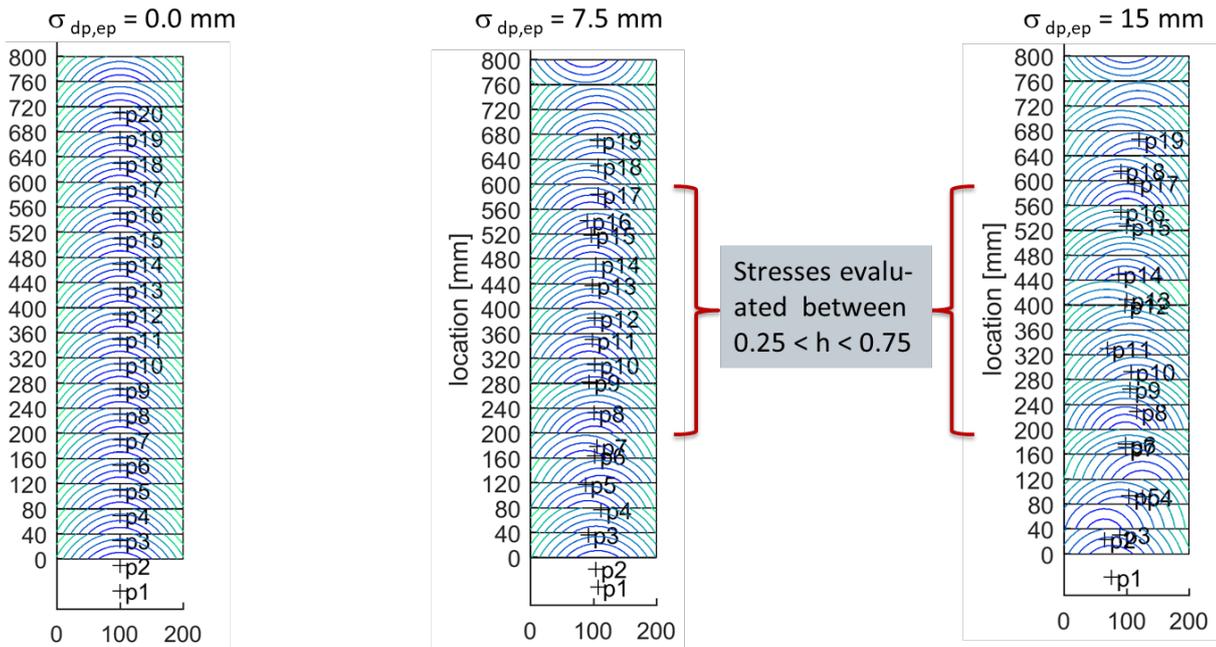
Figure 64: Glulam beam layout in the idealized condition (left) and the more realistic conditions (middle and right).

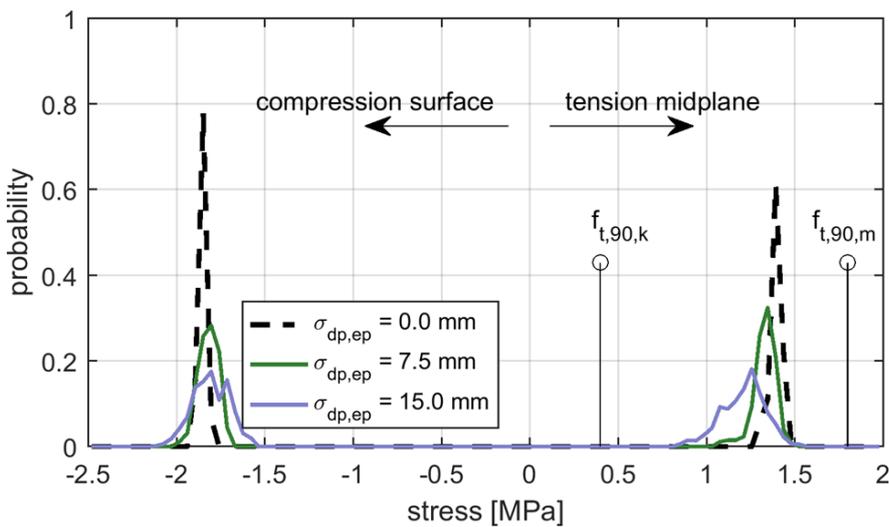
Figure 65: Effect of pith spread on minimum and maximum stresses occurring in the midplane and surface under wetting loads

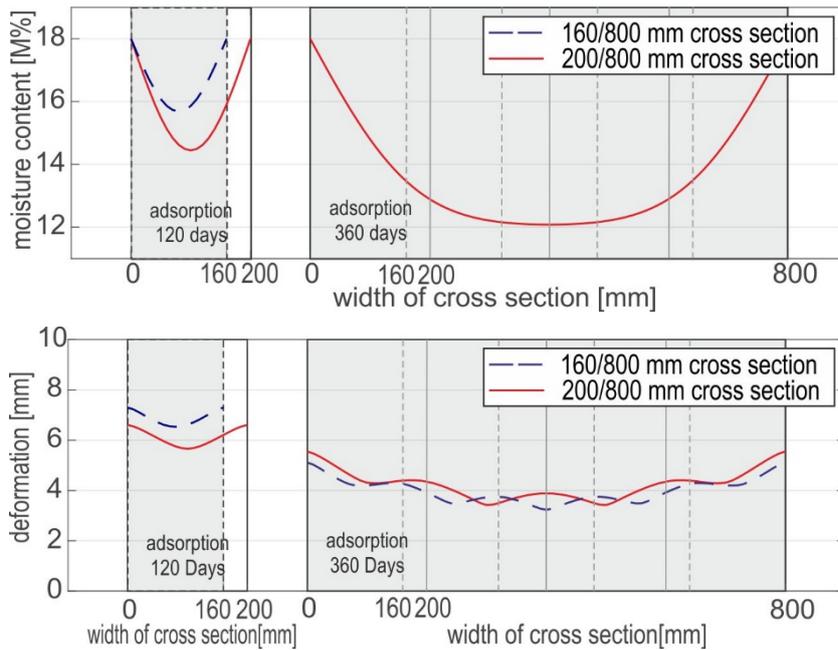
Figure 66: Deformation of timber beams of different widths subjected to step loads of 6 M% moisture content increase. All beams have a height of 800 mm and the duration of the simulations is indicated in the figures. The bottom plot shows the moisture content distributions.

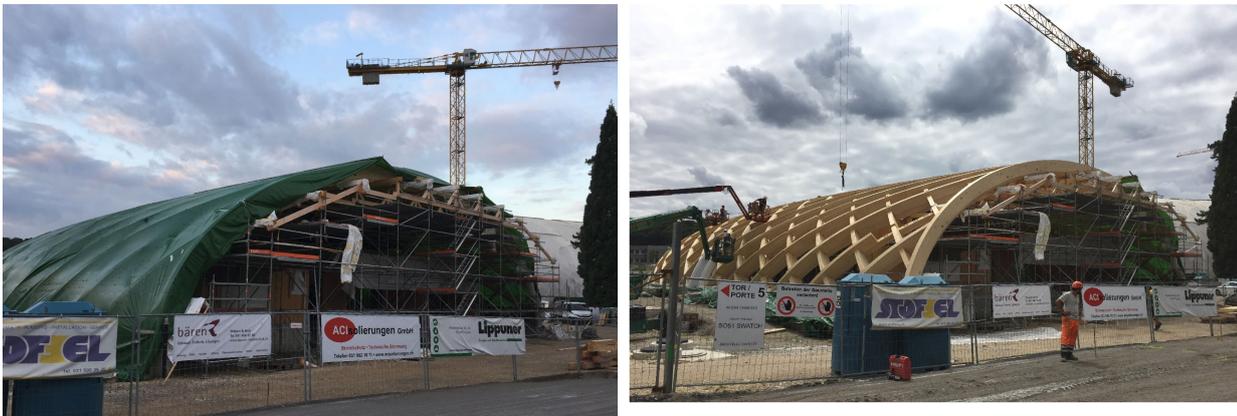
Figure 67: Efficient protection during evenings, nights and weekends or during rain; removing of the protection during the working times (Swatch building, Biel/Bienne)

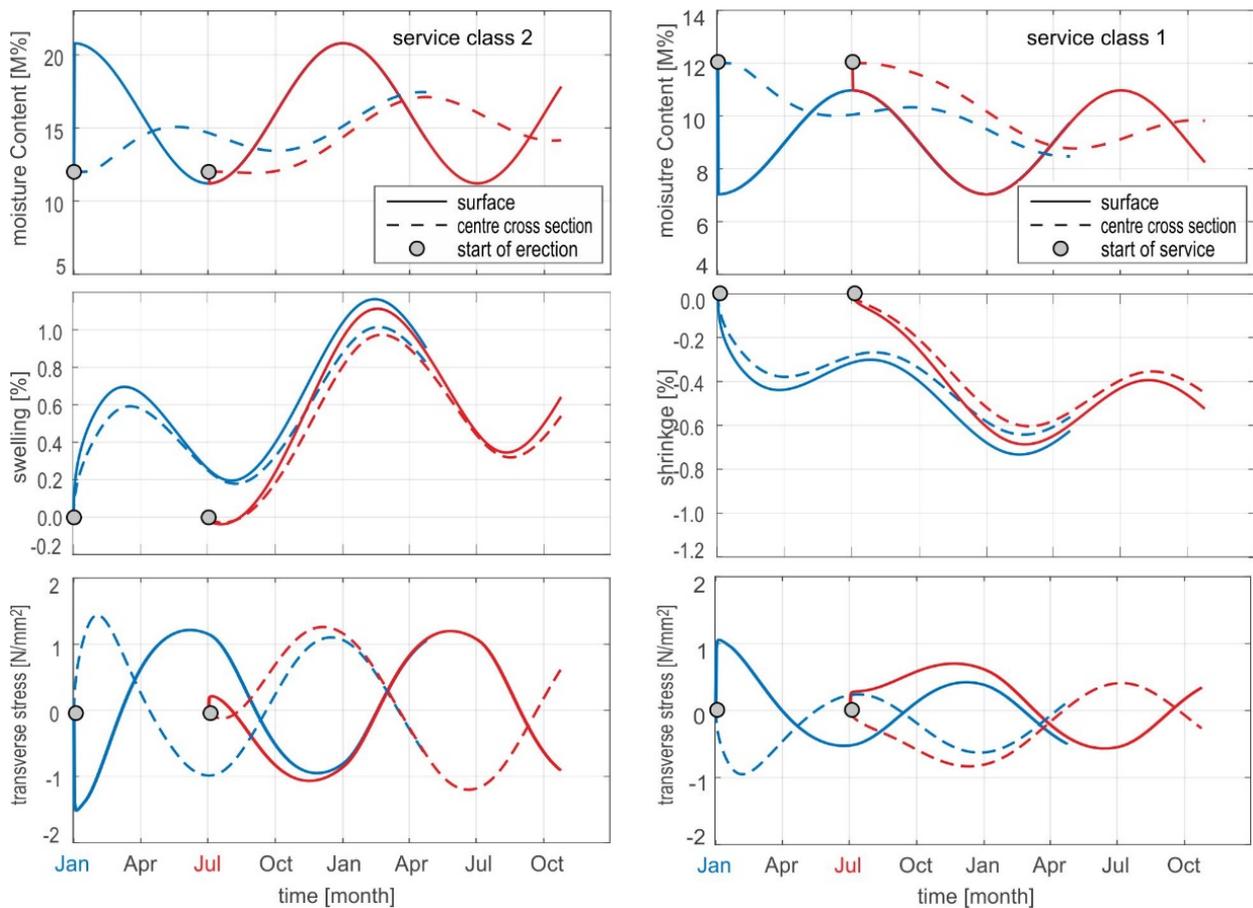
Figure 68: Results of the moisture content (left) and transverse stresses (right) for a cross section of 200/800 mm in Service Class 1 and 2 including seasonal changes of the ambient climate

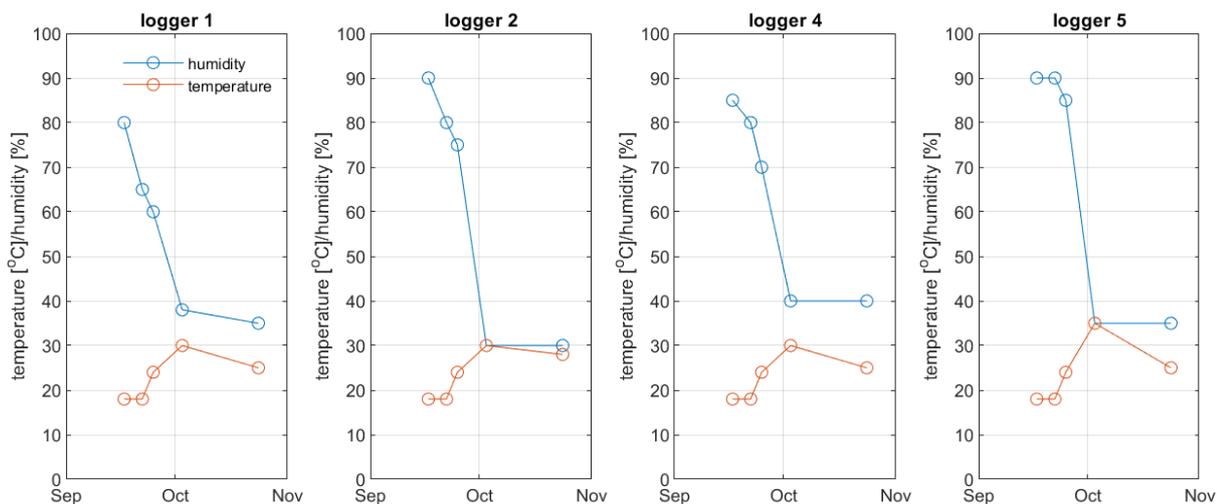
Figure 69: Summary of the measured humidity and temperature obtained from ‘Quellgarten’ on four out of six loggers (raw data not used)

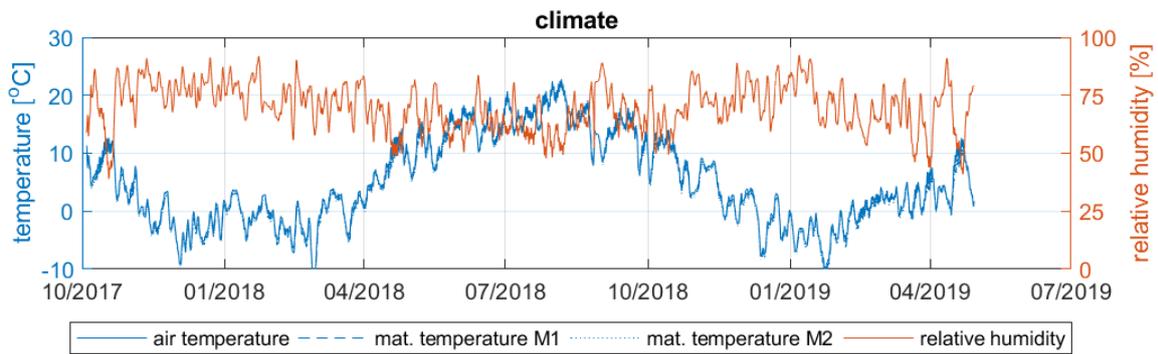
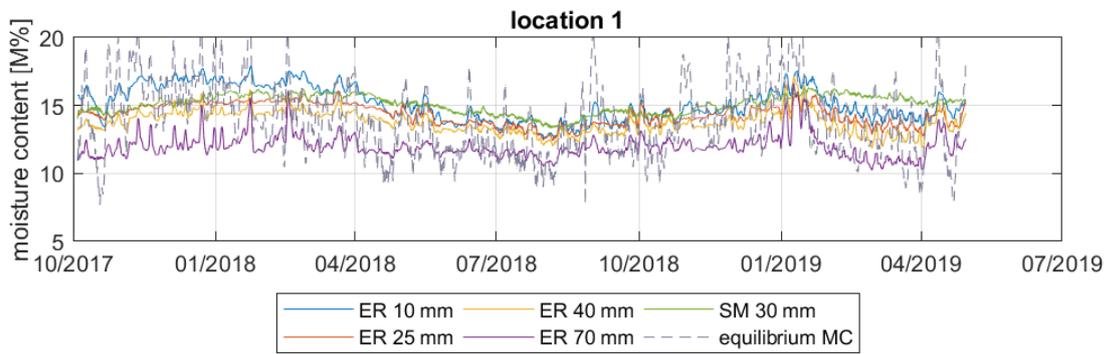
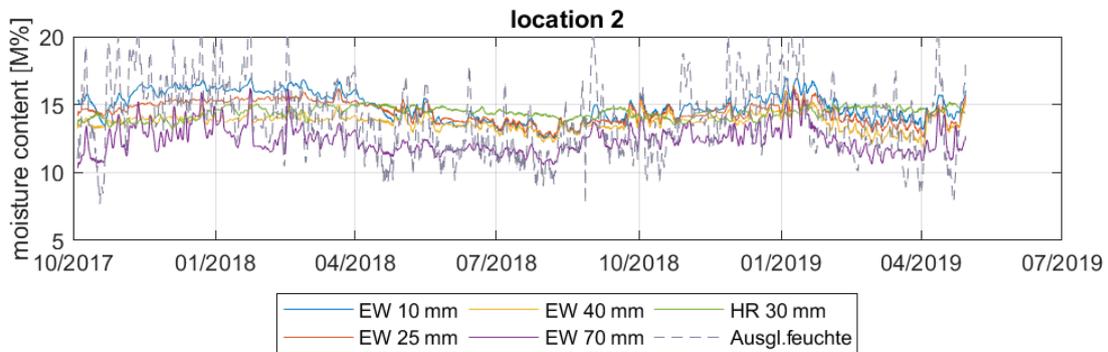
Figure 2: Measured climate and moisture content in the cable car station of Andermatt

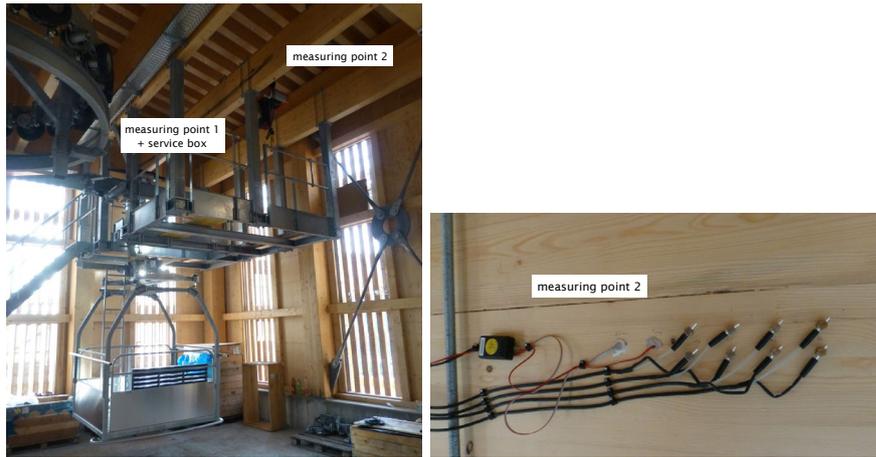
Figure 3: Measured climate and moisture content in the cable car station of Nättschen

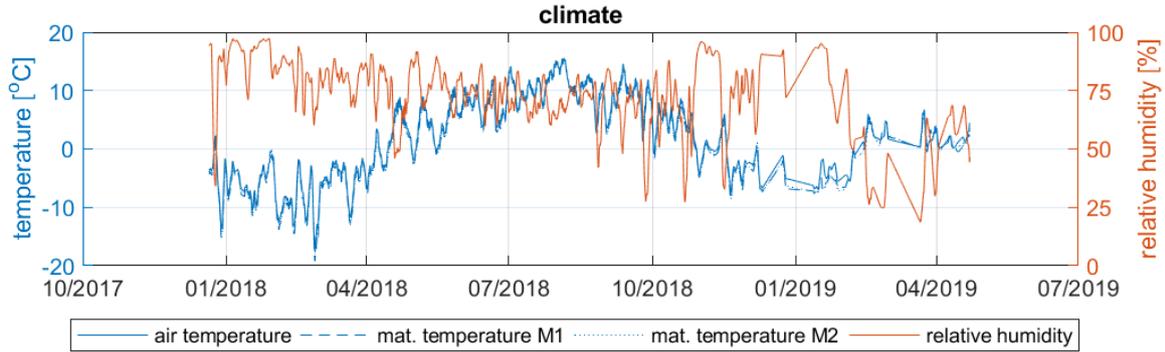
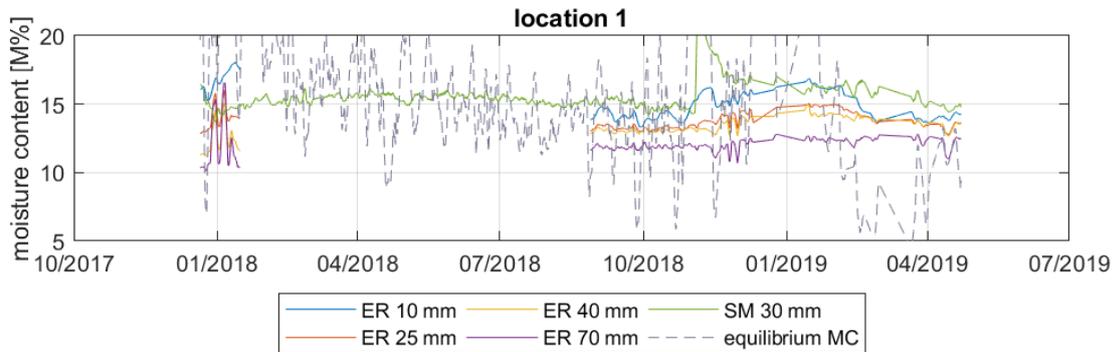
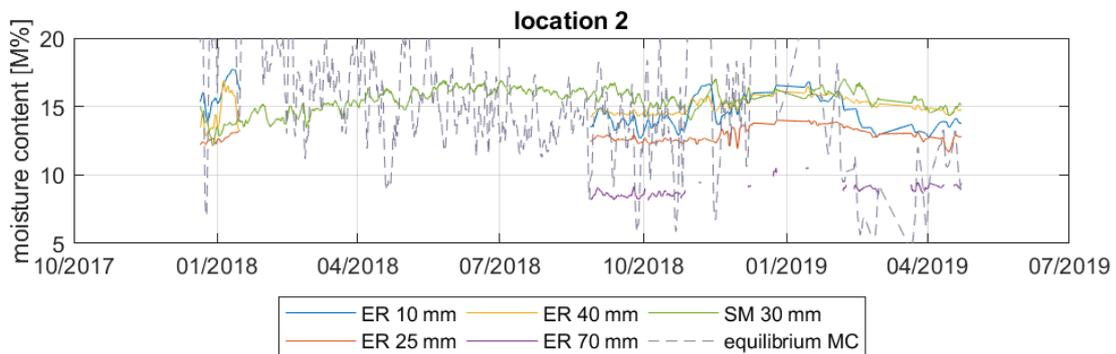
Figure 4: Measured climate and moisture content in the cable car station of Schneehüenerstock

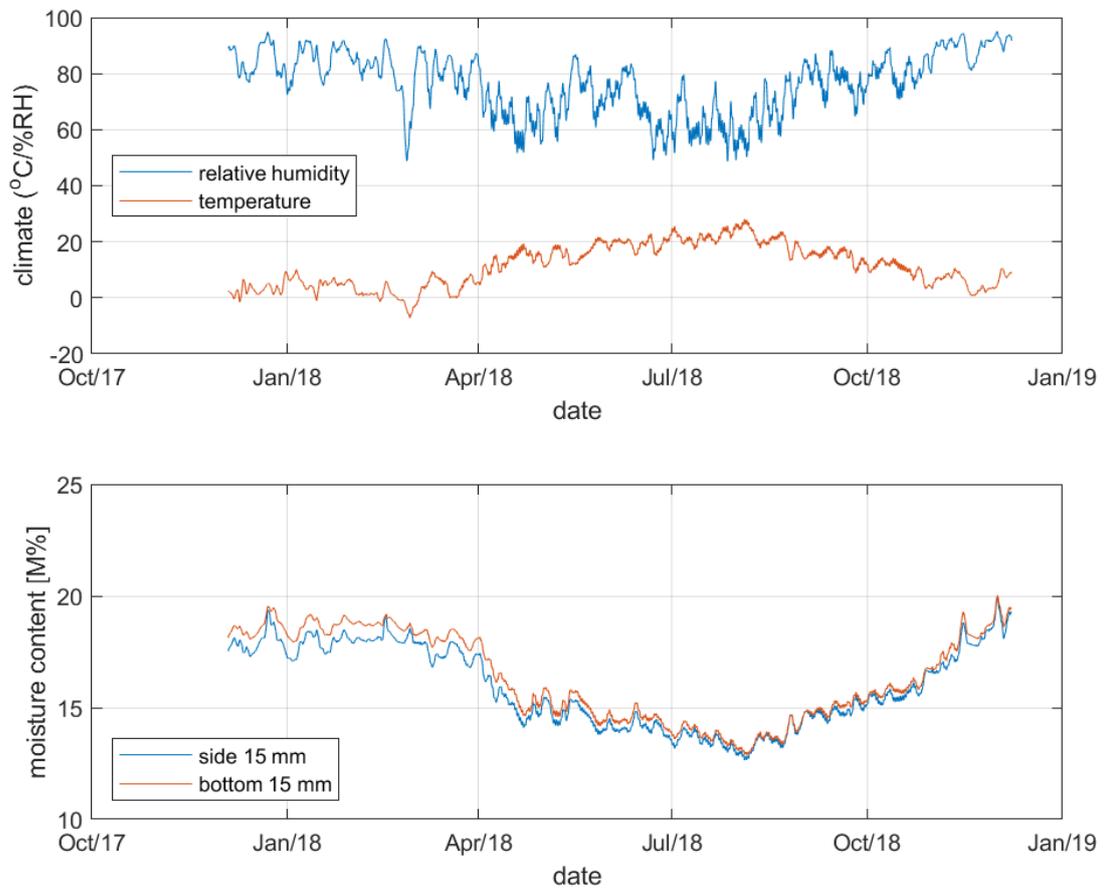
Figure 8: Measured climate and moisture content in the ice rink of Delémont

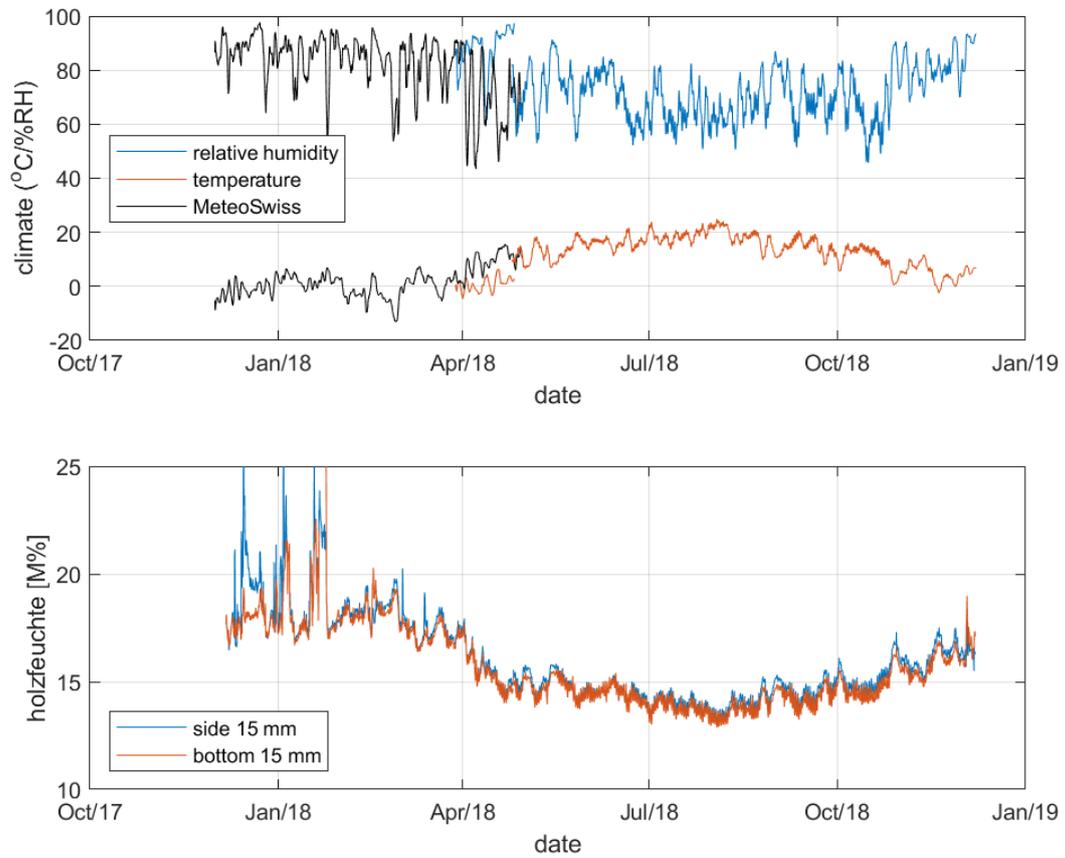
Figure 9: Measured climate and moisture content in the ice rink of Le Locle

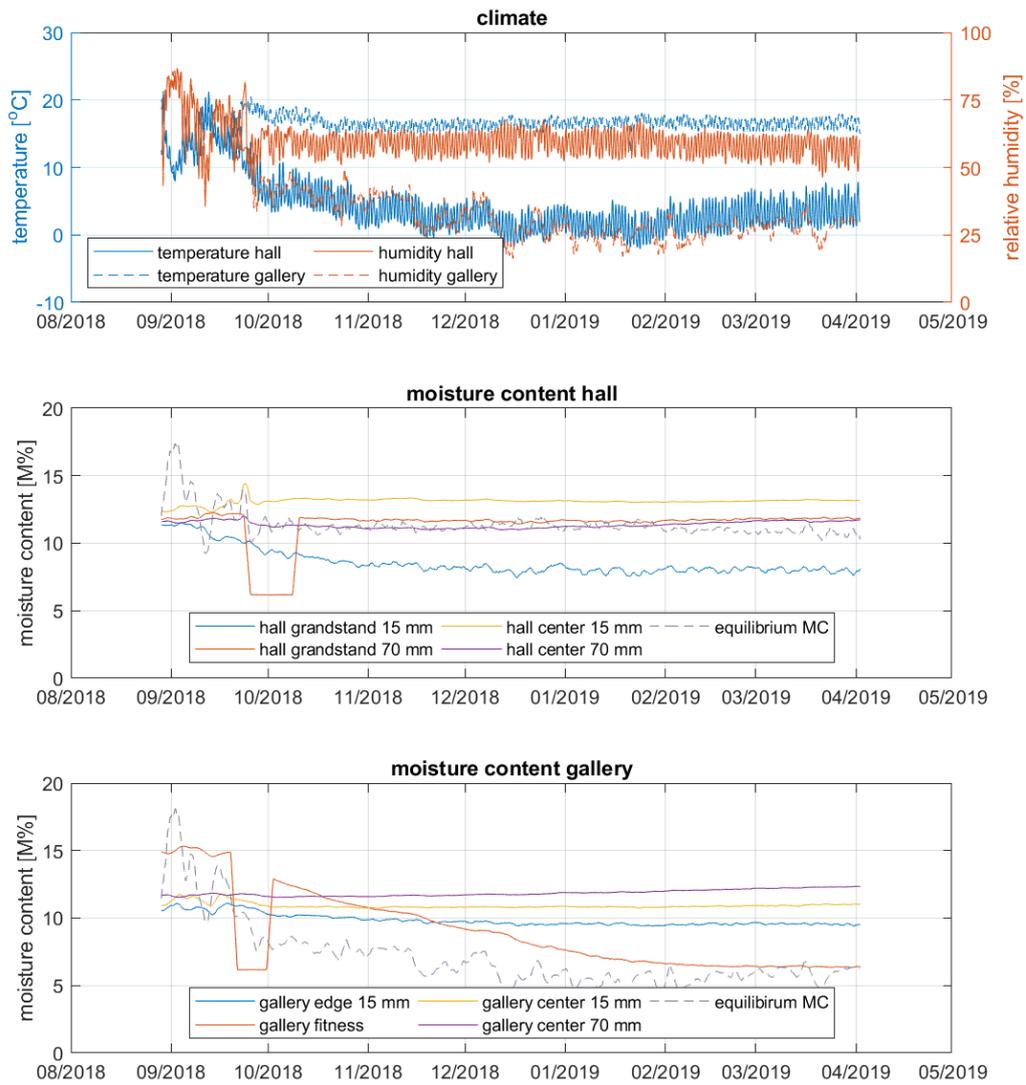
Figure 11: Measured climate and moisture content in the ice rink in Davos

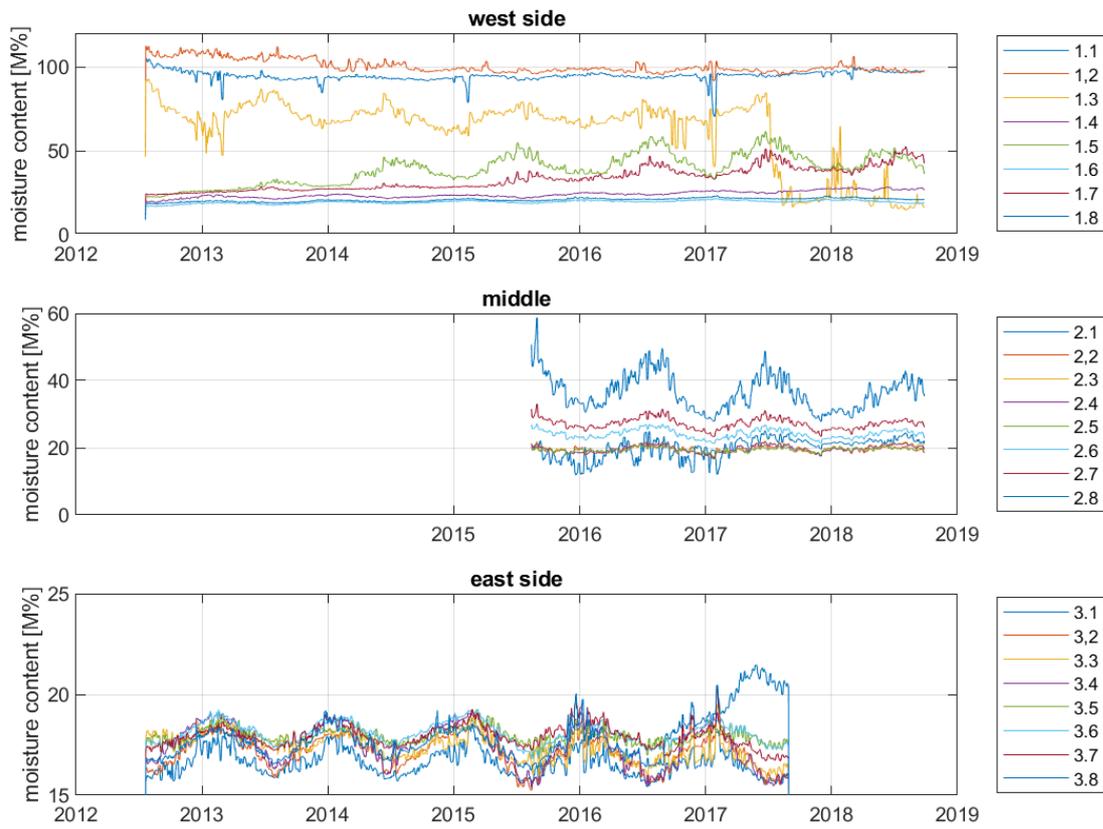
Figure 13: Moisture content measurements made on the Bubenei bridge during about six years

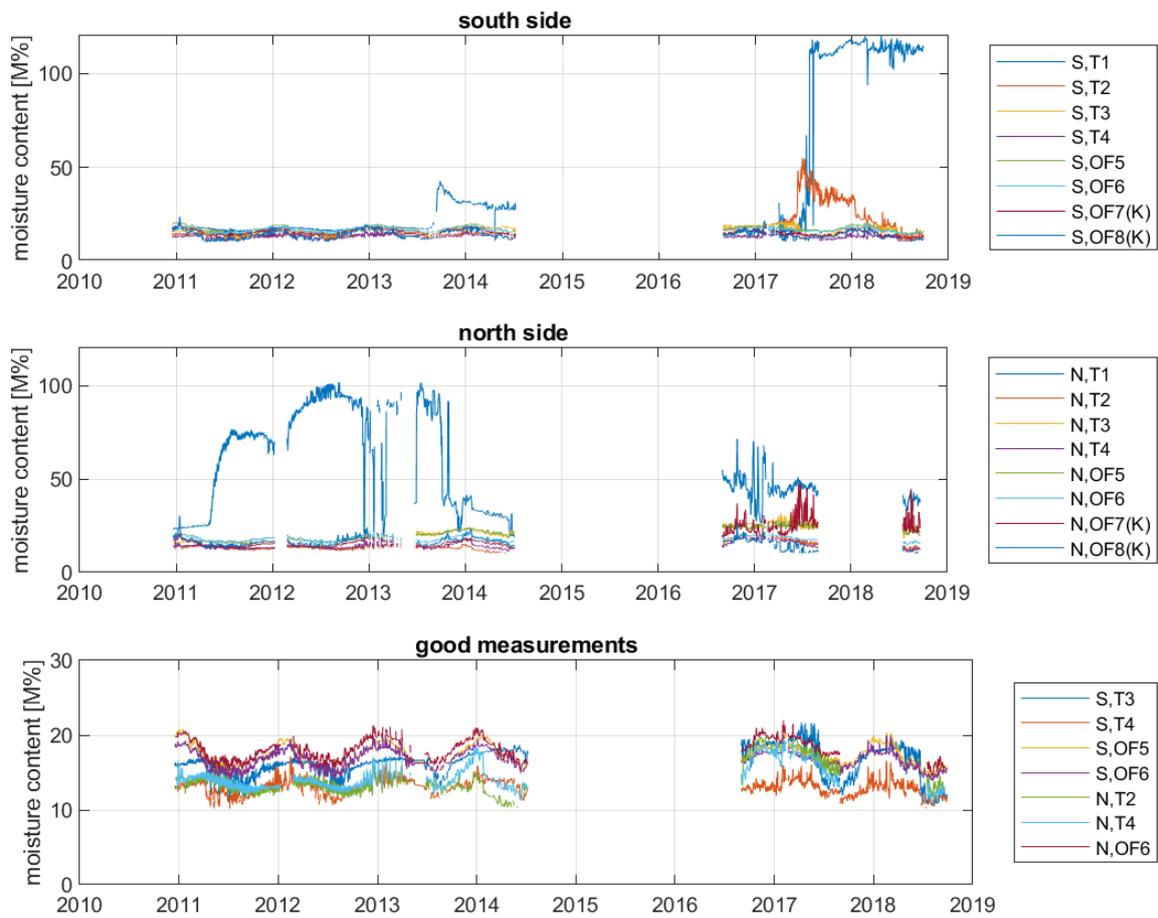
Figure 14: Measured moisture content made on the Obermatt bridge during almost eight years including a gap of two years

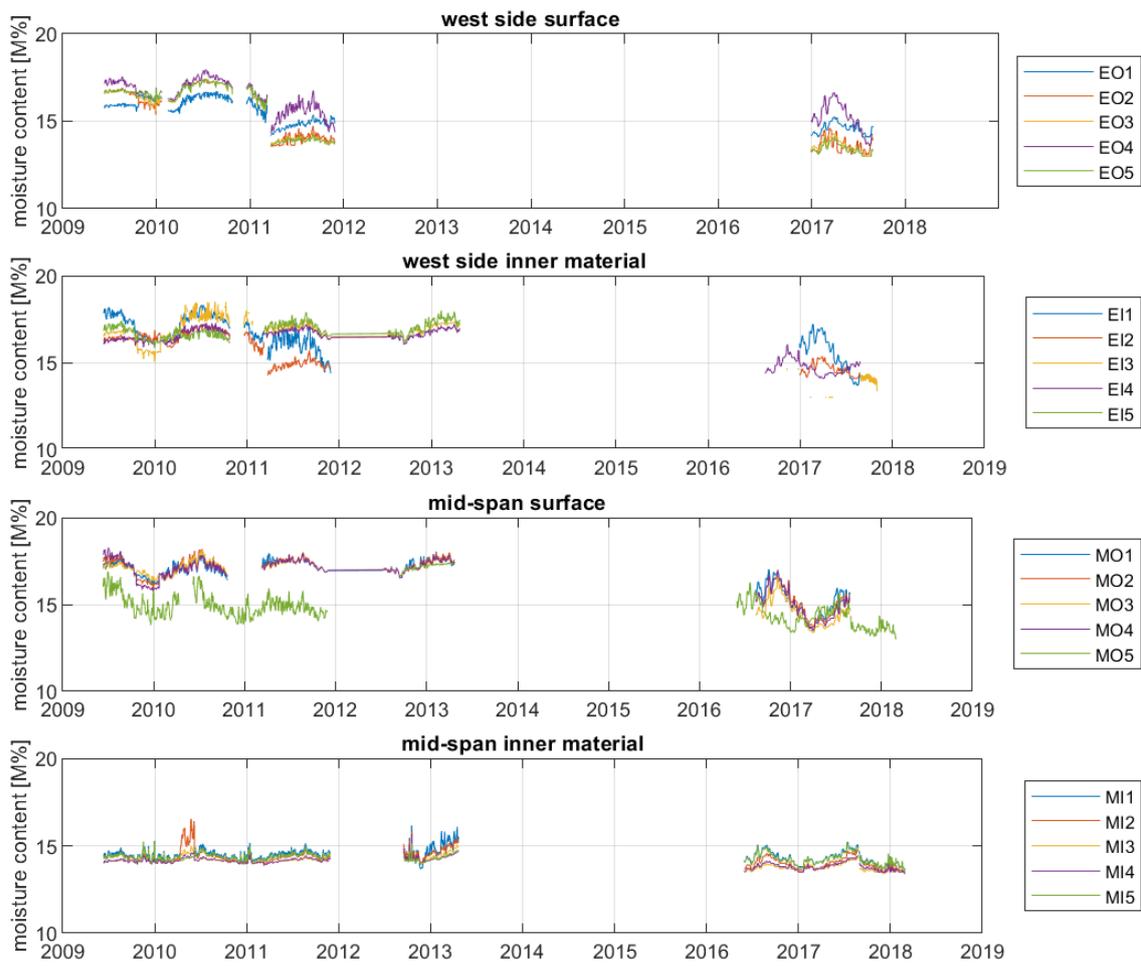
Figure 15: Measured moisture content at the Horen Bridge during almost ten years with a gap of four years

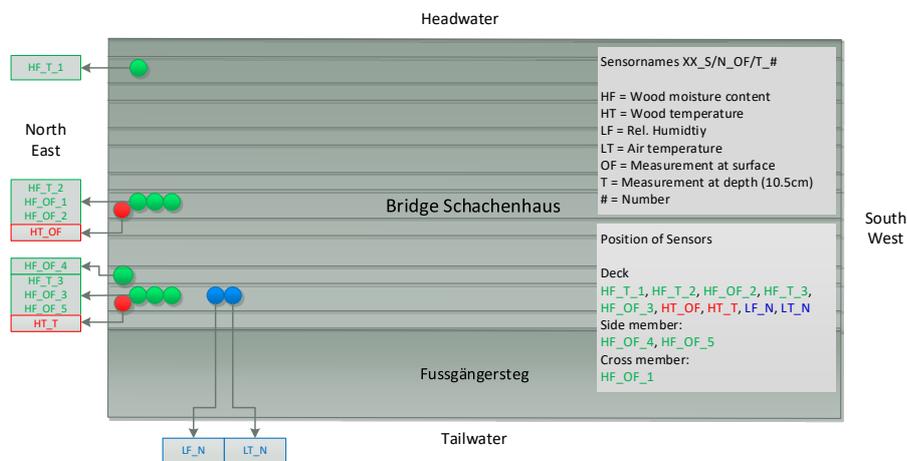
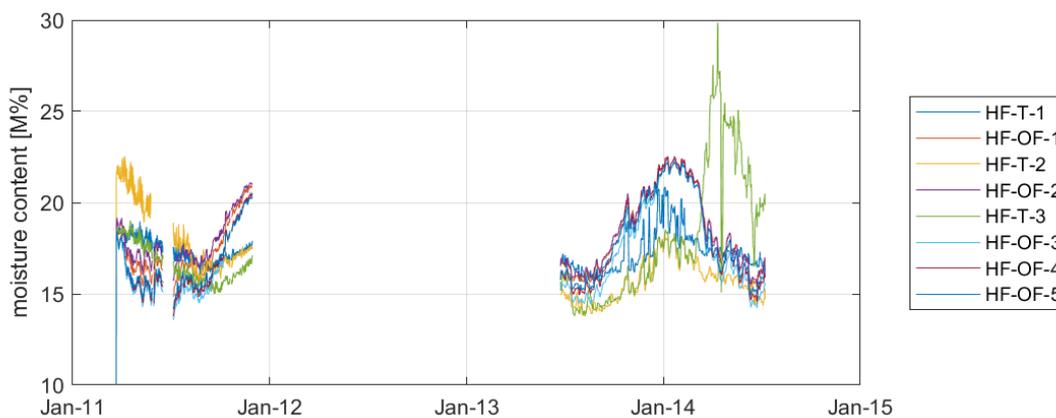
Figure 16: Measured moisture content on the Schachenhaus bridge

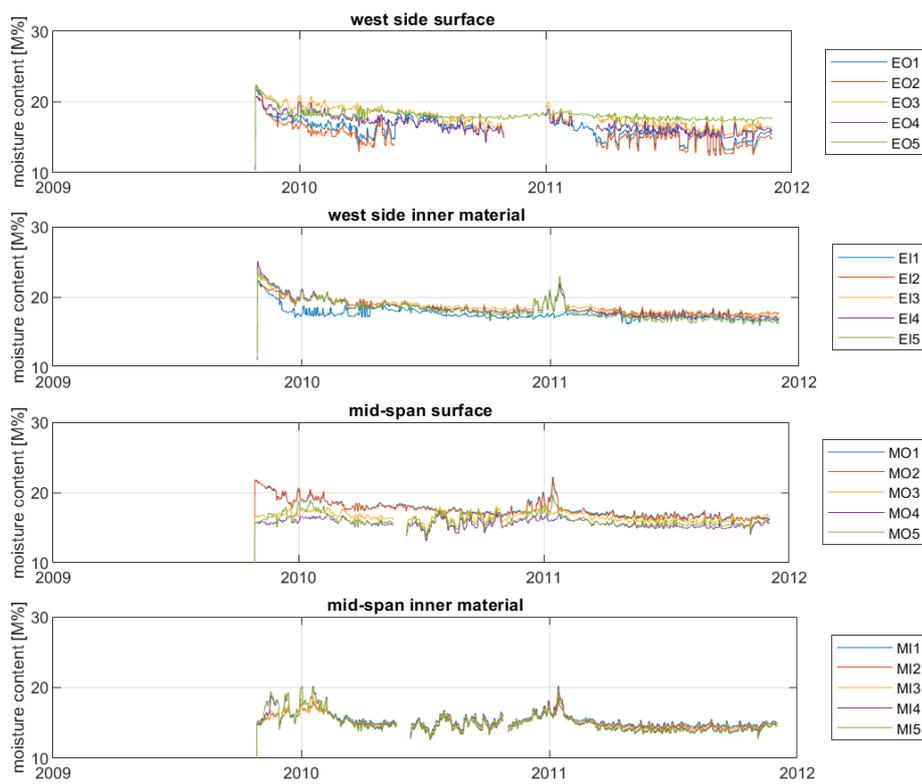
Figure 17: Measured moisture content on the bridge of Muotathal made on two different depths from the end grain of the arches

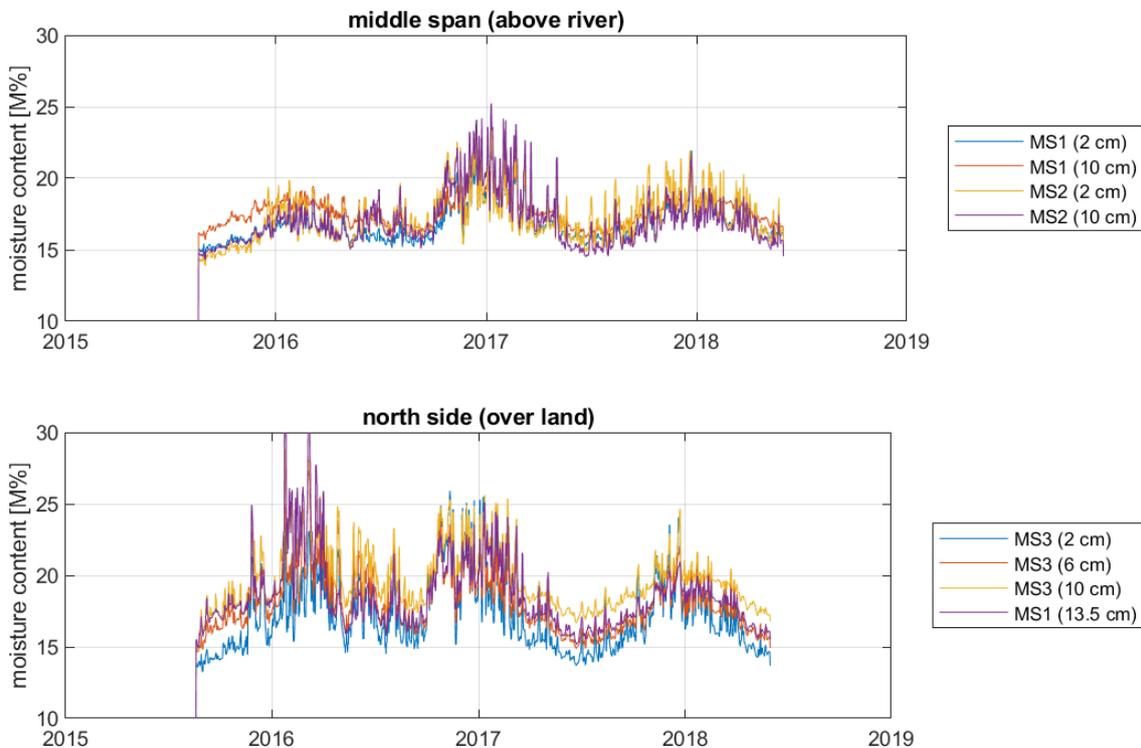
Figure 18: Measured moisture content on the Hoengesberg bridge (DE) over a river (above) and over land (below)

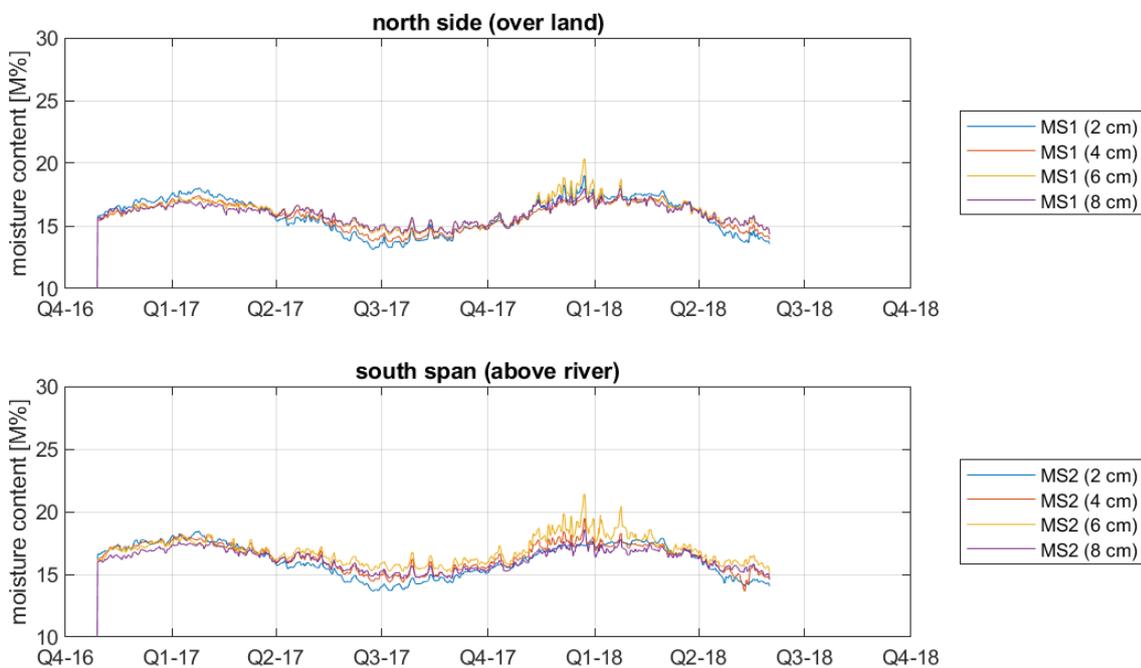
Figure 19: Measured moisture content made on the bridge of Schwäbis Gmünd (DE) for nearly two years

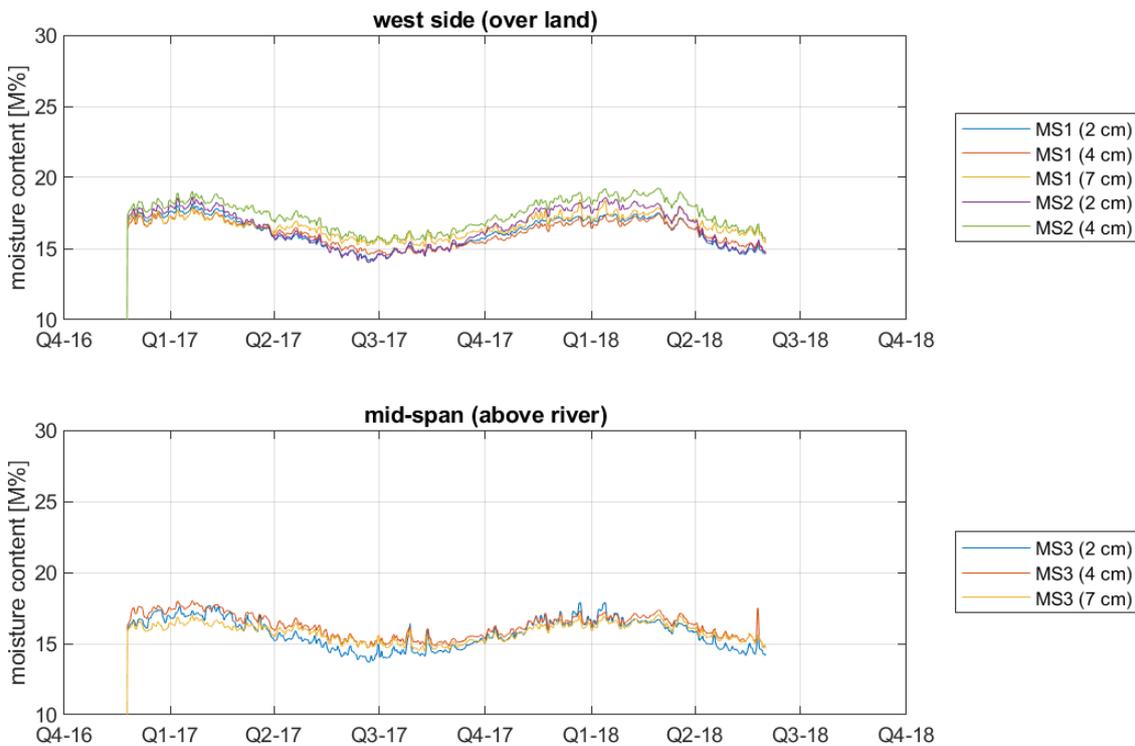
Figure 20: Measured moisture content on the bridge Werdau (DE) for nearly two years

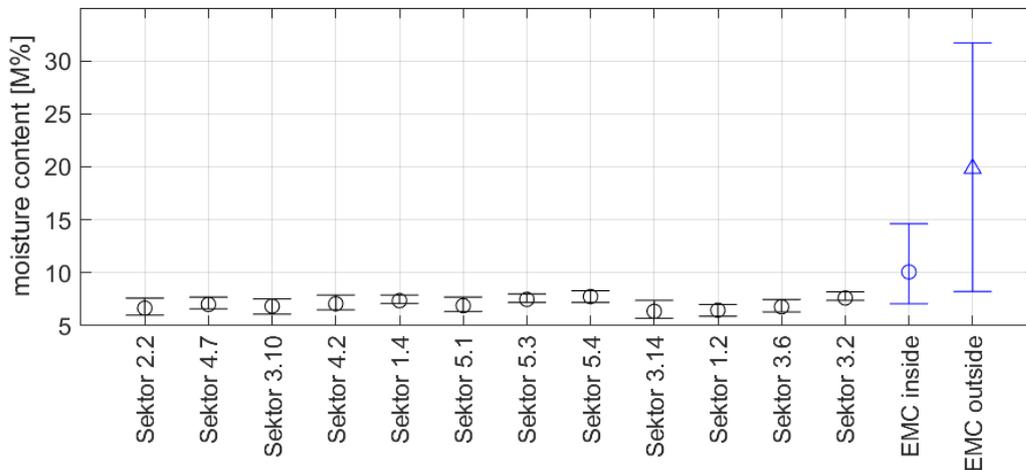
Figure 21: Box plots of wood moisture contents measured in the roof structure. The data was measured from September 2014 to June 2017. The theoretical equilibrium moisture content was calculated using data from the climate loggers in the building.
